C.T. MALE ASSOCIATES

Engineering, Surveying, Architecture & Landscape Architecture, D.P.C.

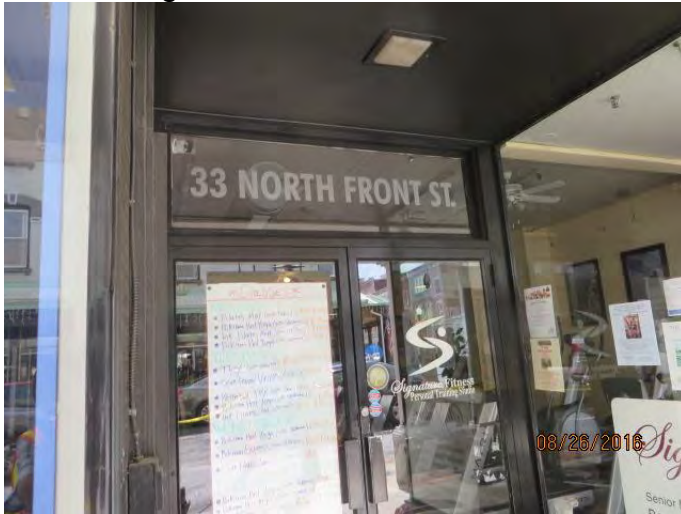
Photo 2 Reported leaks on interior surface of front display window

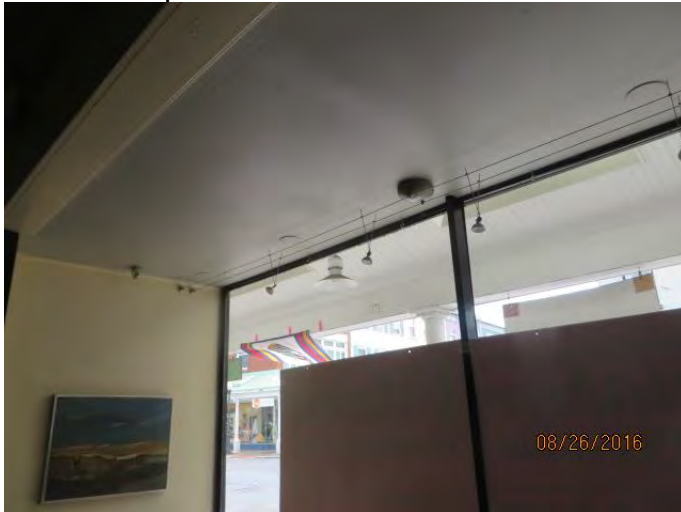
Photo 3 Close up of photo 2, see dried water streaks

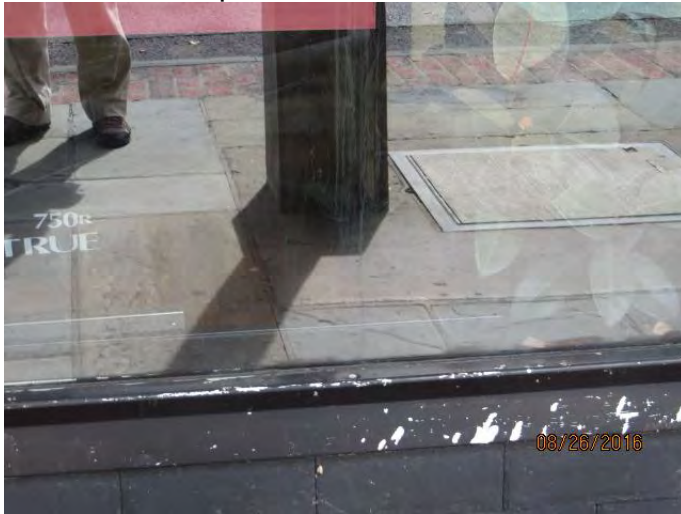
Photo 5 Deteriorated wood infill panel below air conditioner

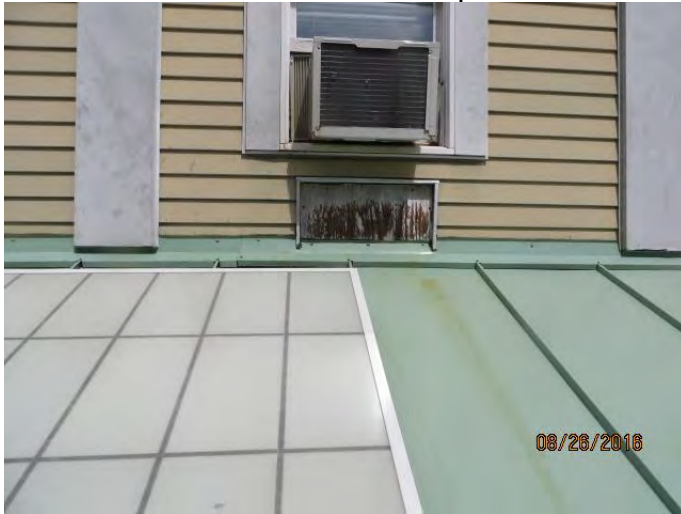
Photo 6 Close up of photo 5

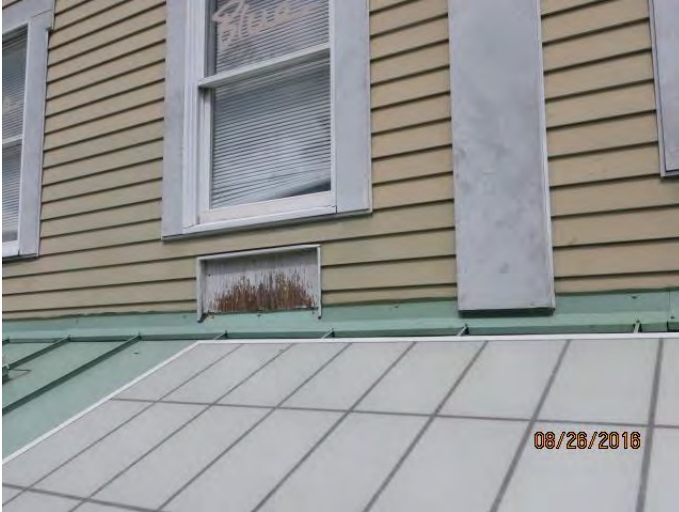
Photo 8 Partially filled gutter

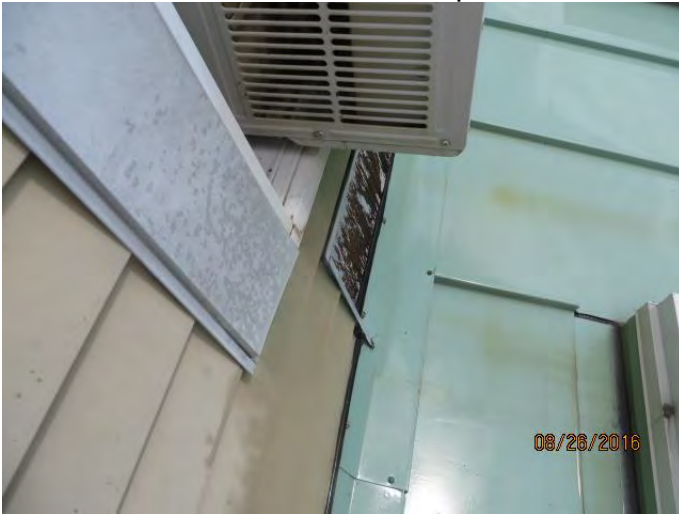
Photo 10 Opening between deteriorated wood infill panel and green metal base flashing

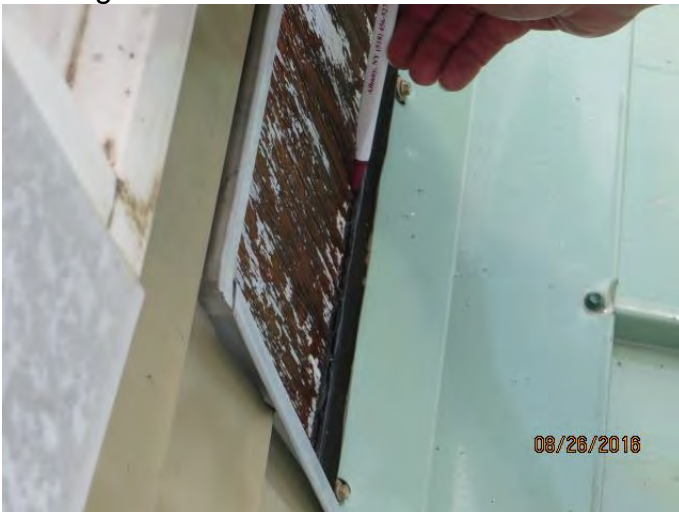
Photo 11 Close up of photo 10

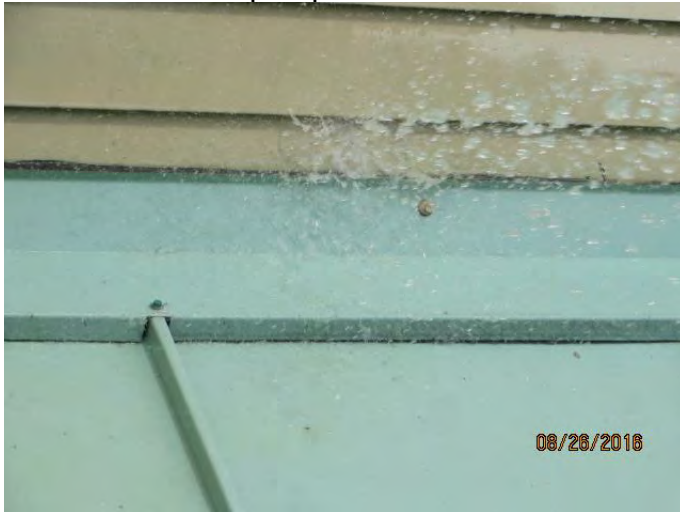
Photo 14 Water leak observed at upper exterior of front display window at 12:12 PM

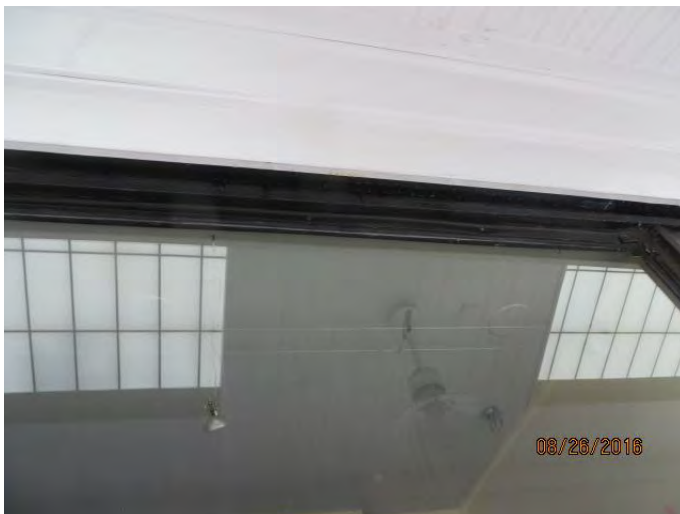
KINGSTON PIKE PLAN: WATER TESTS
33 NORTH FRONT STEET, KINGSTON, NY
PHOTOS TAKEN 8/26/2016

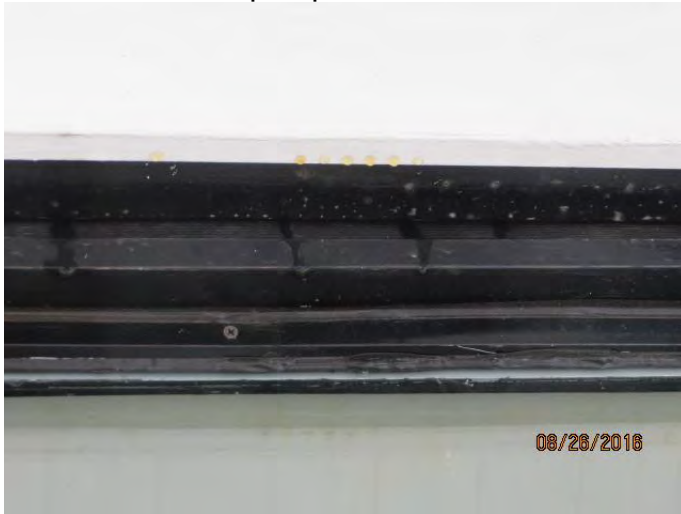
Photo 16 Water on side walk beneath leak shown in photo 14 and 15

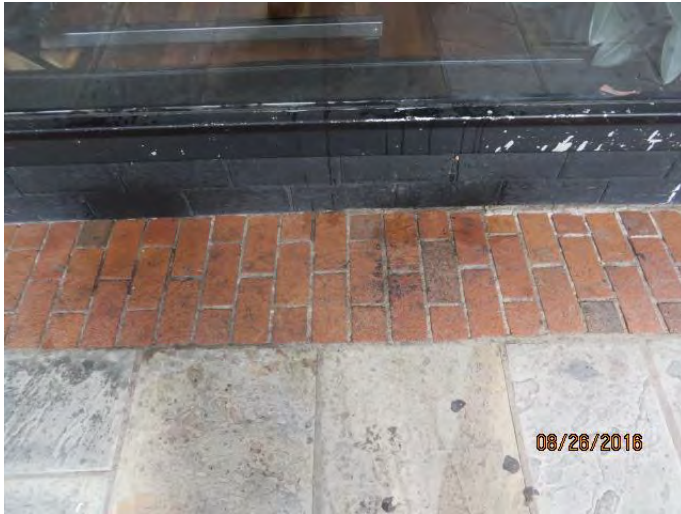
KINGSTON PIKE PLAN: WATER TESTS
33 NORTH FRONT STEET, KINGSTON, NY

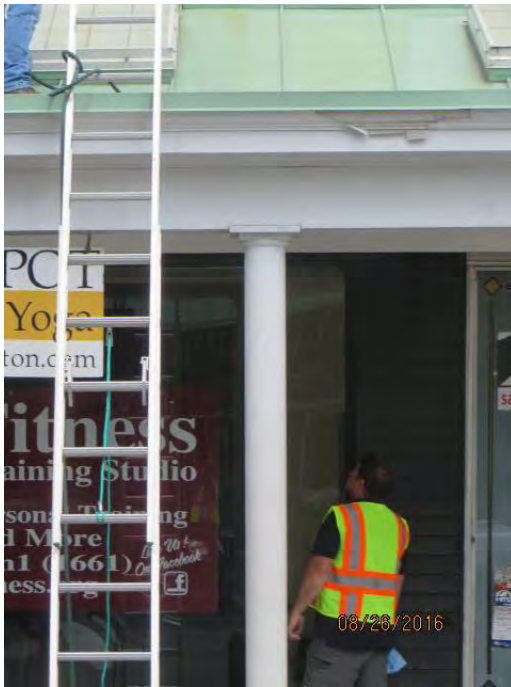
Photo 18 Water leak observed on the interior of front display window at 12:18 PM

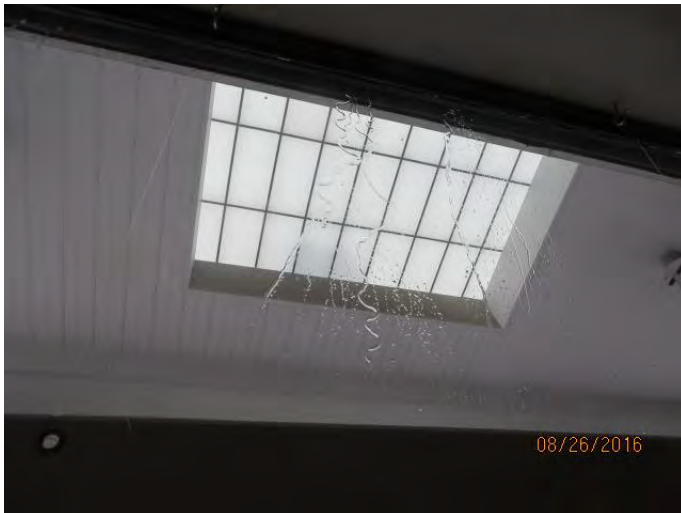
KINGSTON PIKE PLAN: WATER TESTS
33 NORTH FRONT STEET, KINGSTON, NY

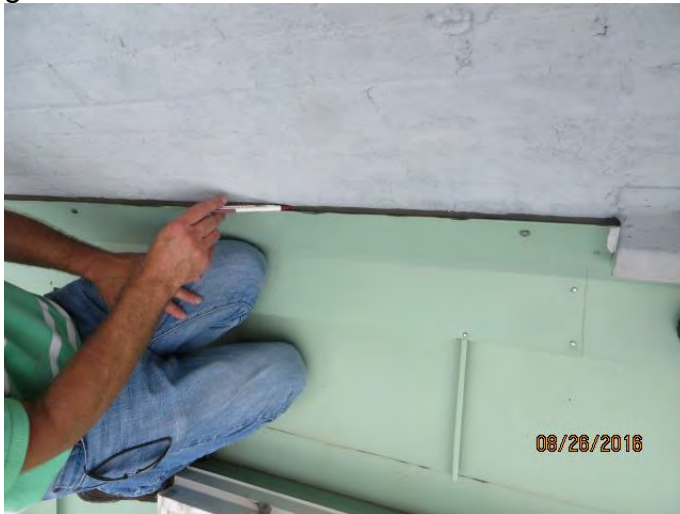
Photo 19 Close up of photo 18

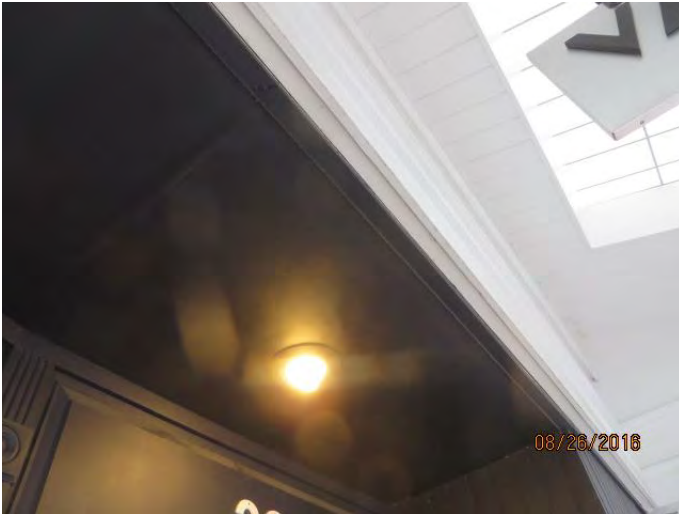
Photo 22 Drops on sidewalk from Water leak at vestibule at 11:17 AM

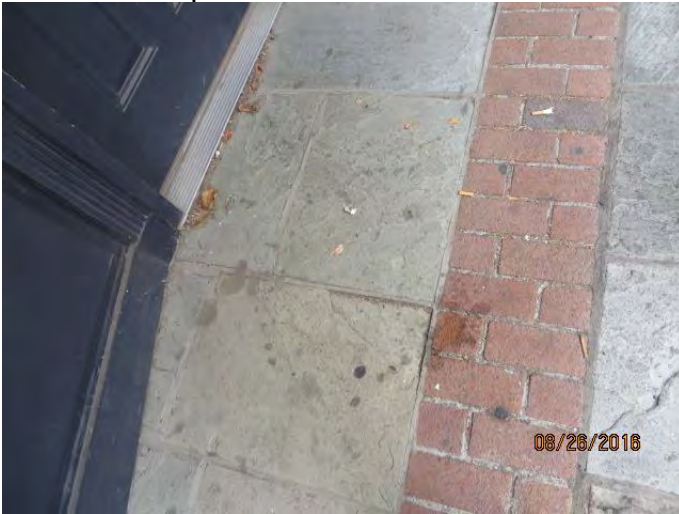
Photo 23 Close up of photo 22

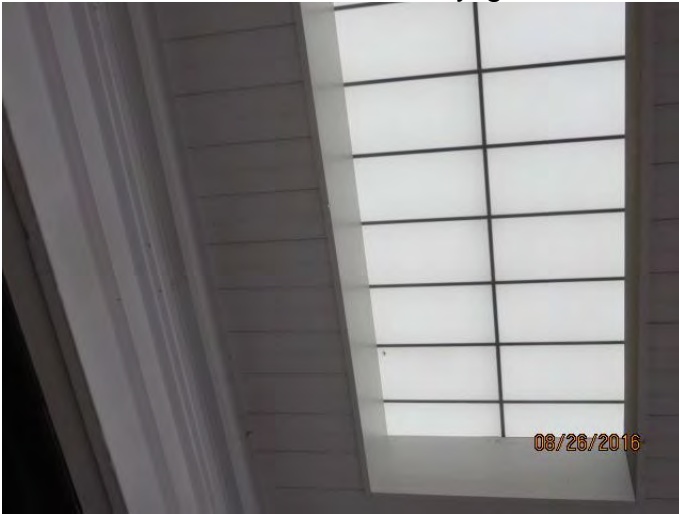
Photo 25 Close up of photo 24

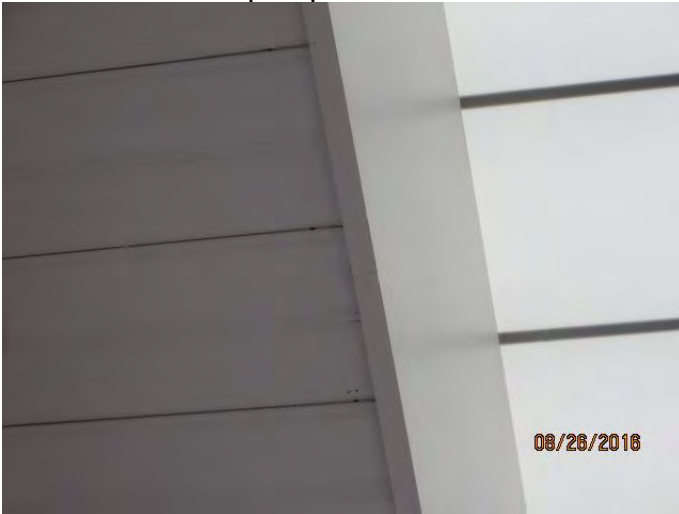
Photo 26 Drops on side walk from water leak at south skylight at 11:17 AM

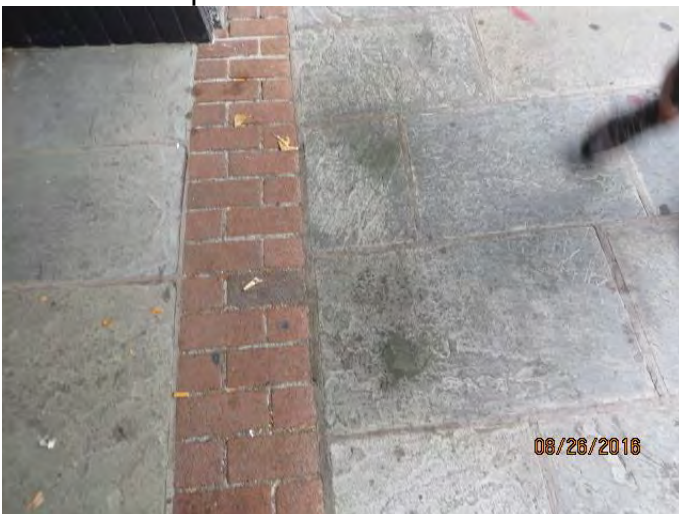
KINGSTON PIKE PLAN: WATER TESTS
39 NORTH FRONT STEET, KINGSTON, NY

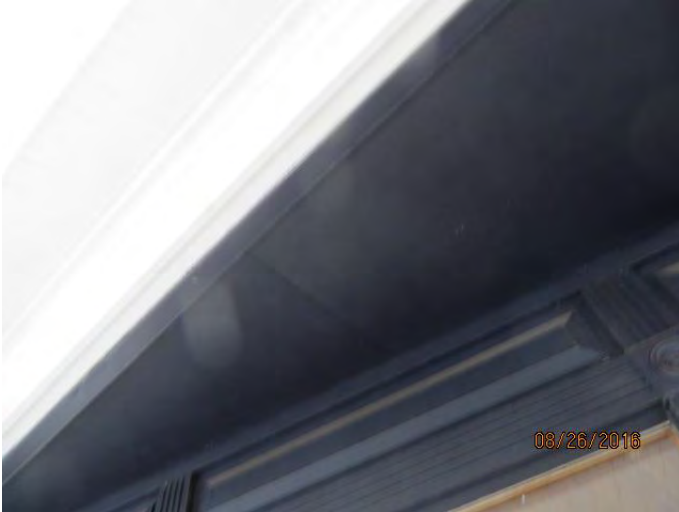
Photo 28 Drops on sidewalk second water leak at vestibule at 11:18 AM

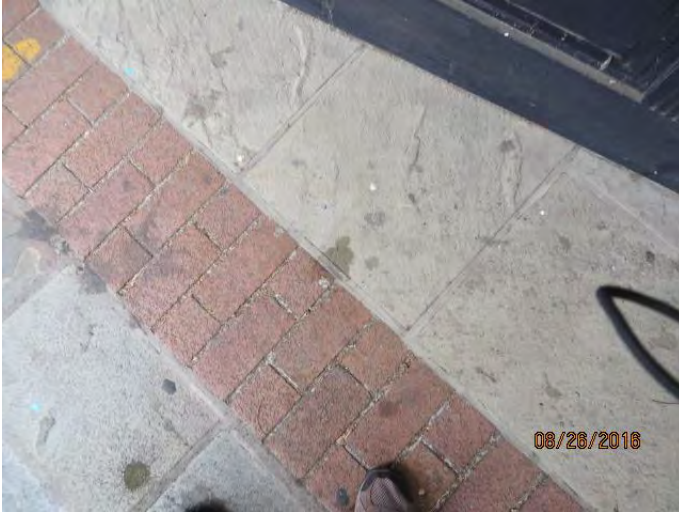
Photo 29 Water leaks at North Skylight

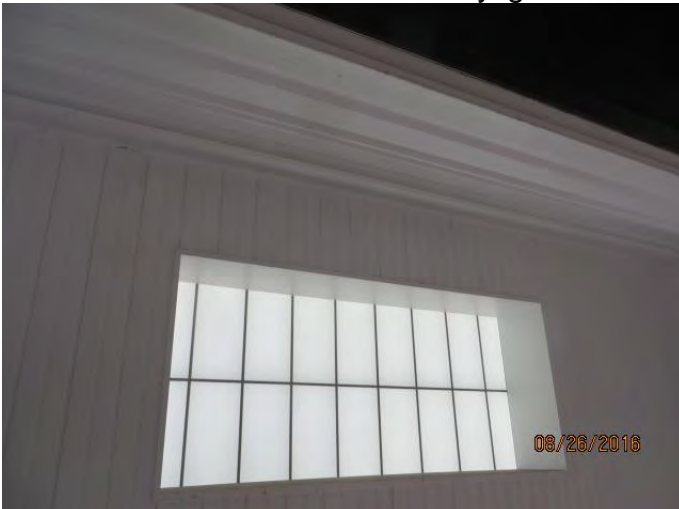
KINGSTON PIKE PLAN: WATER TESTS
39 NORTH FRONT STEET, KINGSTON, NY

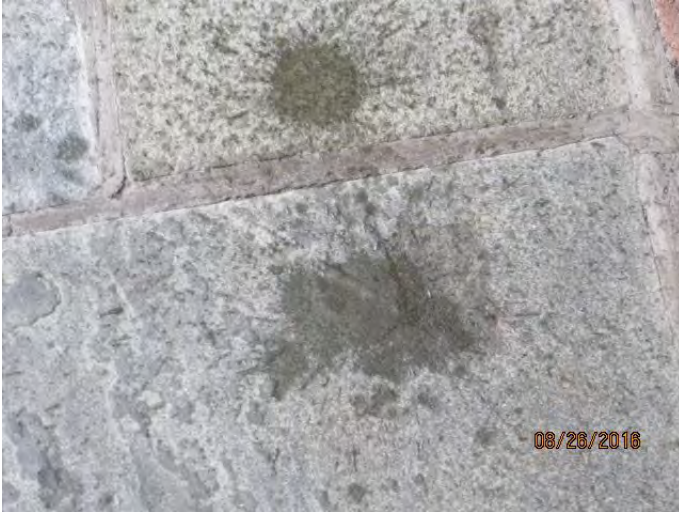
Photo 31 Water leak at vestibule light at 11:24 AM

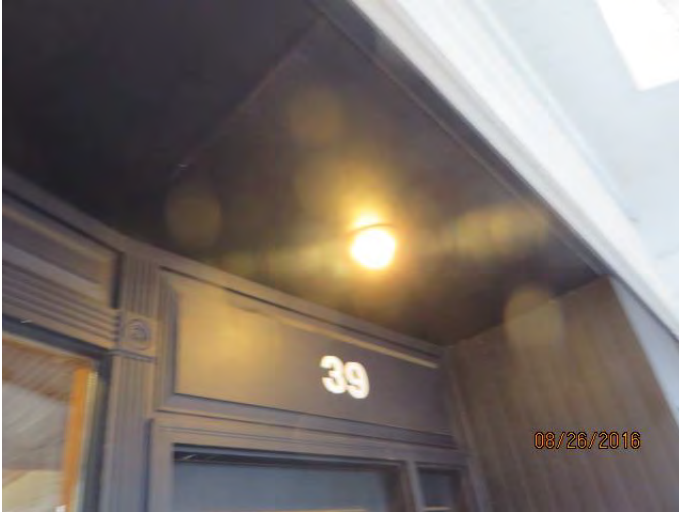
Photo 32 Drops on sidewalk from water leak at vestibule light at 11:24 AM

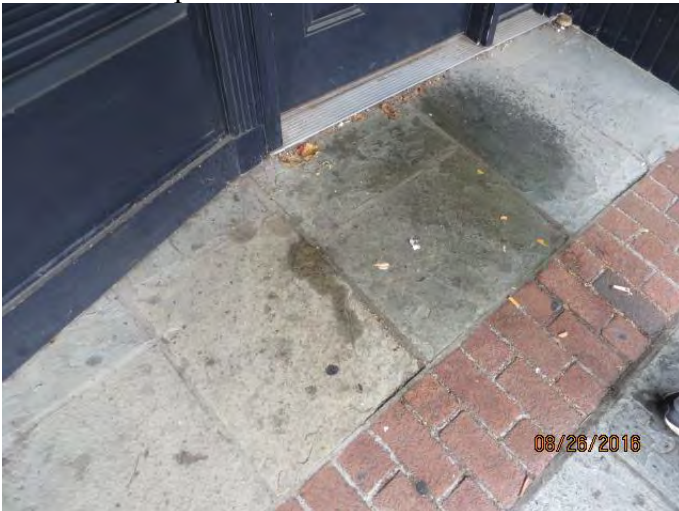
Exterior Consulting & Roofing Management: A Professional Engineering P.C.

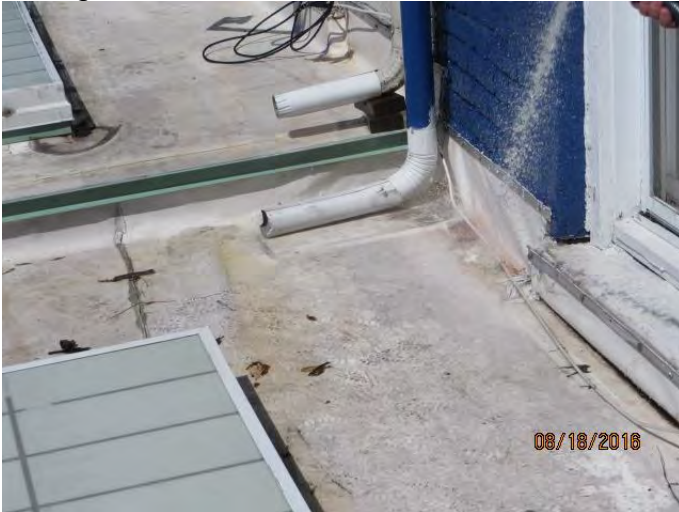
Exterior Consulting & Roofing Management: A Professional Engineering P.C.

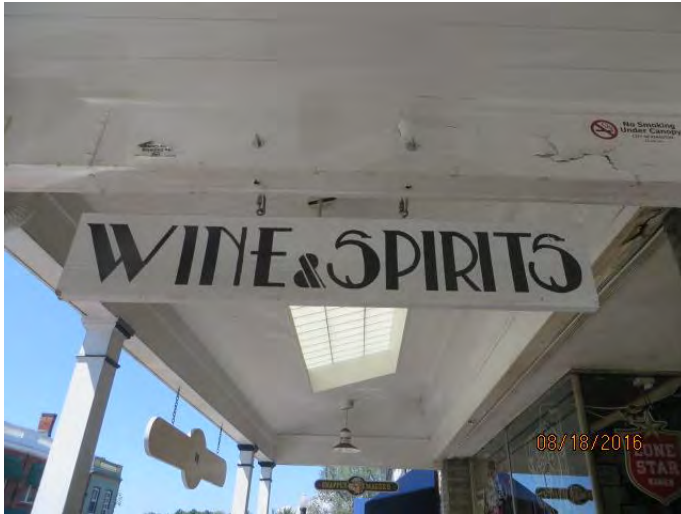
Photo 3 reported area of leaks after heavy blowing rain

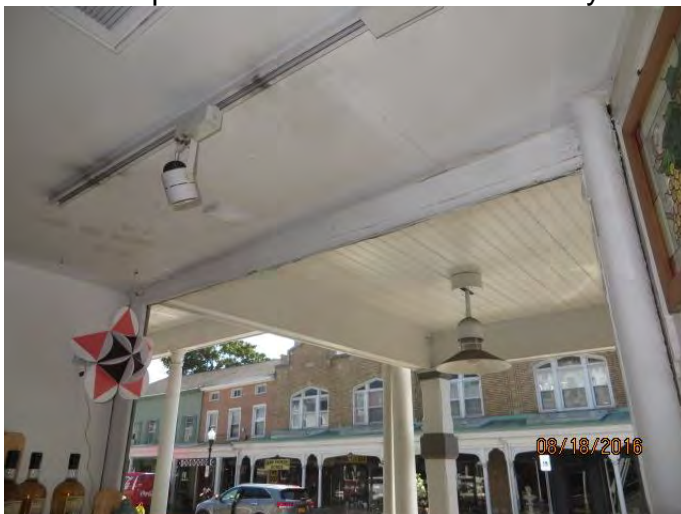
KINGSTON PIKE PLAN: WATER TESTS
57 NORTH FRONT STEET, KINGSTON, NY

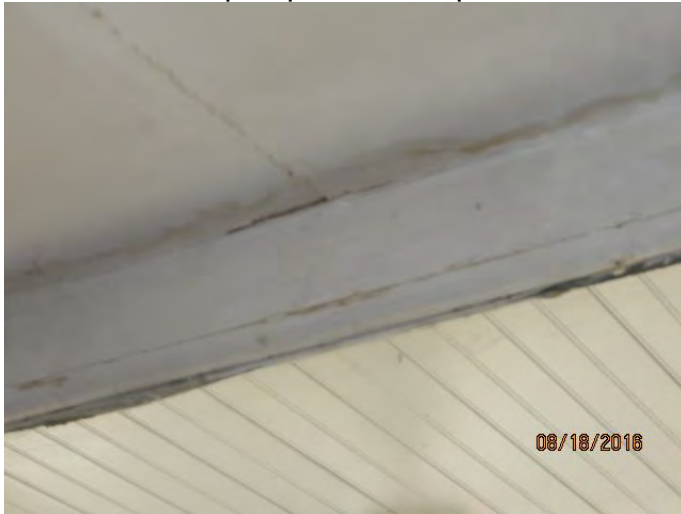
Photo 5 reported area of leaks after heavy blowing rain

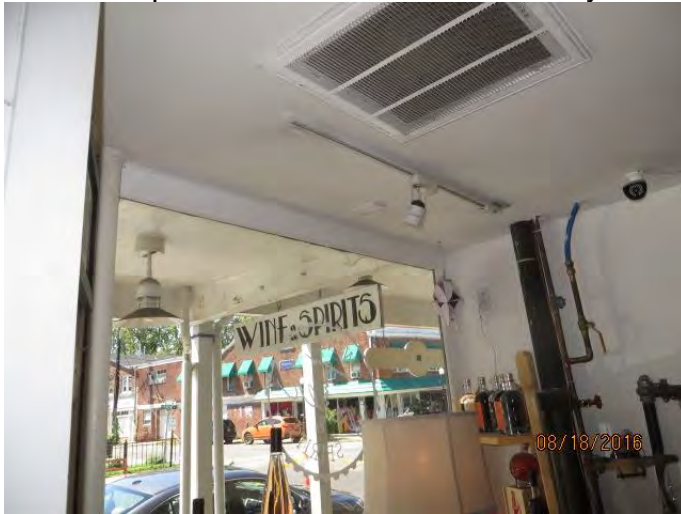
Photo 6 window above area of reported leaks

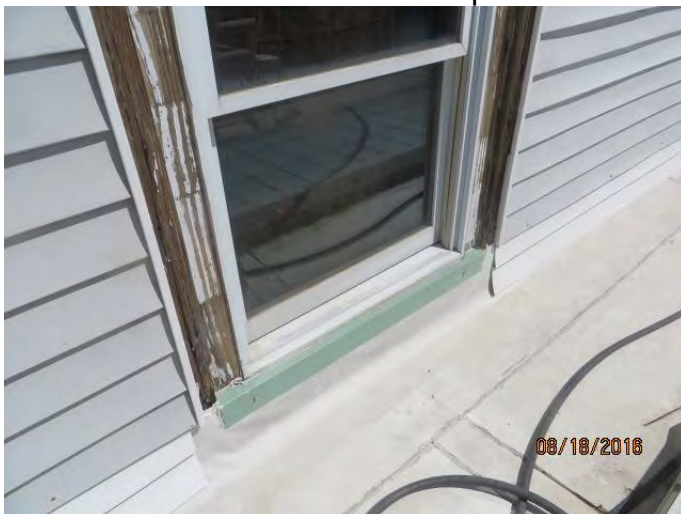
KINGSTON PIKE PLAN: WATER TESTS
57 NORTH FRONT STEET, KINGSTON, NY
PHOTOS TAKEN 8/18/2016

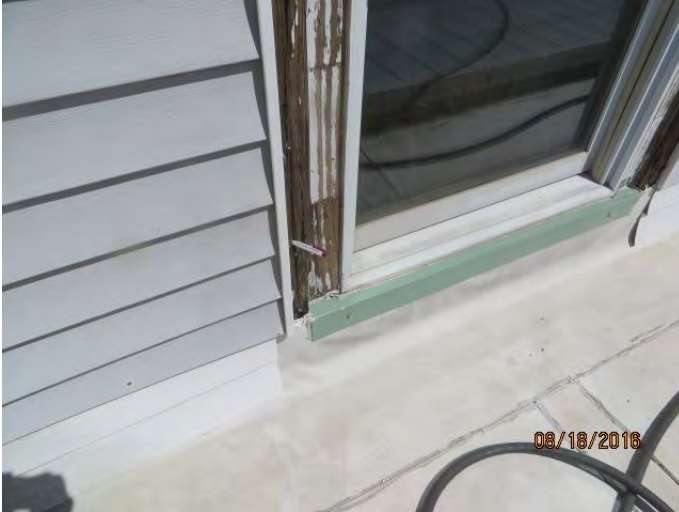
Photo 8 close up of photo 7

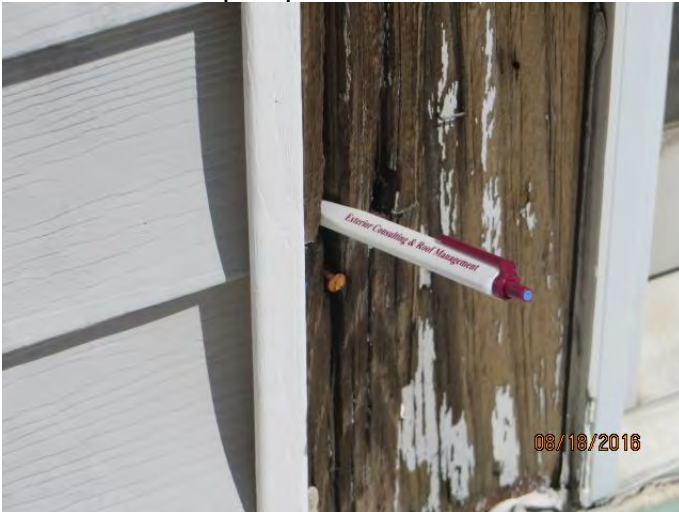
Photo 9 window above area of reported leaks, cracks in window frame

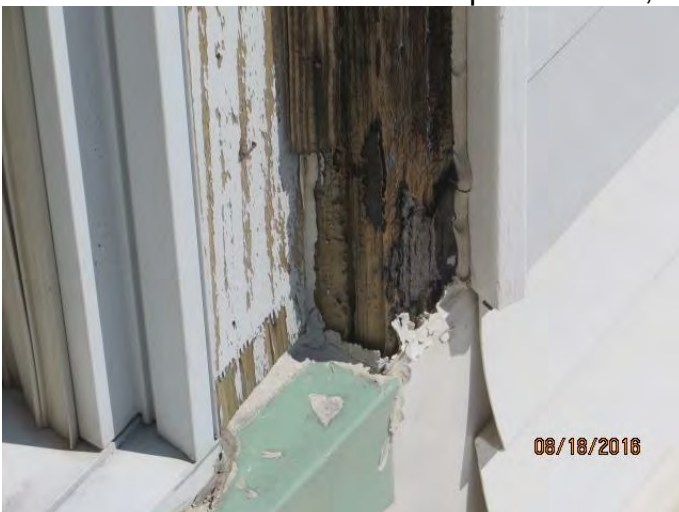
KINGSTON PIKE PLAN: WATER TESTS
57 NORTH FRONT STEET, KINGSTON, NY
PHOTOS TAKEN 8/18/2016

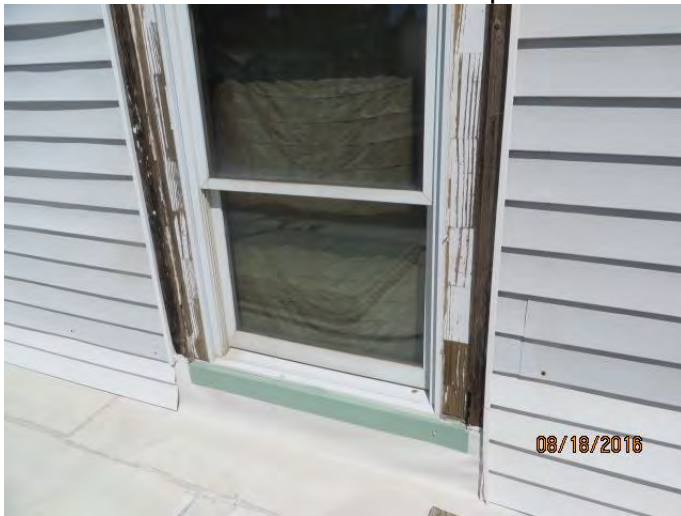
Photo 11 cracks in window frame

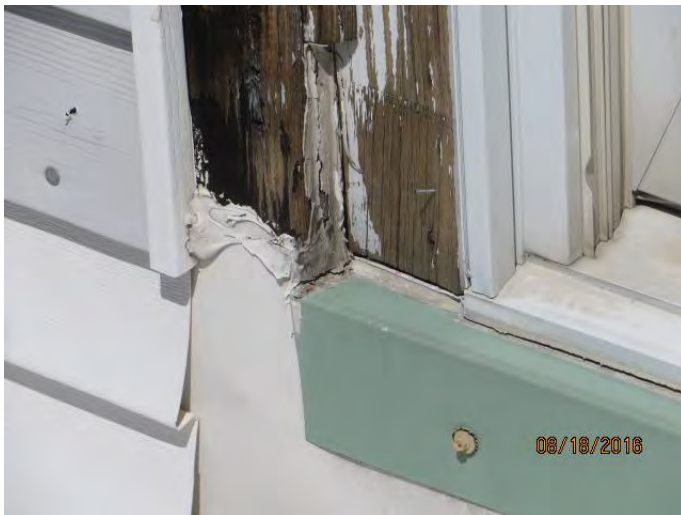
Photo 12 cracks in window frame

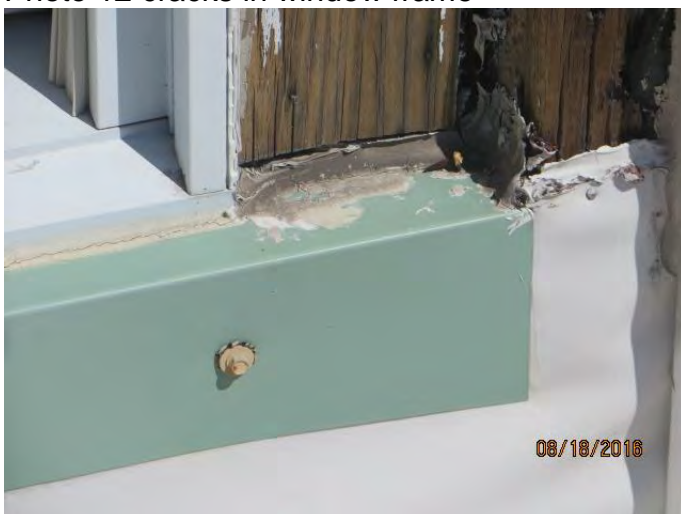
KINGSTON PIKE PLAN: WATER TESTS
57 NORTH FRONT STEET, KINGSTON, NY
PHOTOS TAKEN 8/18/2016

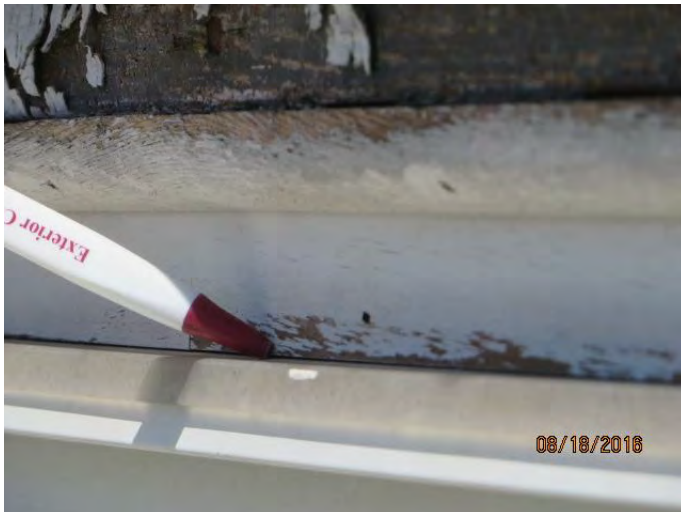
KINGSTON PIKE PLAN: WATER TESTS
57 NORTH FRONT STEET, KINGSTON, NY
PHOTOS TAKEN 8/18/2016

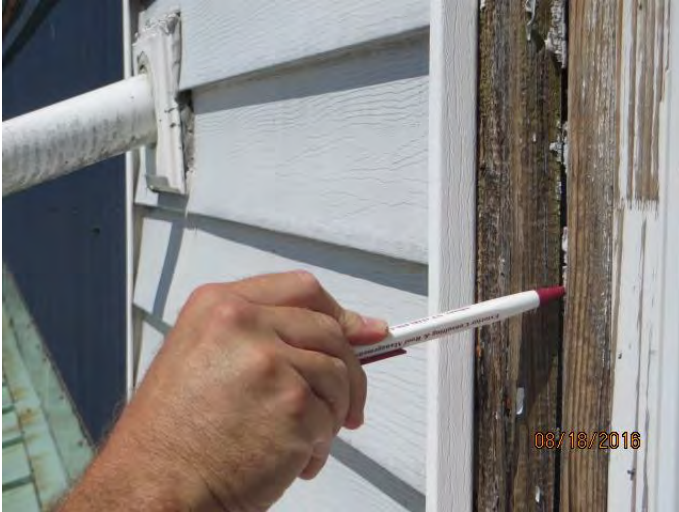
Photo 20 close up of photo 19

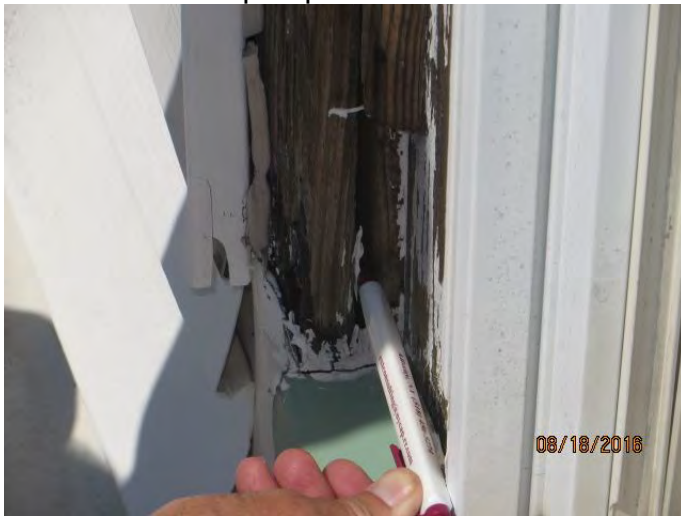
Photo 23 water test base flashing along base of wall over reported leak locations

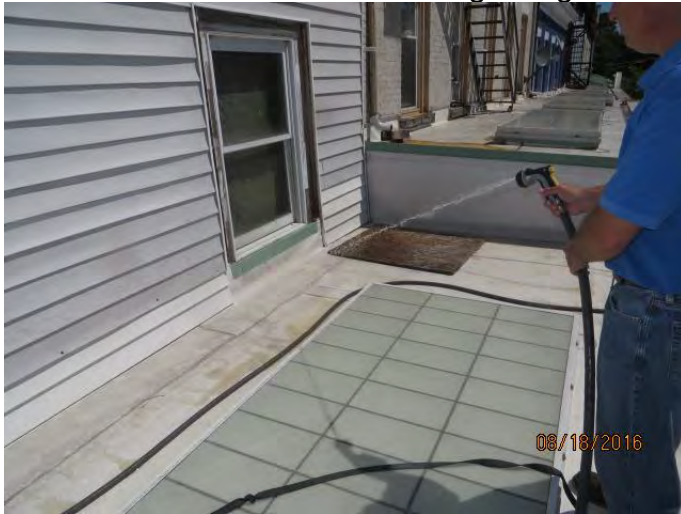
Photo 24 exterior leak appeared on walkway

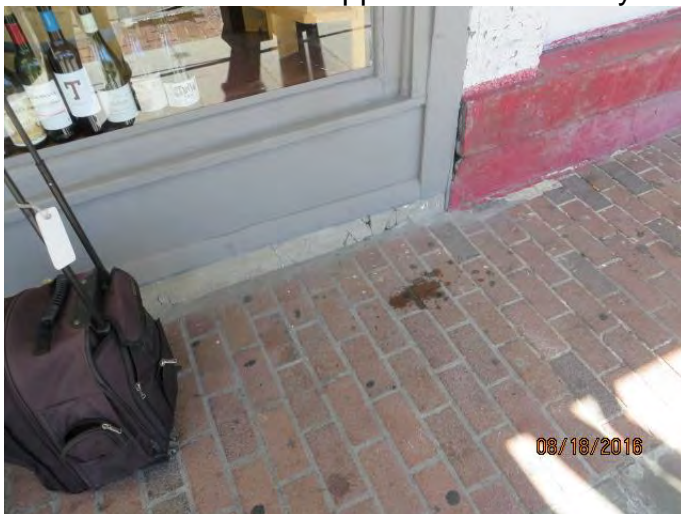
KINGSTON PIKE PLAN: WATER TESTS
57 NORTH FRONT STEET, KINGSTON, NY
PHOTOS TAKEN 8/18/2016

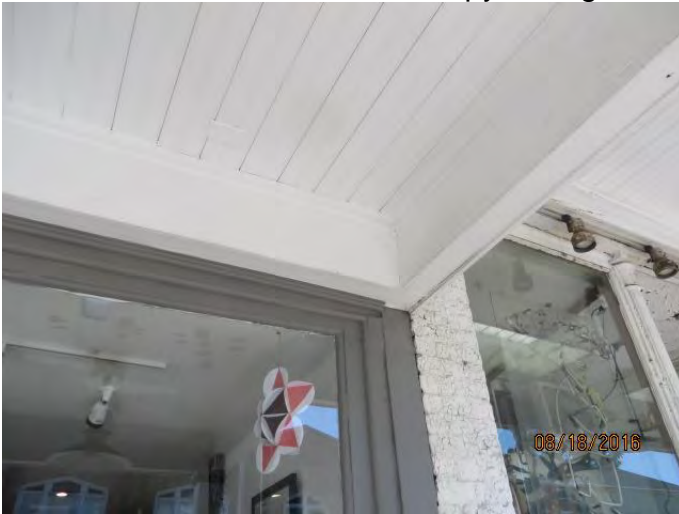
Photo 26 water testing canopy

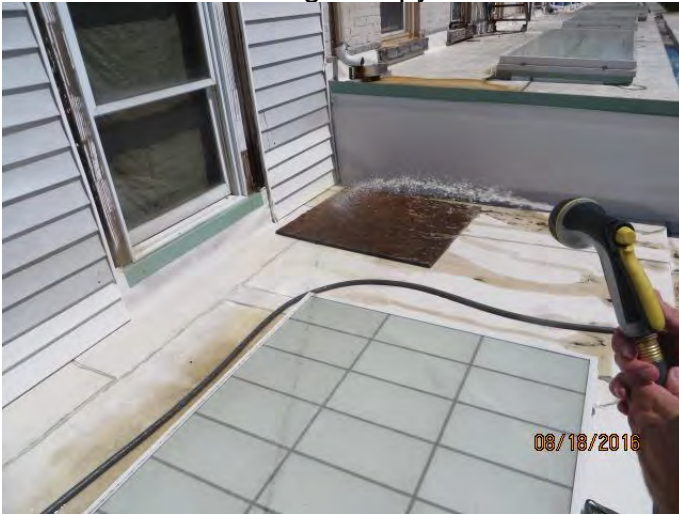
Photo 27 lifted up wood in vicinity of exterior leak

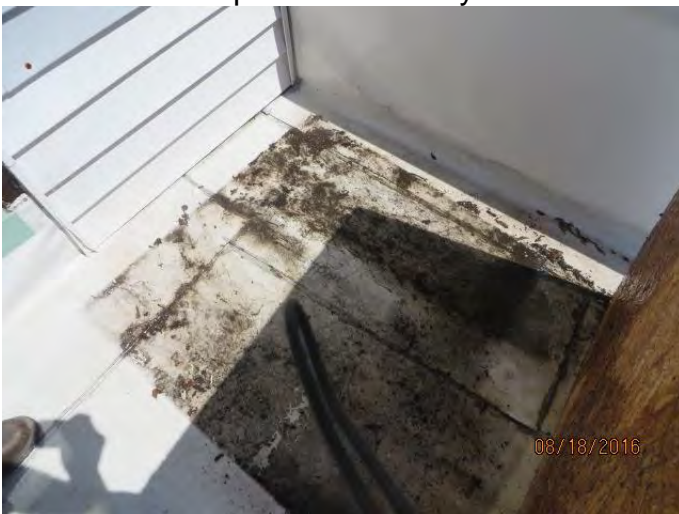
KINGSTON PIKE PLAN: WATER TESTS
57 NORTH FRONT STEET, KINGSTON, NY
PHOTOS TAKEN 8/18/2016

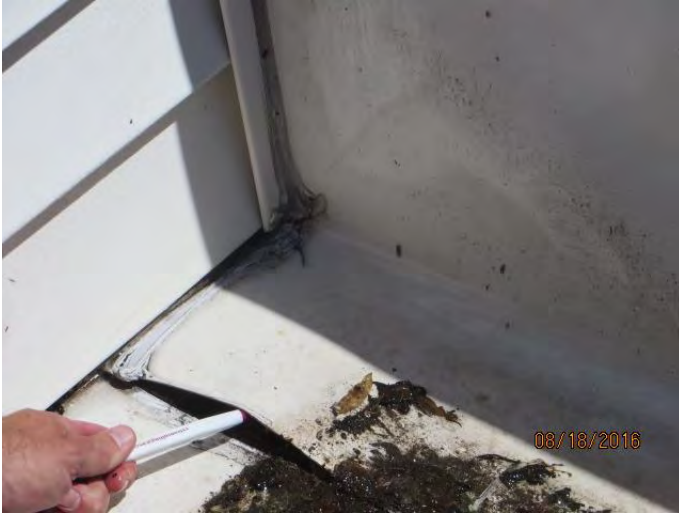
Exterior Consulting & Roofing Management: A Professional Engineering P.C.

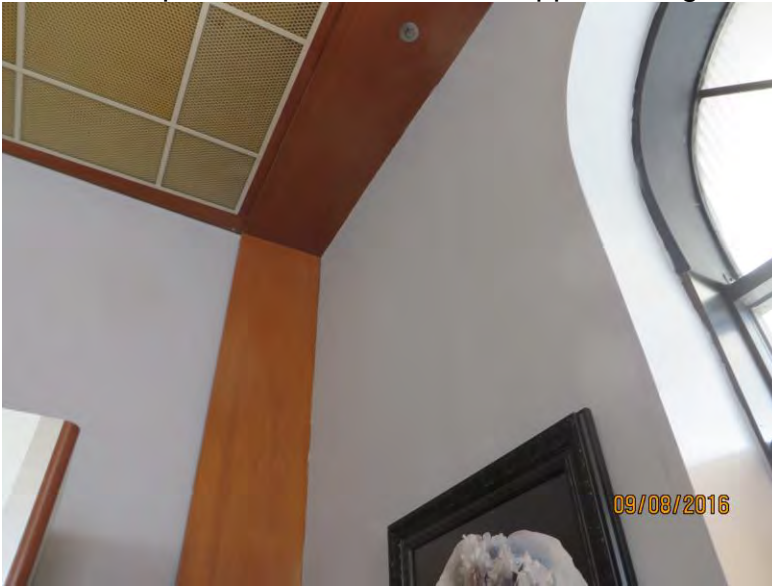
Photo 4 Water stains and deteriorated wood on the canopy underside on the opposite side of the wall from the reported leak location

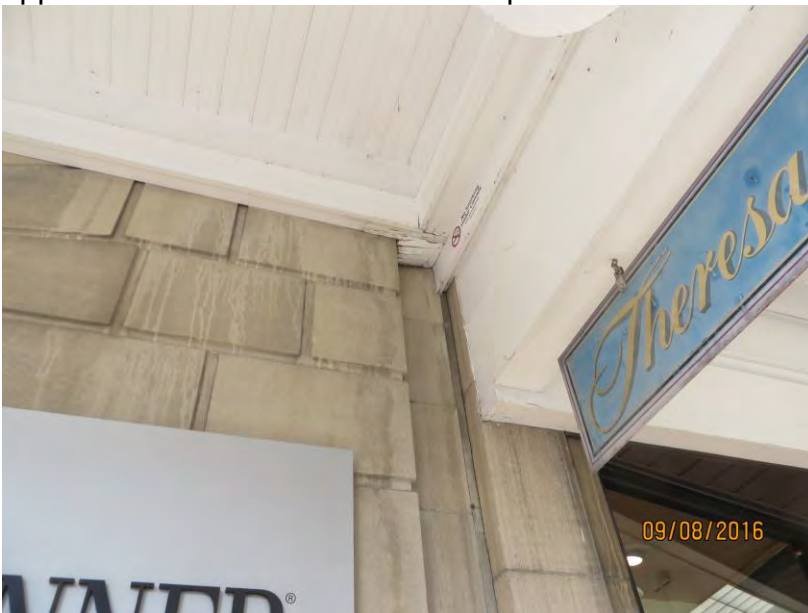
KINGSTON PIKE PLAN: WATER TESTS
301 WALL STREET STEET, KINGSTON, NY
PHOTOS TAKEN 9/8/2016

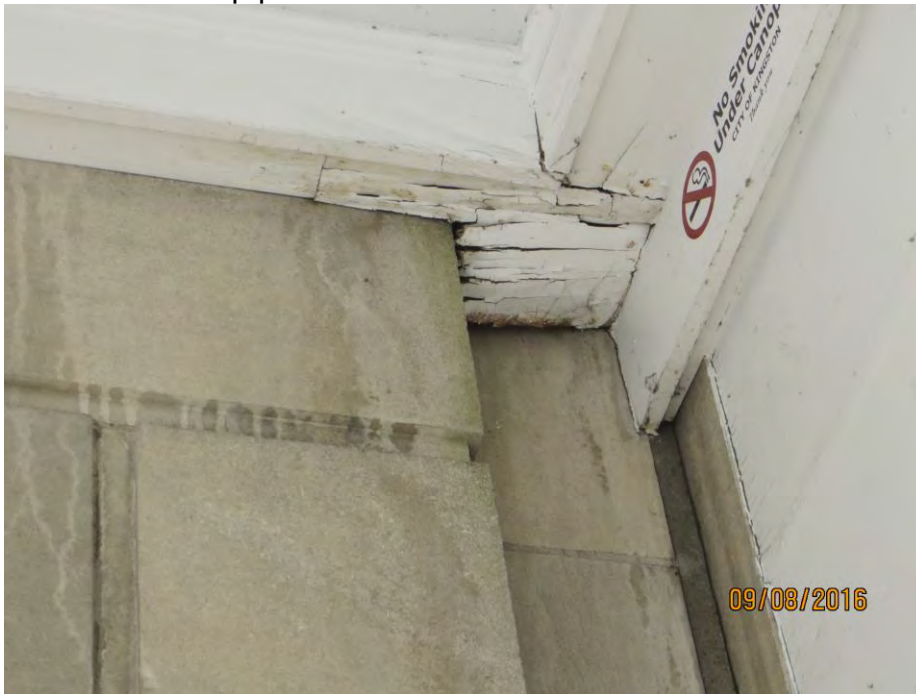
Photo 6 Flashing directly above canopy water stains and deteriorated wood

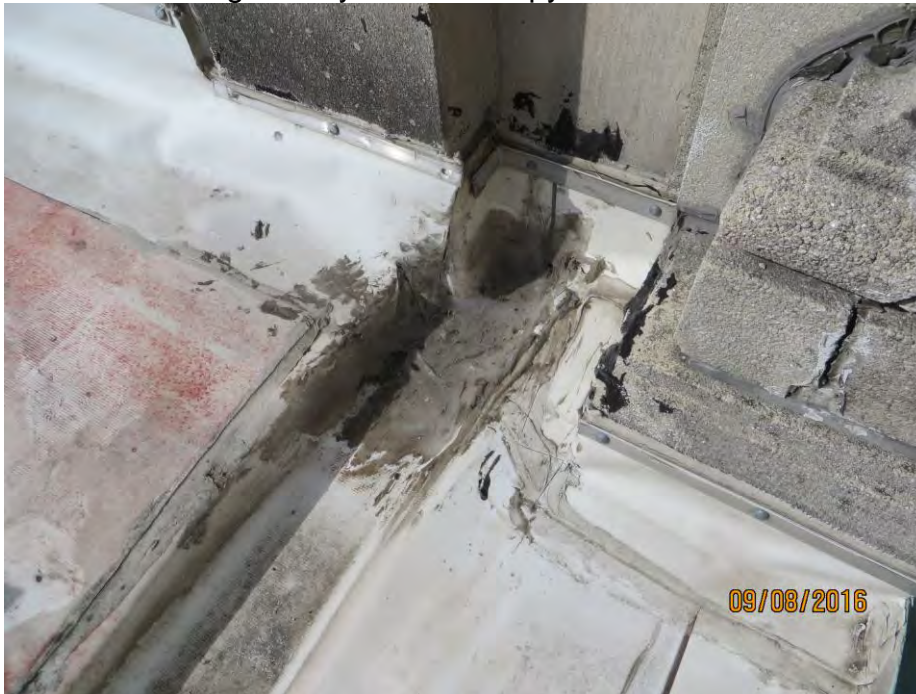
KINGSTON PIKE PLAN: WATER TESTS
301 WALL STREET STEET, KINGSTON, NY

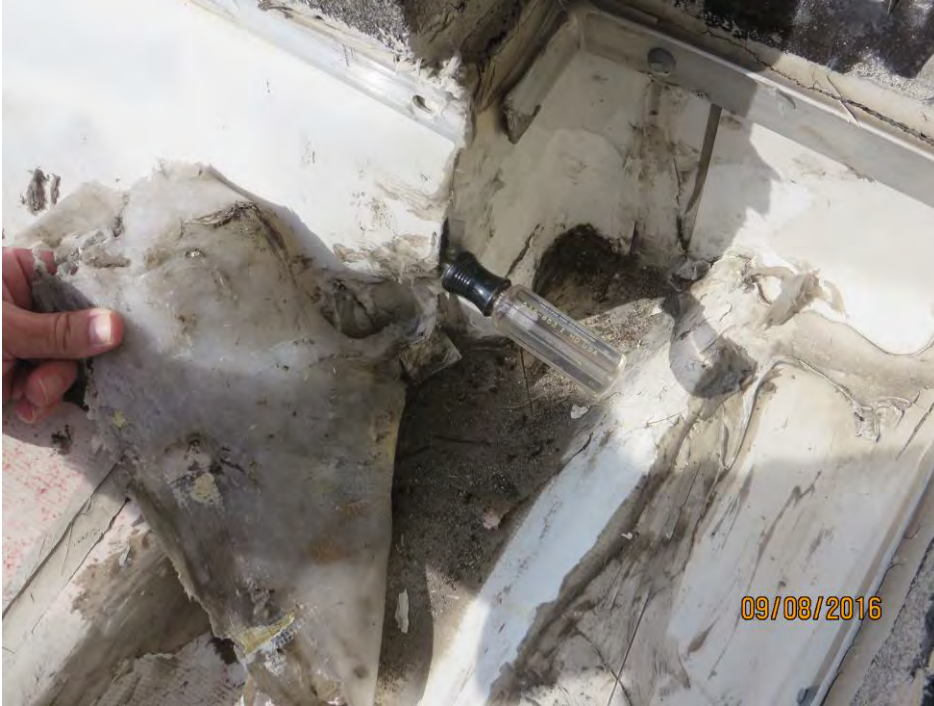
Photo 8 Crack in sealant at top of termination bar, seam probe inserted into crack

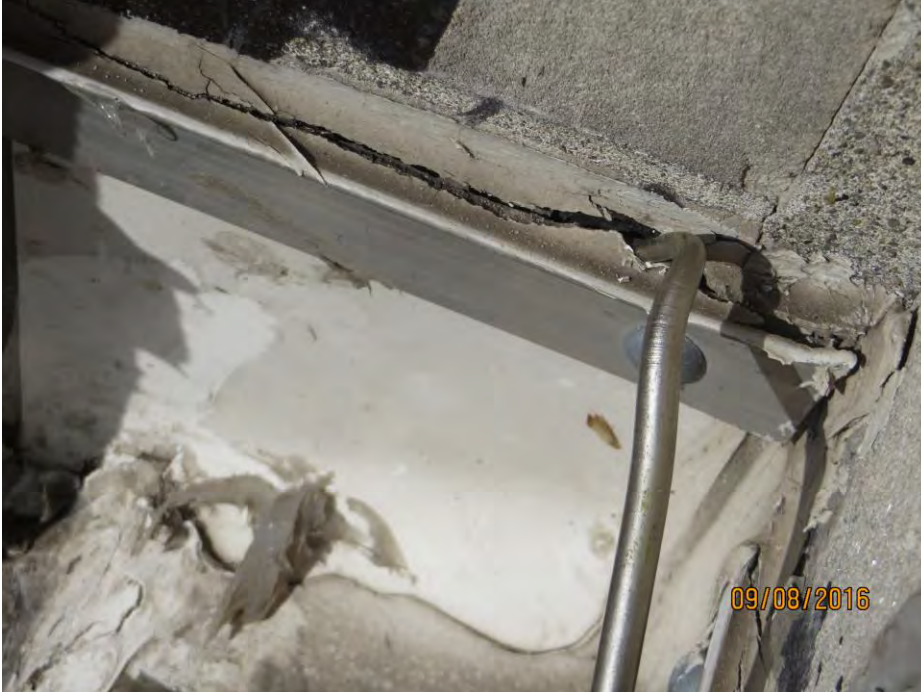
KINGSTON PIKE PLAN: WATER TESTS
301 WALL STREET STEET, KINGSTON, NY

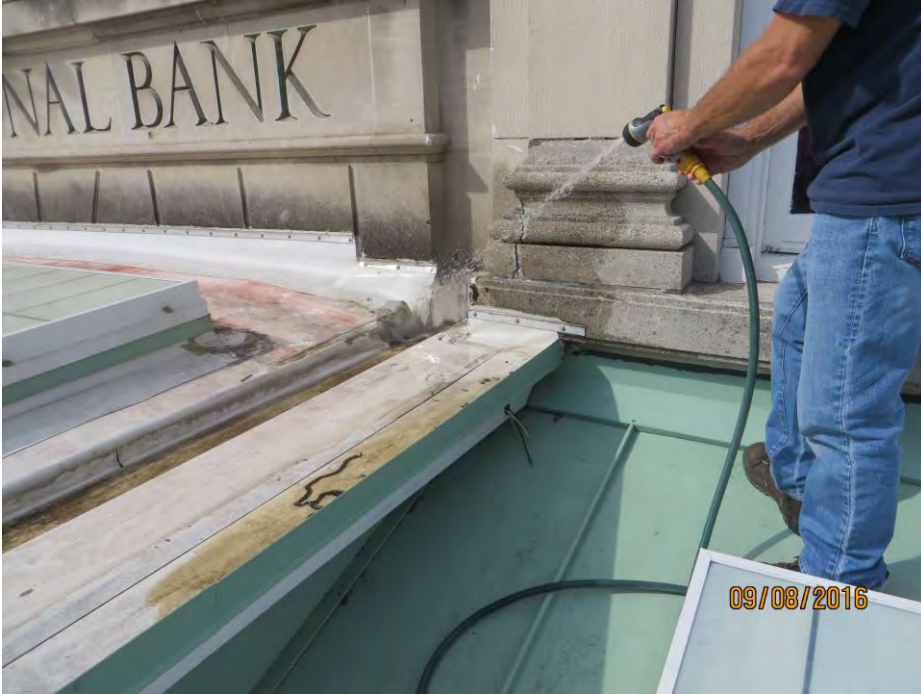
Photo 10 At 10:17 AM, water observed at water stained and damaged wood on underside of canopy directly below water test

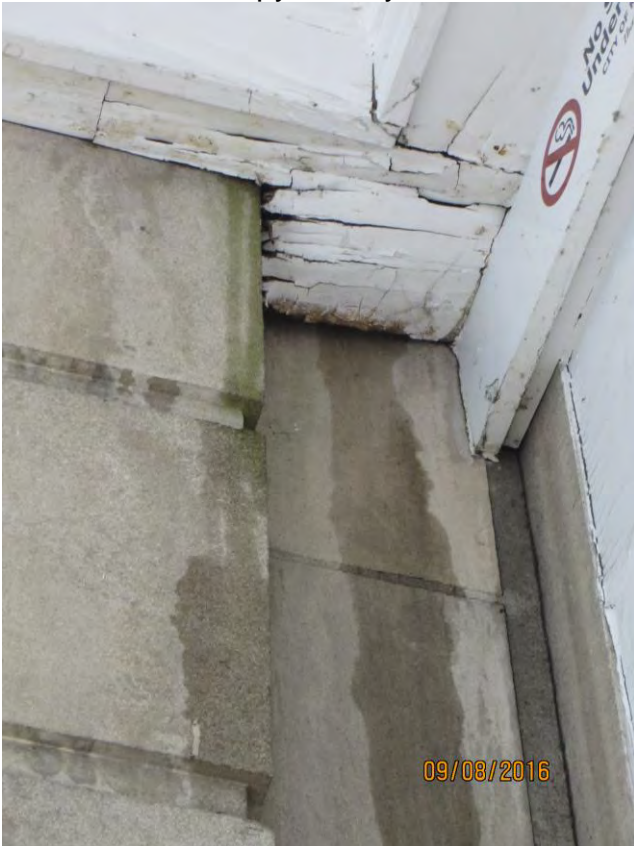
KINGSTON PIKE PLAN: WATER TESTS
301 WALL STREET STEET, KINGSTON, NY

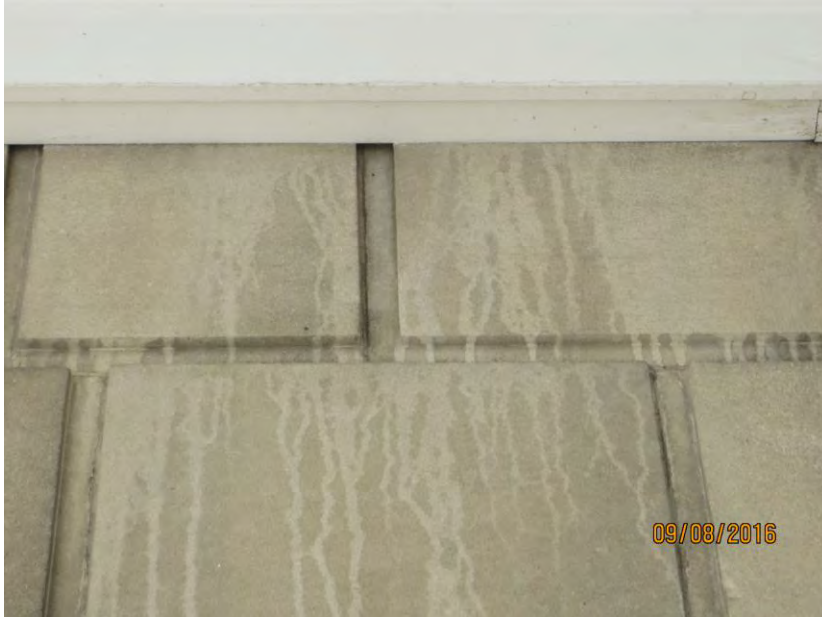
Photo 12 Commence water test at top of base flashing along the wall directly above the water stains on the wall at 10:21 AM.

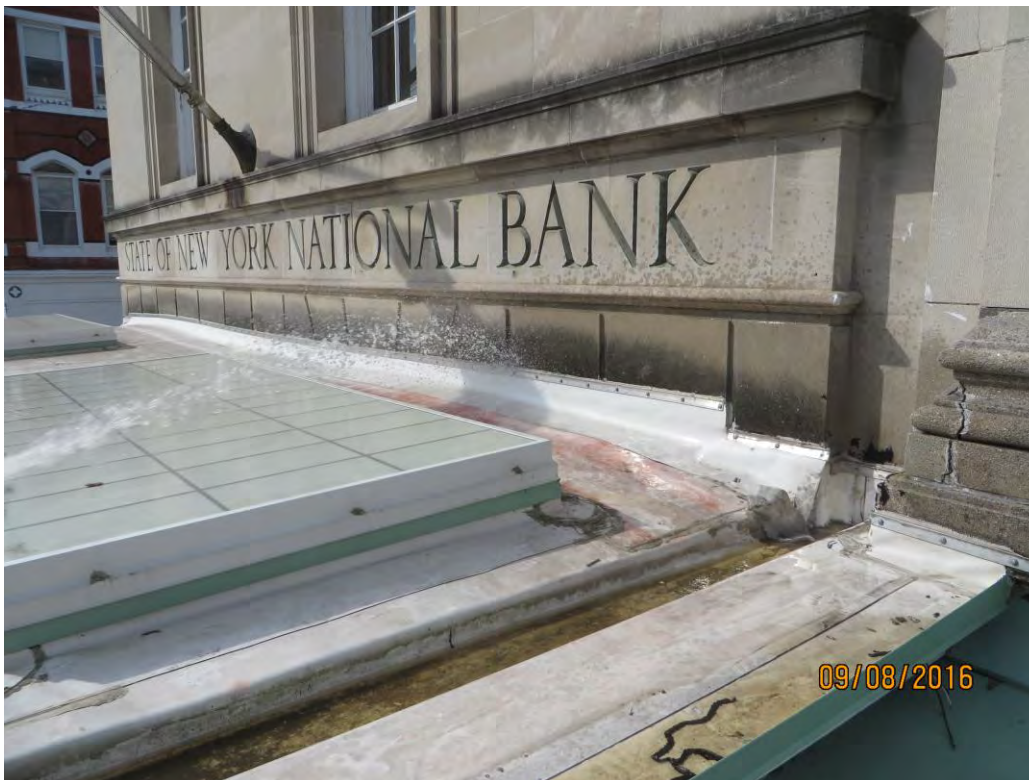
KINGSTON PIKE PLAN: WATER TESTS
301 WALL STREET STEET, KINGSTON, NY
