C.T. MALE ASSOCIATES

Re: *Results of Water Spray Testing*
Pike Plan Restoration Project
Kingston, NY
C.T. Male Associates Project No. 15.5150

REF: Kingston-Pike Plan: Water Tests
34 North Front Street: Dominick's Café/Dream Weavers

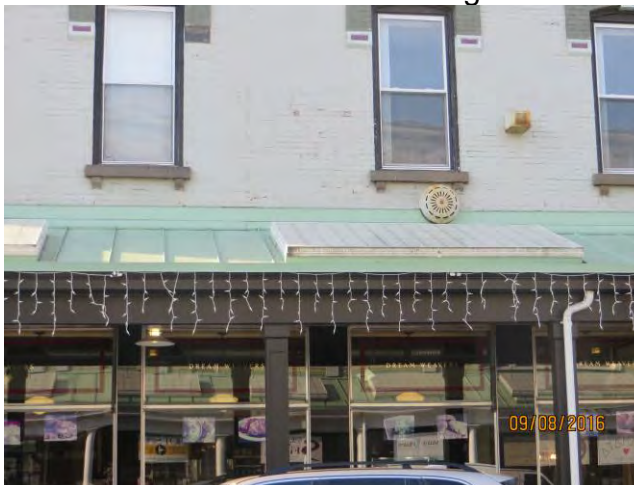
The whole ledge across the entire side of the building (on the N. Front St. side) that is attached to the Pike Canopy drips through light fixtures inside the building, see photos 3, 4, 5, 6 and 7.

Photo 3 Leaks reported inside the building beneath the top of the green metal roof where it contacts the building

Remove the green metal base flashing at the top of the metal canopy roof where it contacts the building, see photos 4 and 5, and properly replace the metal flashing and sealants.

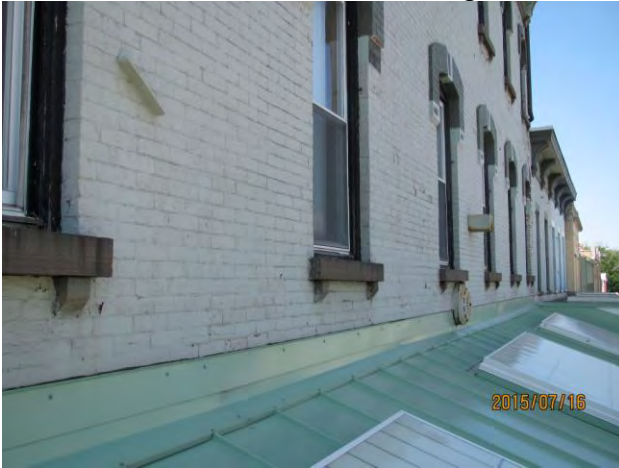
Photo 4 Leaks reported inside the building beneath the top of the green metal roof where it contacts the building

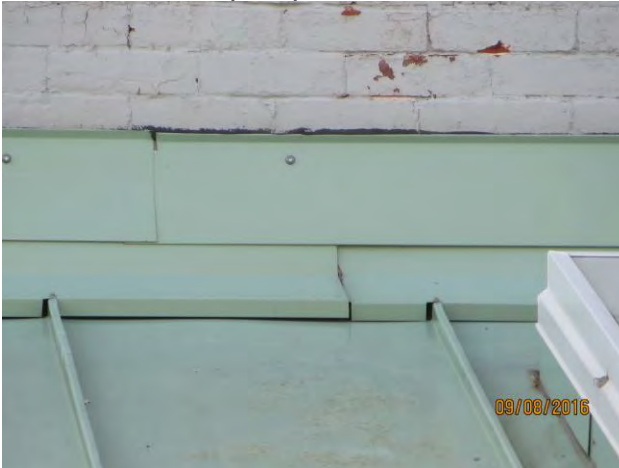
Then, water test began at the top edge of the green metal base flashing, see photo 5 at 10:25 AM. At 10:41 AM, water drips were observed at the underside of the soffit.

Photo 5 Close up of photos 3 and 4

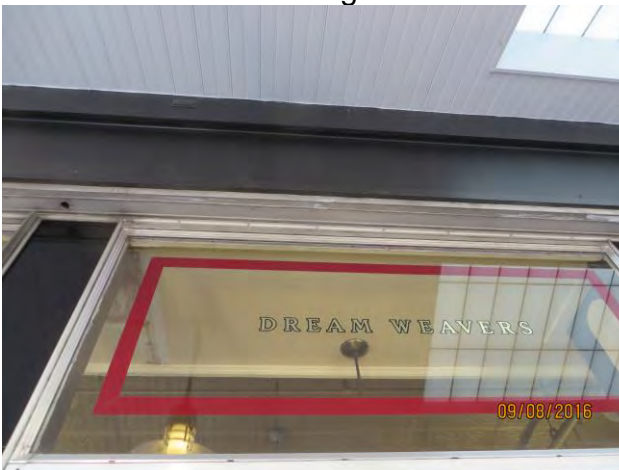
Photo 6 leaks reported along the window line beneath where the green metal roof contacts the building

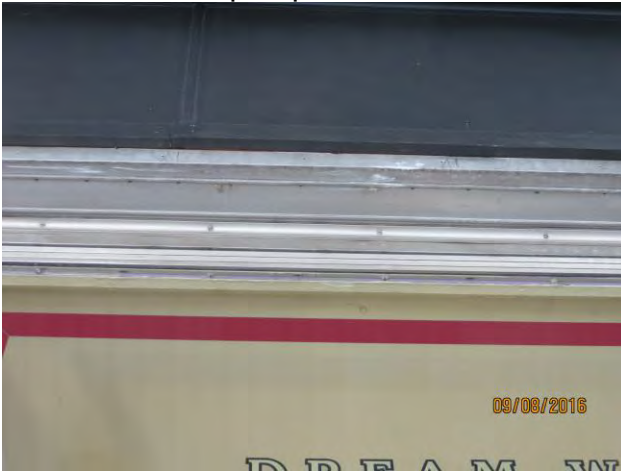
Photo 7 Close up of photo 6

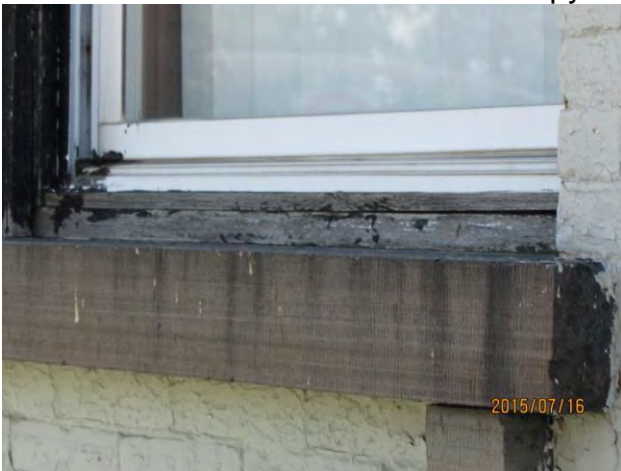
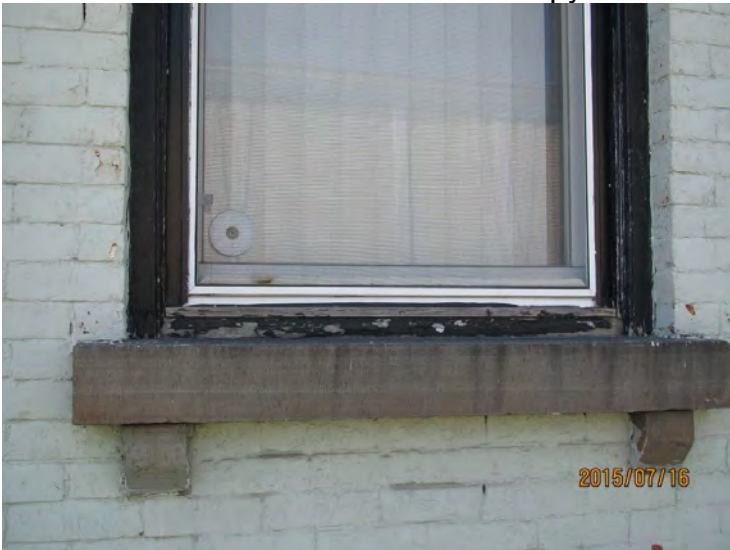
The wood window sills above canopy are deteriorated and can easily allow water to enter the building, see photos 8 and 9.

Photo 8 wood window sills above canopy are deteriorated

Photo 9 wood window sills above canopy are deteriorated

Repair deteriorated wood window sills.

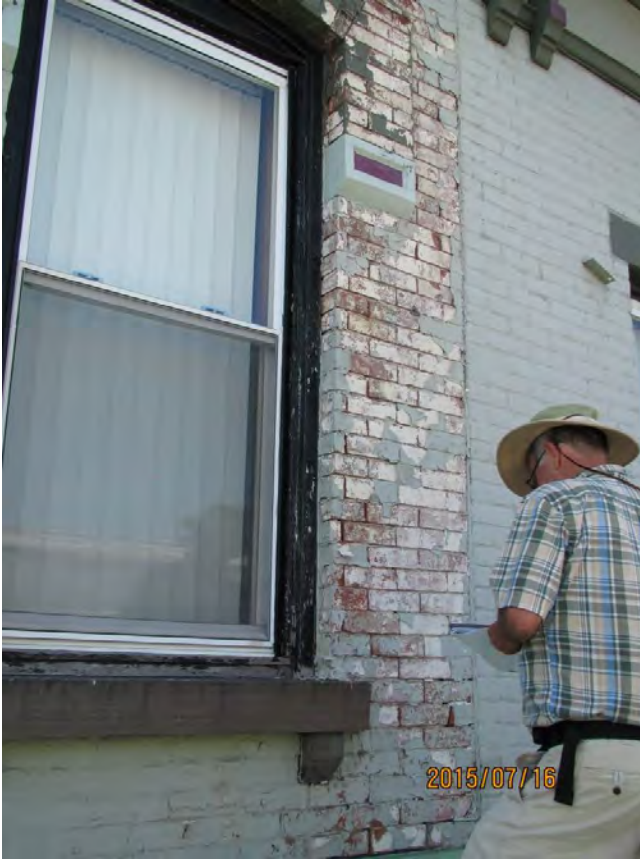
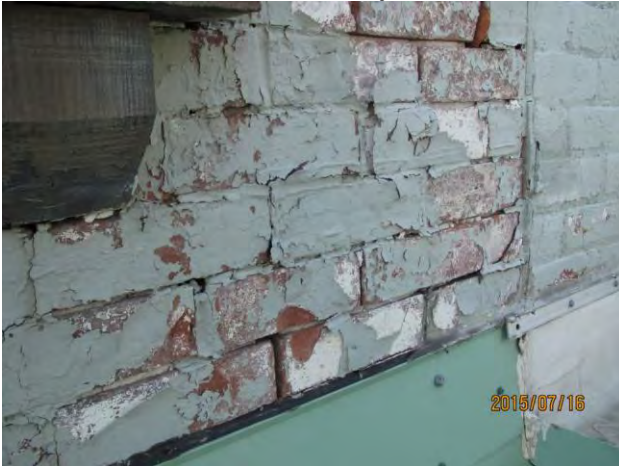
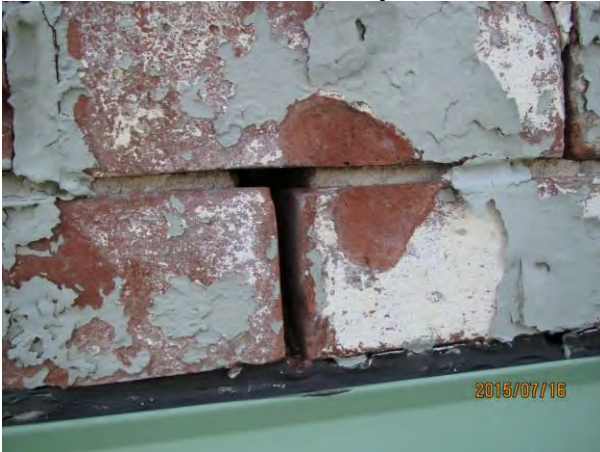
The brick wall mortar joint above the canopy deteriorated in some location and can allow water to enter the building, see photos 10, 11, and 12..

Photo 10 brick wall mortar joints above the canopy are deteriorated

Photo 11 brick wall mortar joints above the canopy are deteriorated

Photo 12 brick wall mortar joints above the canopy are deteriorated

Repair the deteriorated brick mortar joints.

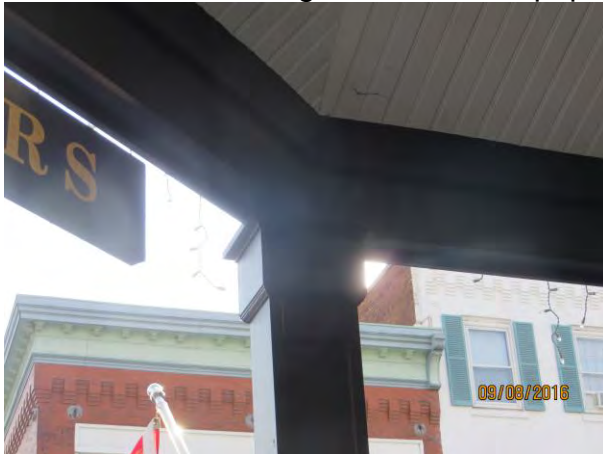
Photo 15 leaks through the column top, previously not reported

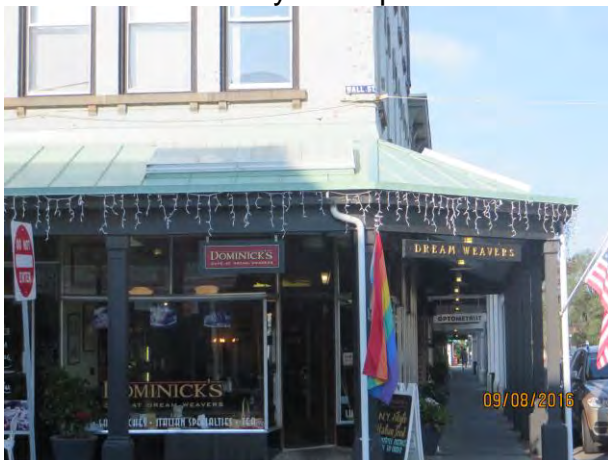
Photo 16 Previously not reported leak at top of column near white downspout

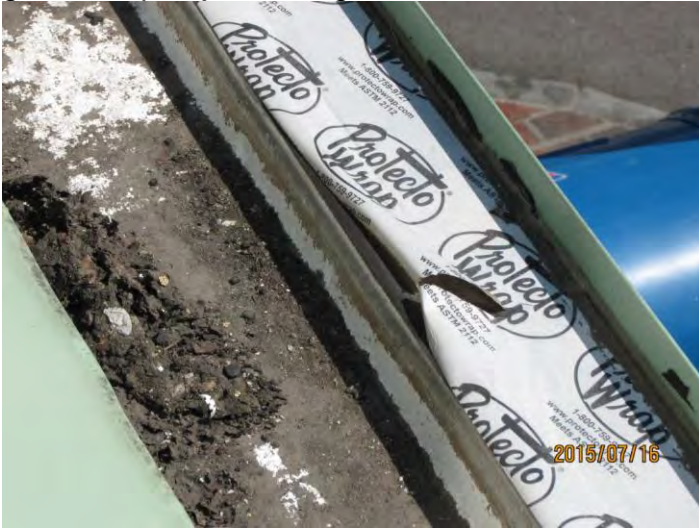
The metal edge gravel stop flashing adjacent to the gutter is not the proper material as it is sensitive to UV degradation and is deteriorating. See photo 18.

Photo 18 Improper flashing material (Protecto Wrap) used to flash metal edge gravel stop adjacent to gutter

Remove the metal edge gravel stop flashing and replace with the material that is compatible with the gutter membrane and not sensitive to UV degradation.

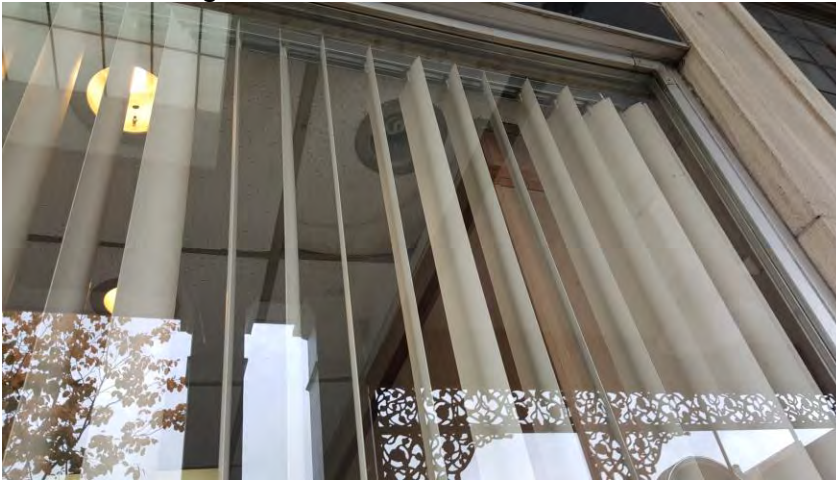
Leak "A" complaint:
Leak in front of office (damaged ceiling tile)

Photo 2 Ceiling tile with water stains

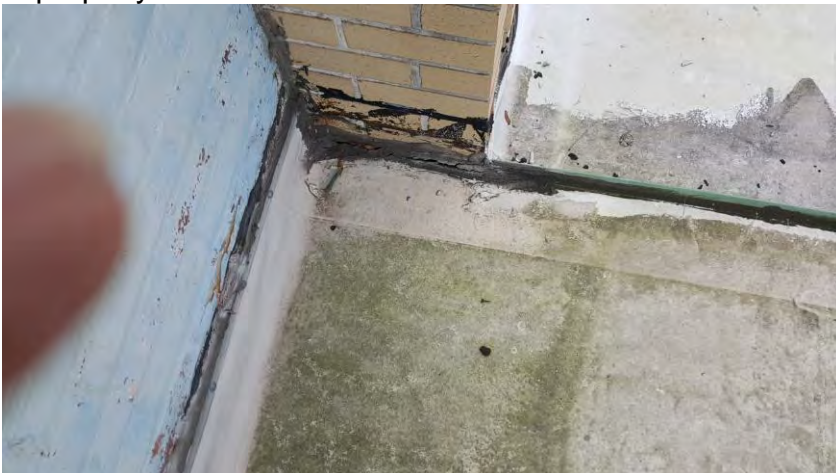
Finding for Leak "A":
Lack of proper roof system flashing, see photo 3. This deficiency was overwhelmingly obvious and did not require a water test.

Photo 3 Directly above the water stained ceiling tile, the roof was found to be improperly terminated to the brick wall.

Recommendation to resolve Leak "A":
Properly install base flashing from roof to brick wall

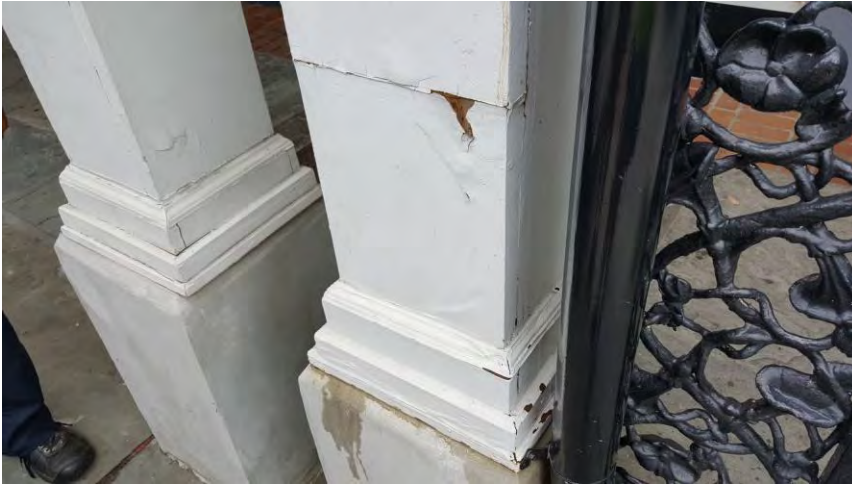
Leak "B" complaint: Previously not reported.
Wood column at curb between 38 and 40 North Front Street had water damage, see photo 4.

Photo 4 Previously unreported water damage to column between 38 and 40 North Front St

Recommendation for Leak "B":
Clean out gutters and reflash gutters.

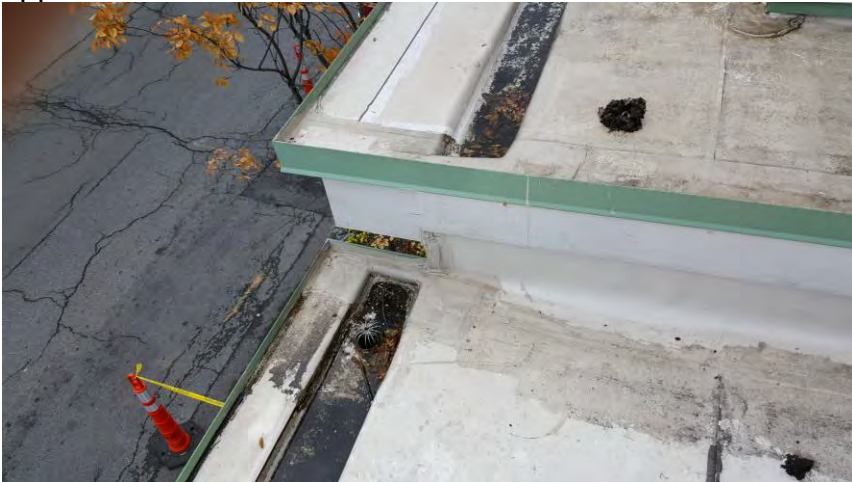
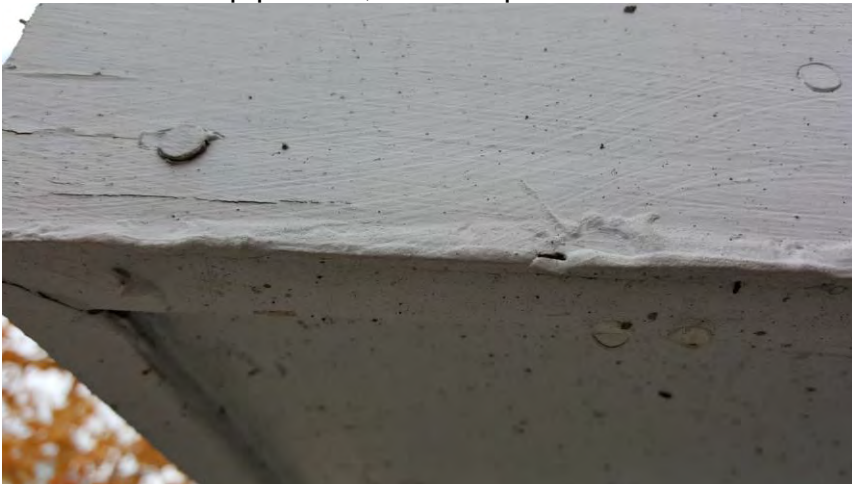
Finding for Leak "B":
The gutters above the column were plugged, see photo 5. Water was dripping from the upper fascia board without any water tests being performed, see photos 5 and 6.

Photo 5 Above damaged column, gutter is plugged and water dripping down from upper fascia

Photo 6 Close up photo 5, water drips are difficult to see

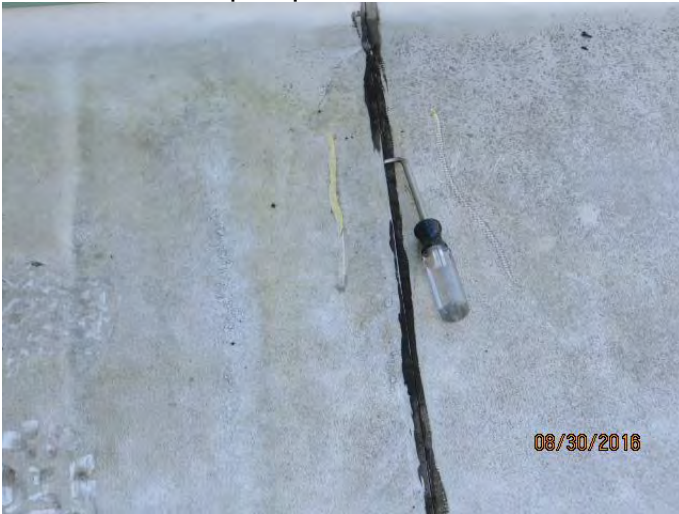
There are several openings in the roof membrane that allows water to enter, see photos 4 thru 9 and 31 and 32. These locations were water tested and leaks were observed at each locations in a very short period of time, see photos 33 thru 43. Water testing of the roof membrane at the open seam adjacent to the second skylight, started at 9:56 AM and water was observed below at 10:05 AM. Water testing at the base flashing opening started at 10:08 AM and water was observed below at 10:13 AM.

Photo 9 Close up of photo 8

The roof membrane openings must be repaired.

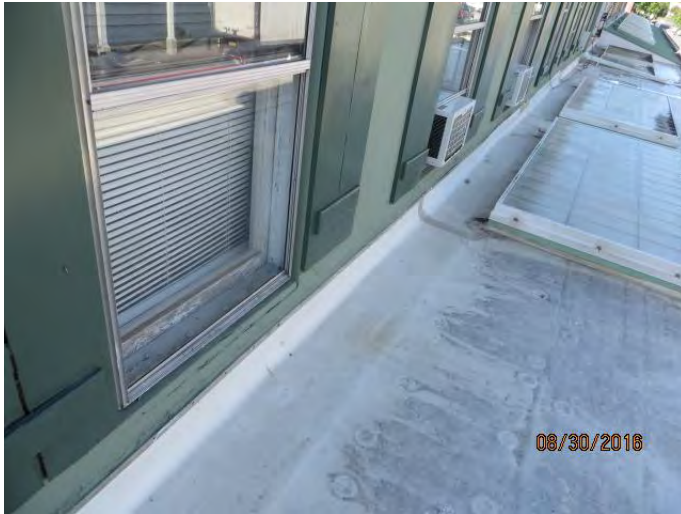
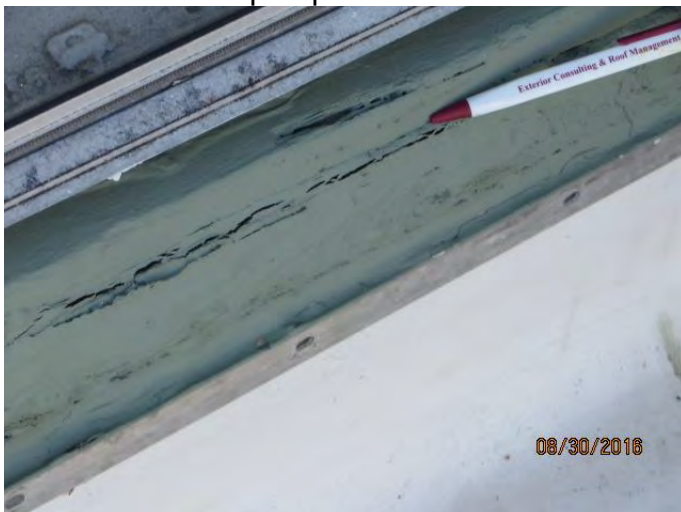
There are many opportunities for water infiltration through the windows, see photos 10 thru 18 and 21 thru 28.

Photo 10 Crack in wood below window

Photo 12 Close up of photo 11

The many opportunities for water infiltration at the windows must be remedied.

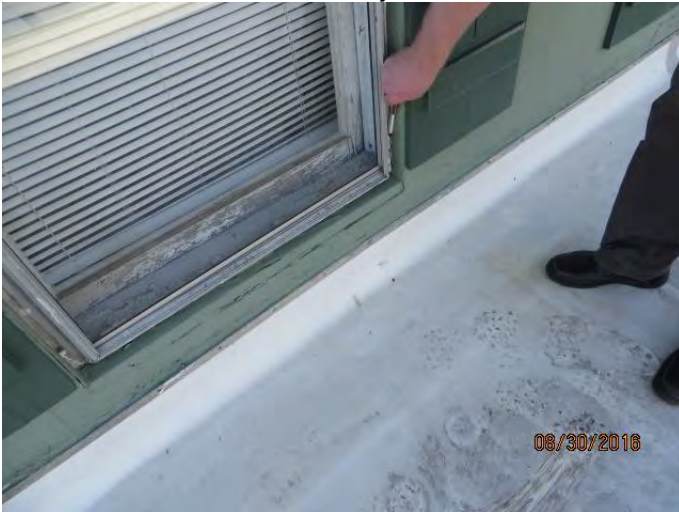
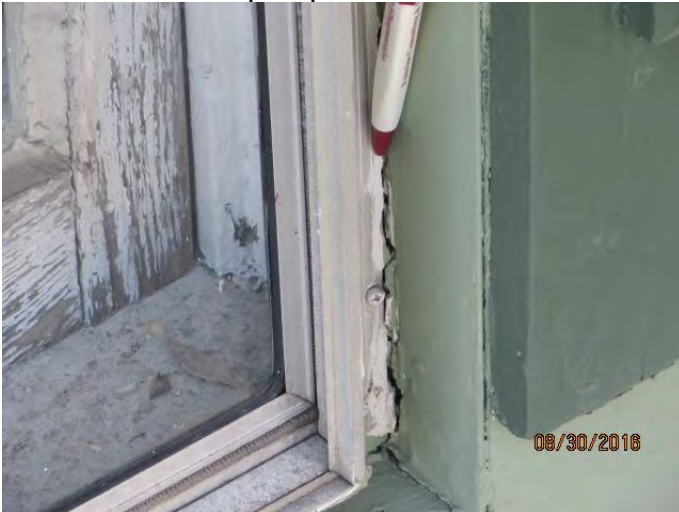
Photo 13 Crack in window jamb sealant

Photo 14 Close up of photo 13

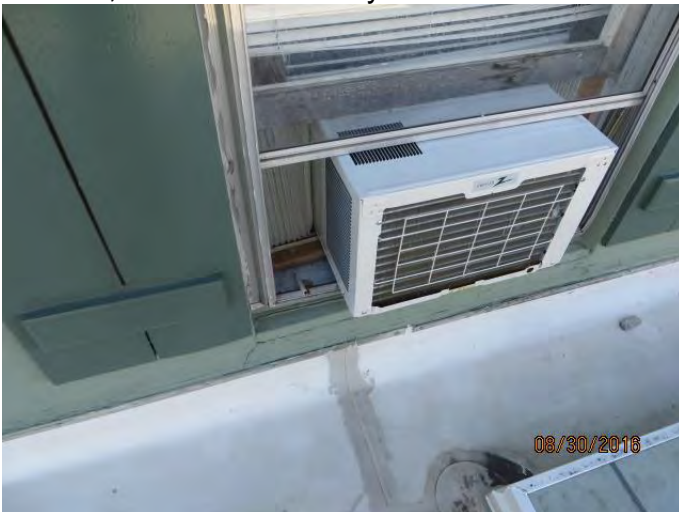
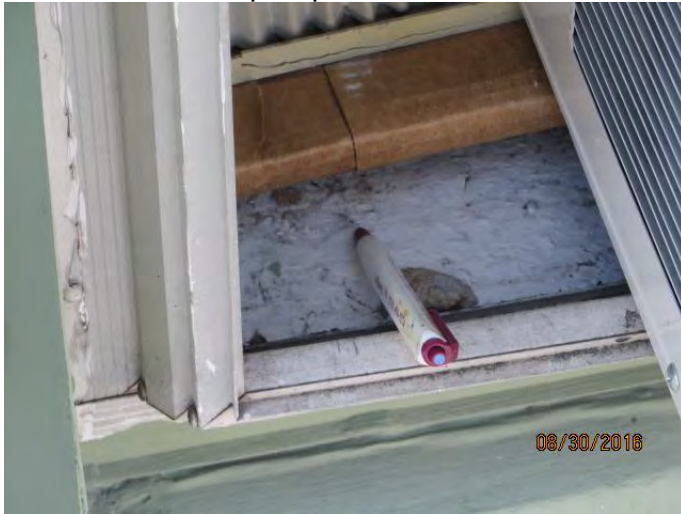
Photo 15 Fifth window from the west end, air conditioner closure not at window exterior, allows water entry

Photo 16 Close up of photo 15

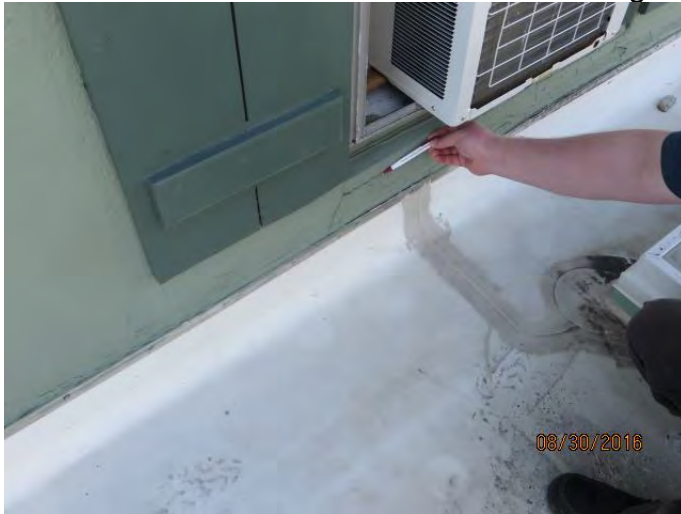
Photo 17 Crack in wood above base flashing

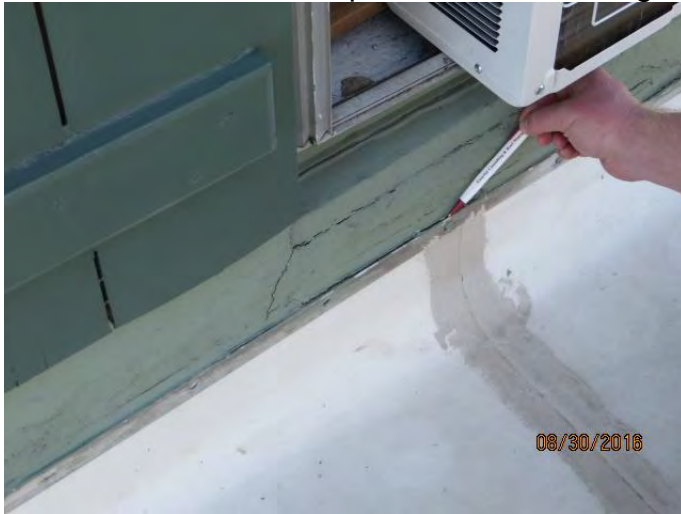
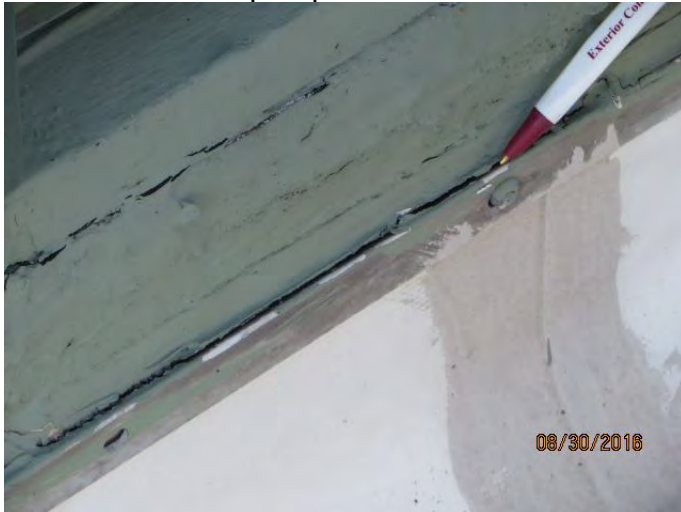
The sealant (caulking) at the top of the base flashing has cracked, see photo 19 and 20.

Photo 19 Crack at the top of the base flashing

Photo 20 Close up of photo 19

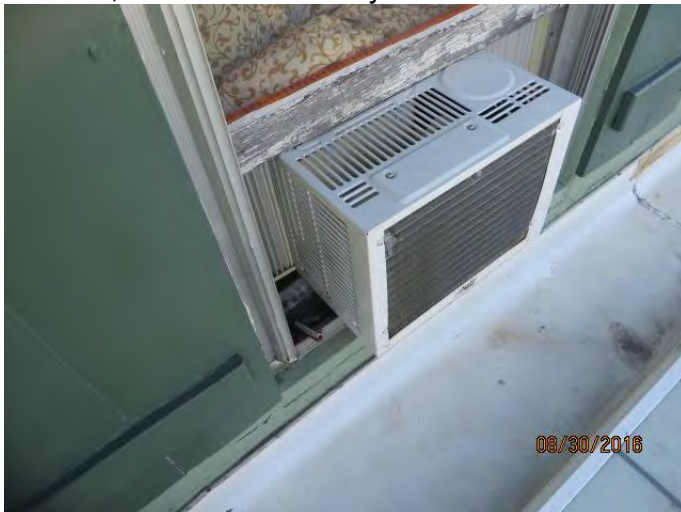
Photo 21 Sixth window from the west end, air conditioner closure not at window exterior, allows water entry

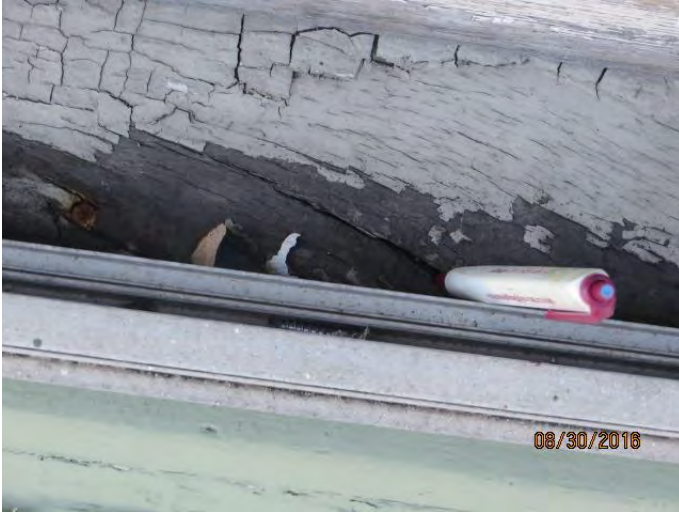
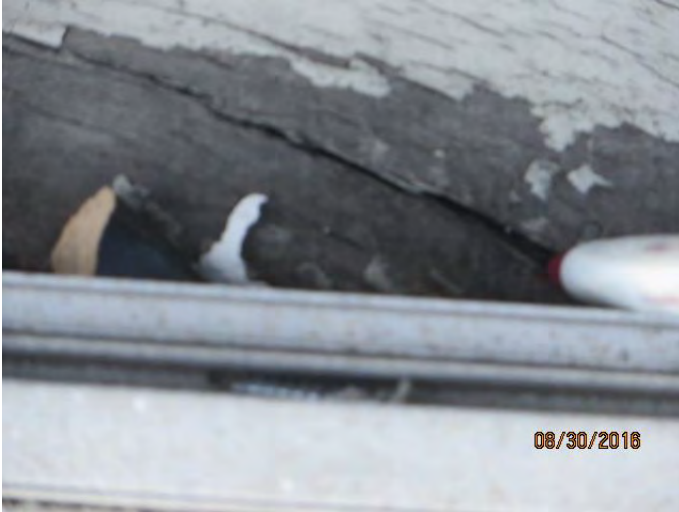
Photo 25 Eighth window from west end, crack in window sill frame

Photo 26 Close up of photo 25

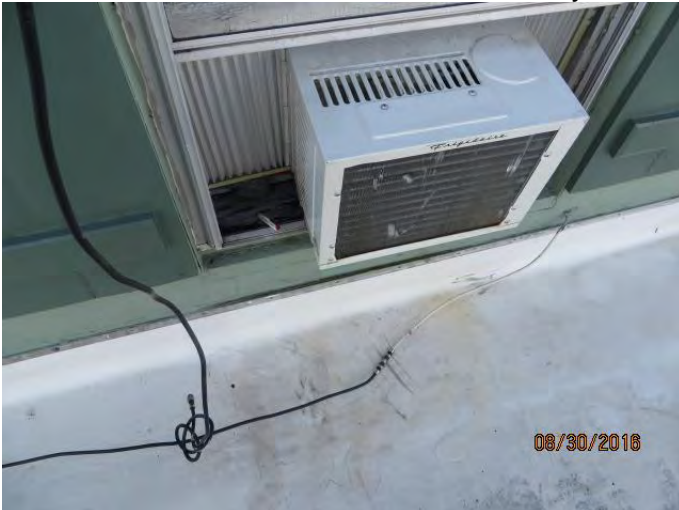
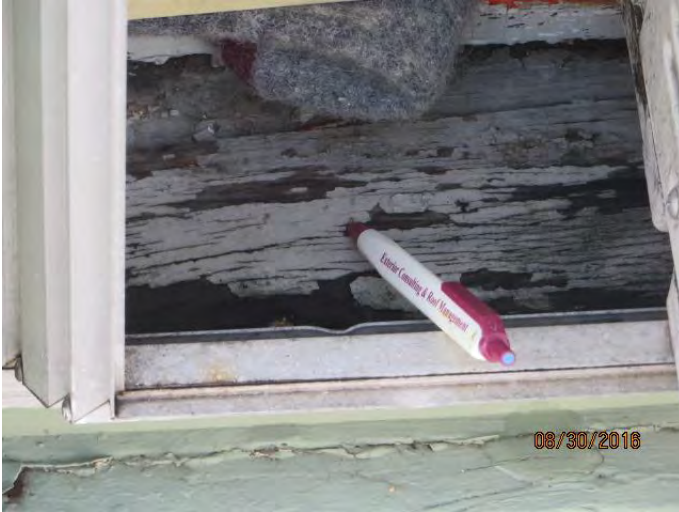
Photo 27 Ninth window from the west end (farthest east), air conditioner closure not at window exterior, allows water entry

Photo 28 Close up of photo 27

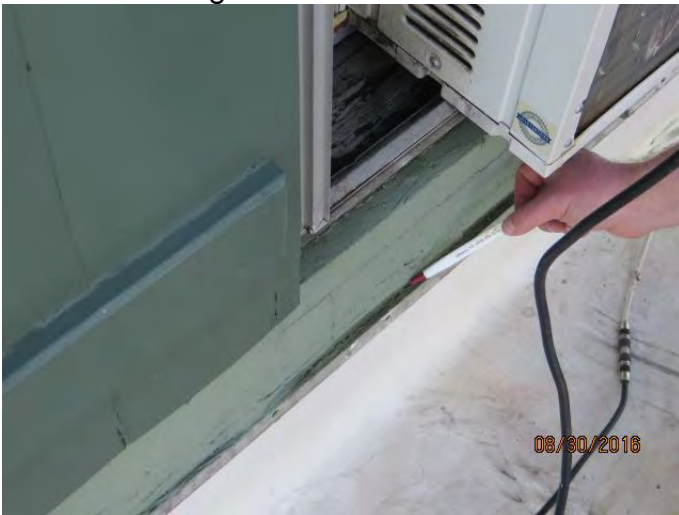
Photo 29 Ninth window from the west end (farthest east), cracks in sealant at top of base flashing

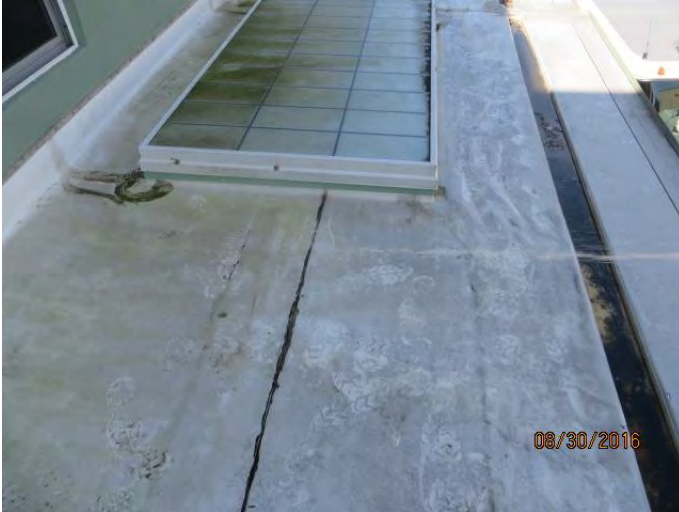
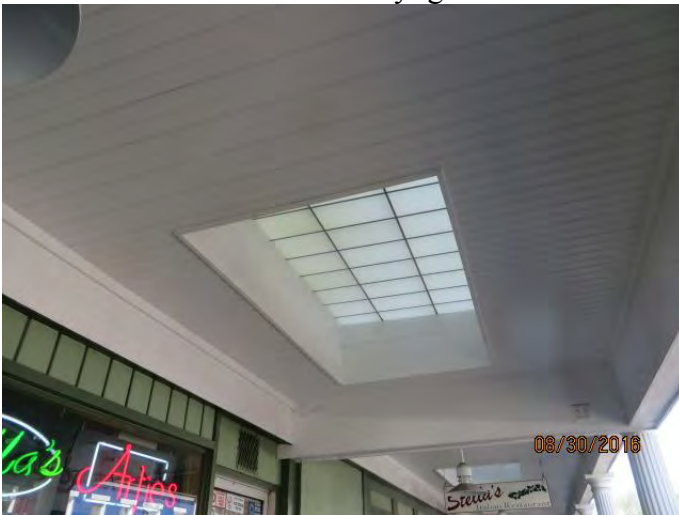
Photo 37 Water test on roof membrane opening of photo 8 and 9 at 9:56 AM

Photo 38 Water observed at skylight fascia at 10:05 AM beneath water test of photo 37

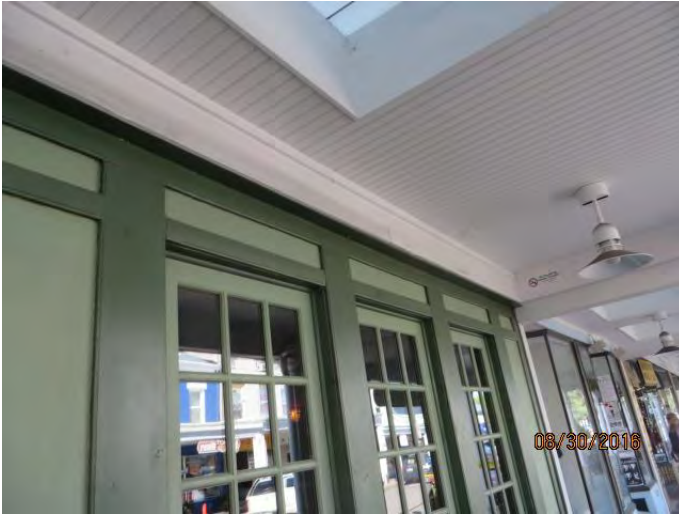
Photo 43 At 10:13 AM water observed at base of white fascia board beneath water test of photo 42

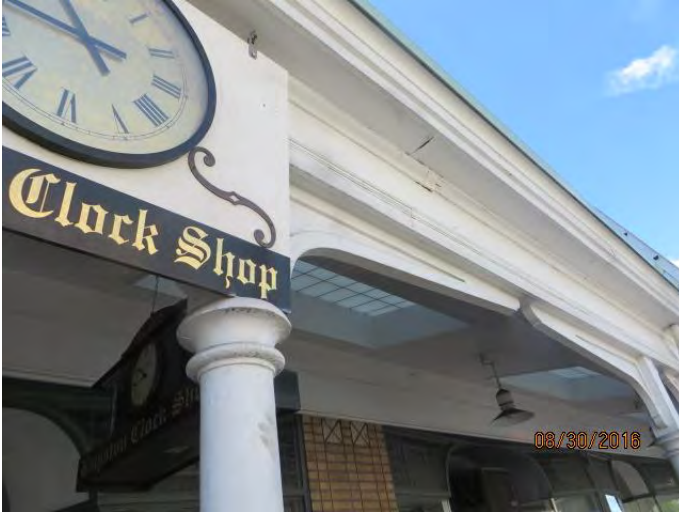
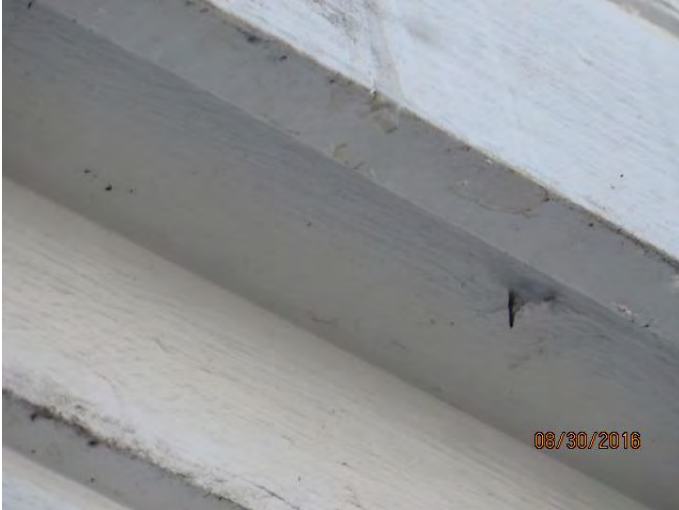
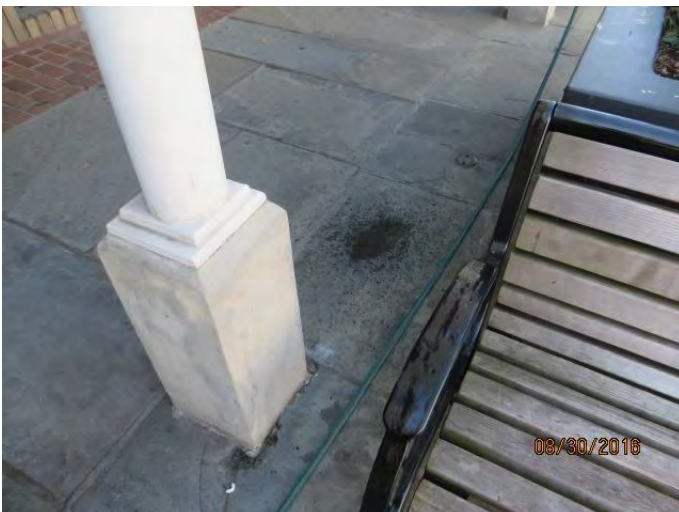
Photo 13 Water leak observed at fascia not previously reported

Photo 14 Close up of photo 13, see water drops

Photo 15 Water on side walk beneath fascia leak

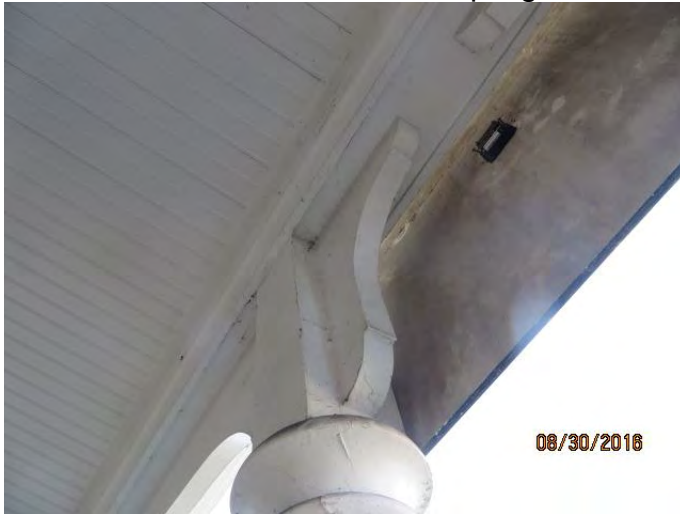
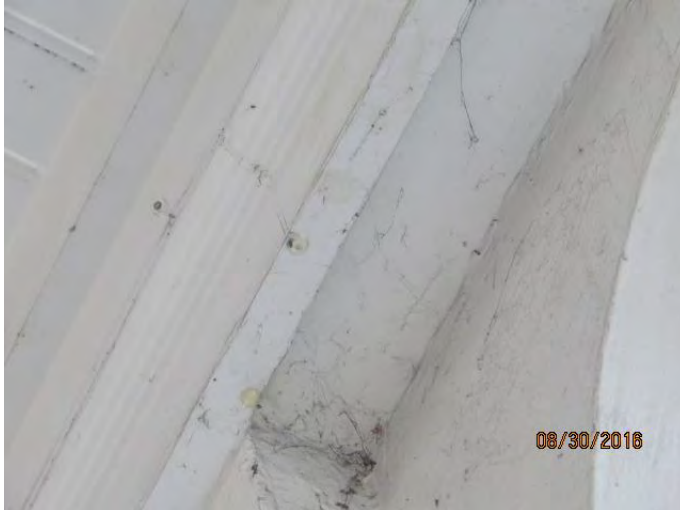
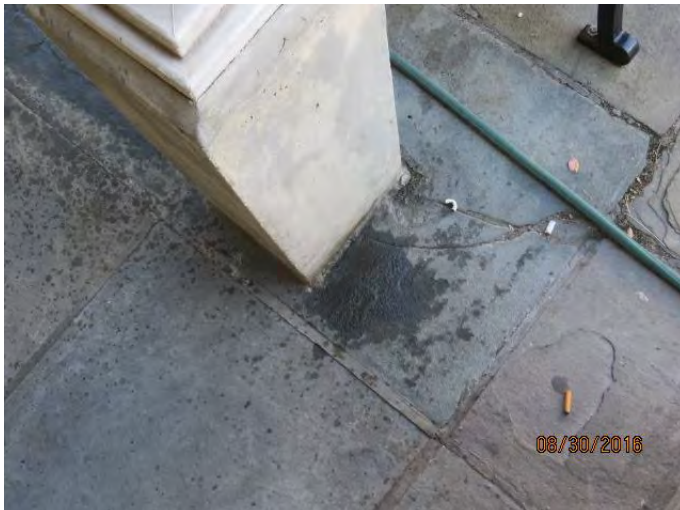
Photo 16 Leak behind Clock Shop sign

Photo 17 Close up of photo 16, difficult to see water drops

Photo 18 Water on sidewalk from leak Clock Shop sign

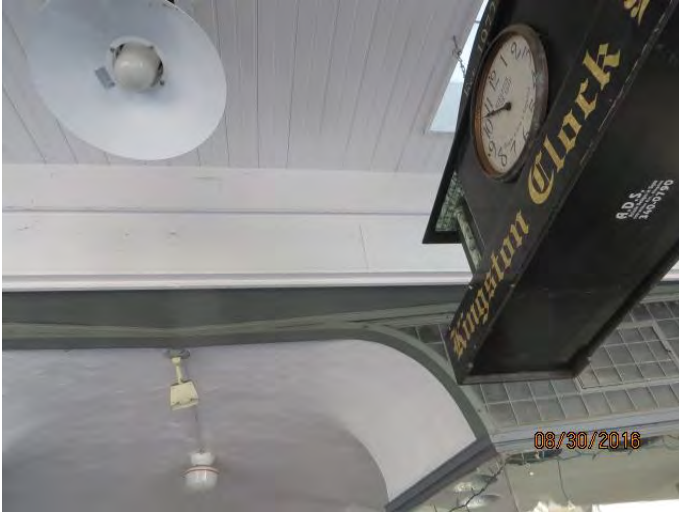
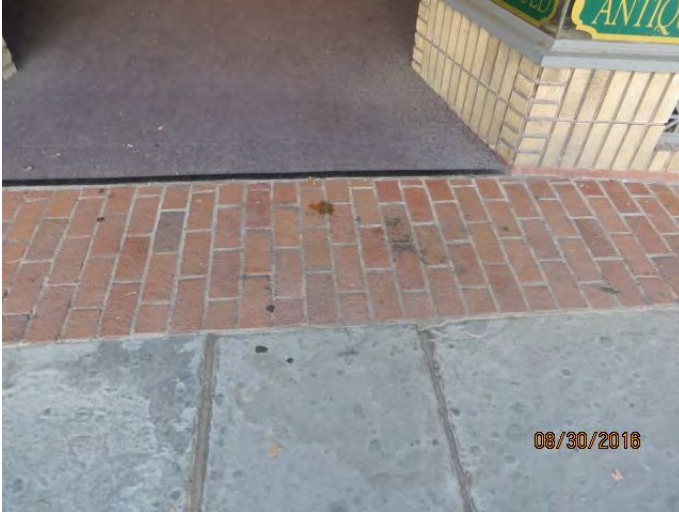
Photo 19 Water leak at fascia of front entrance

Photo 20 Water on sidewalk beneath leak shown in photo 19

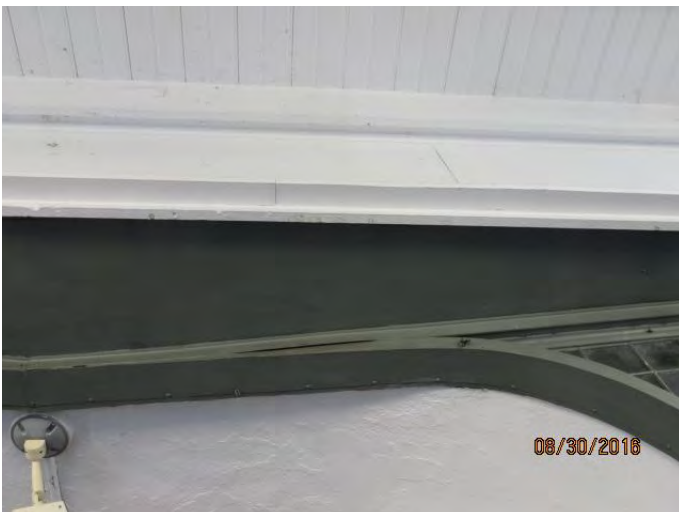
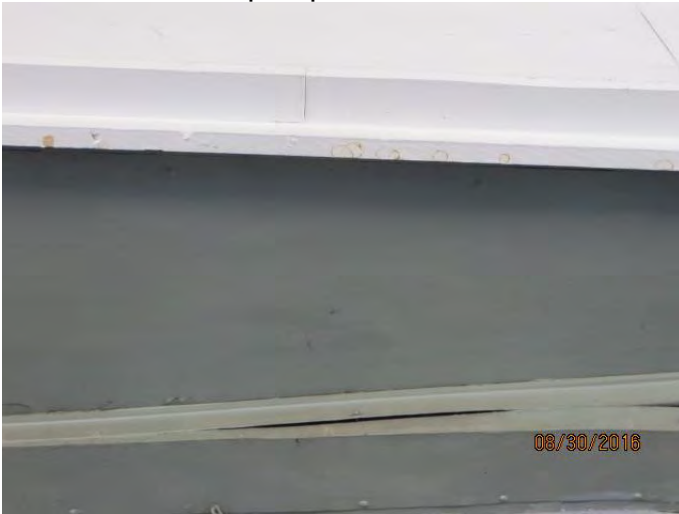
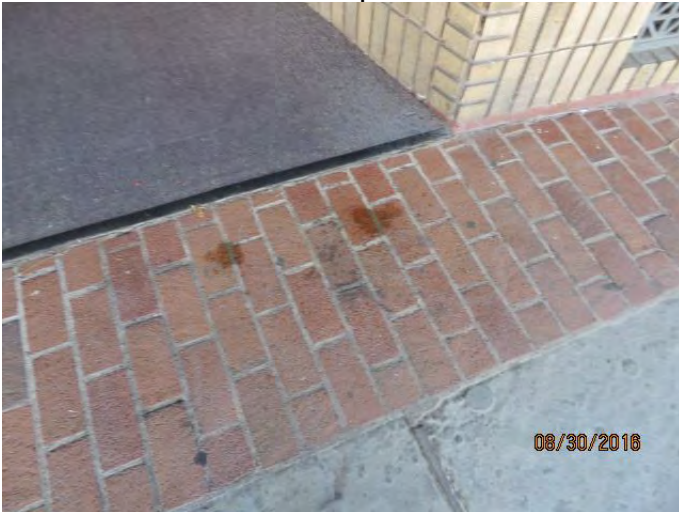
Photo 21 Second Water leak at fascia of front entrance

Photo 22 Close up of photo 21

Photo 23 Second water spot on sidewalk beneath leak shown in photo 21

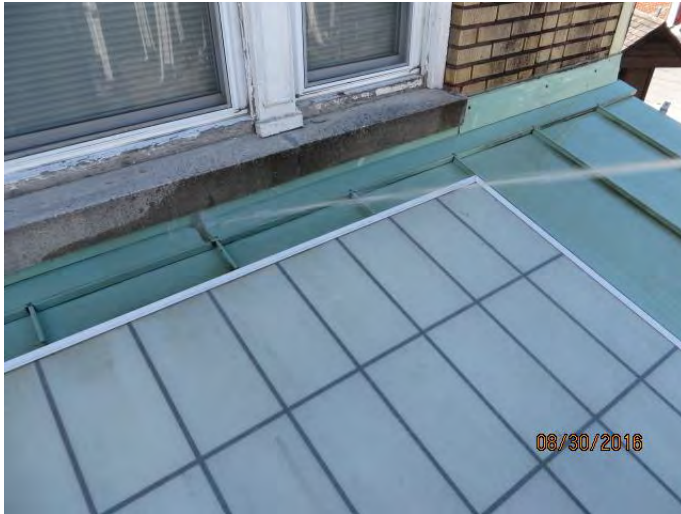
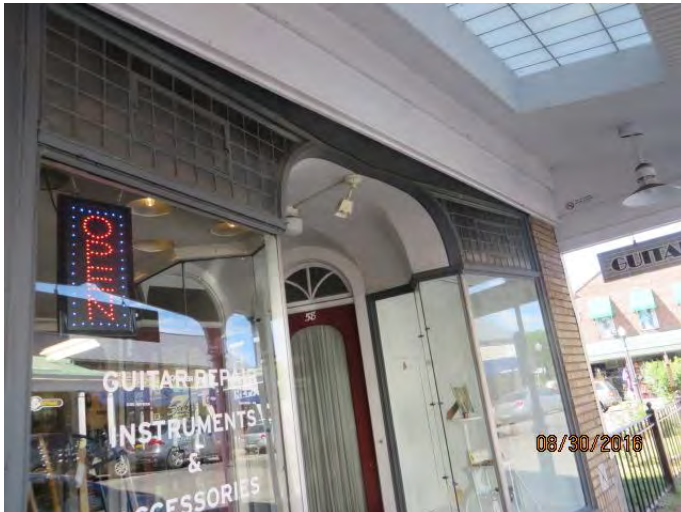
Photo 8 Begin water test on green metal base flashing at 11:08 AM across width of 58 N. Front St.

Photo 9 Water leaks observed across the front of 58 N. Front St. at 11:09 AM

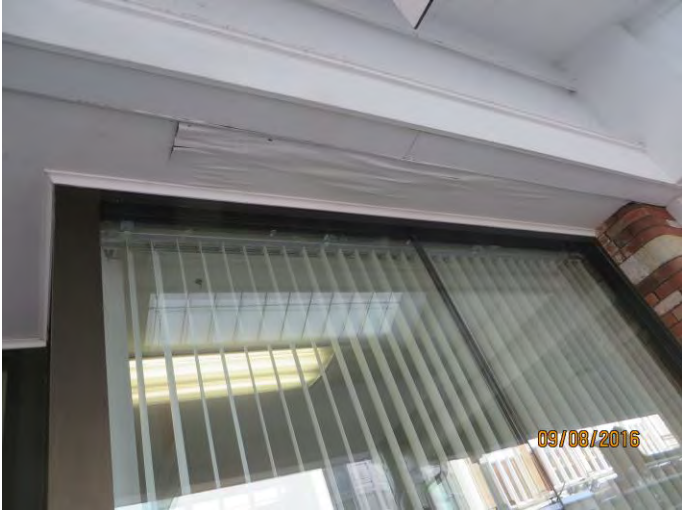
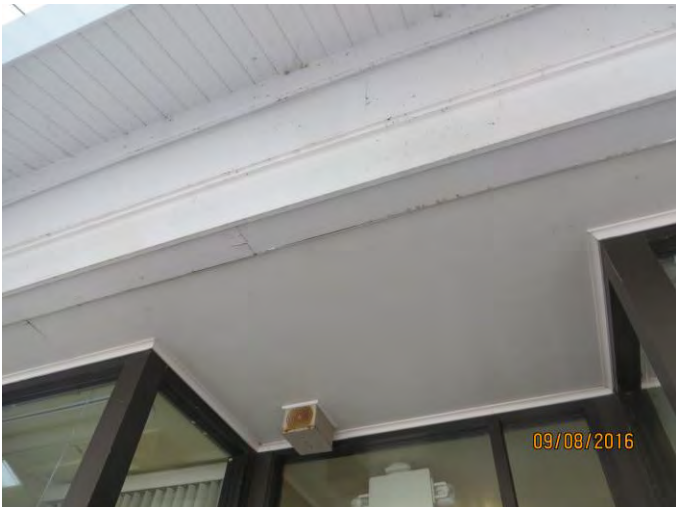
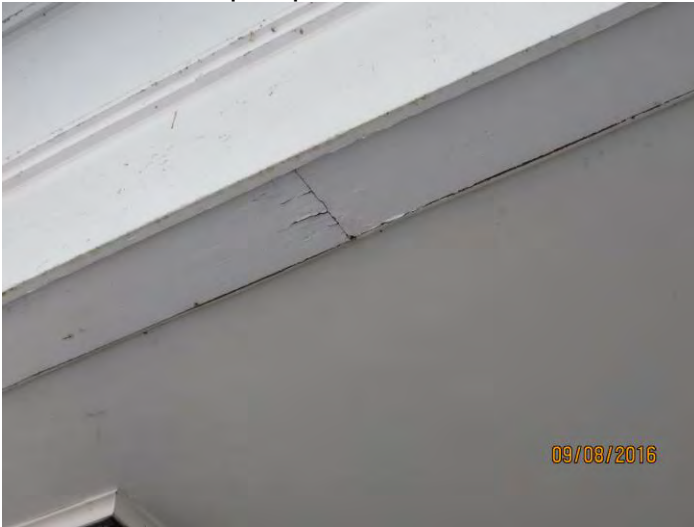
Photo 2 Water damage to soffit

Photo 3 Water stains on soffit

Photo 4 Close up of photo 3

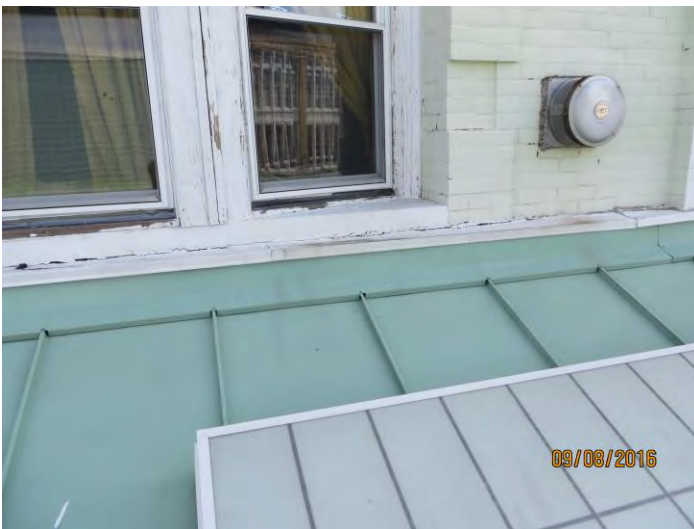
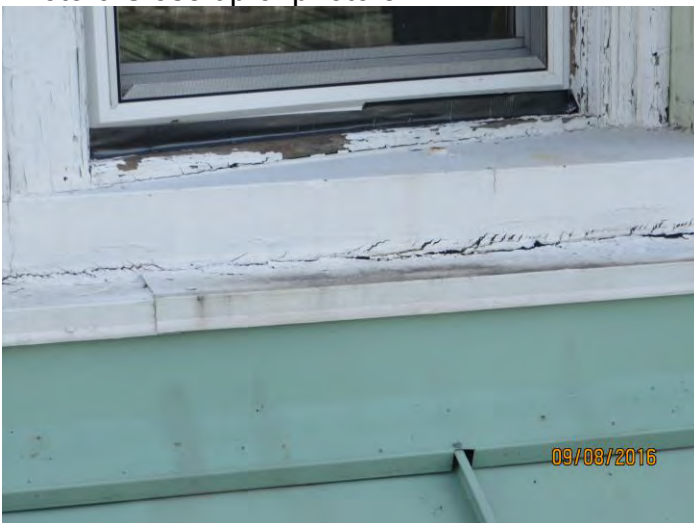
Photo 5 Window sills above metal canopy has large openings that were taped off for the water tests

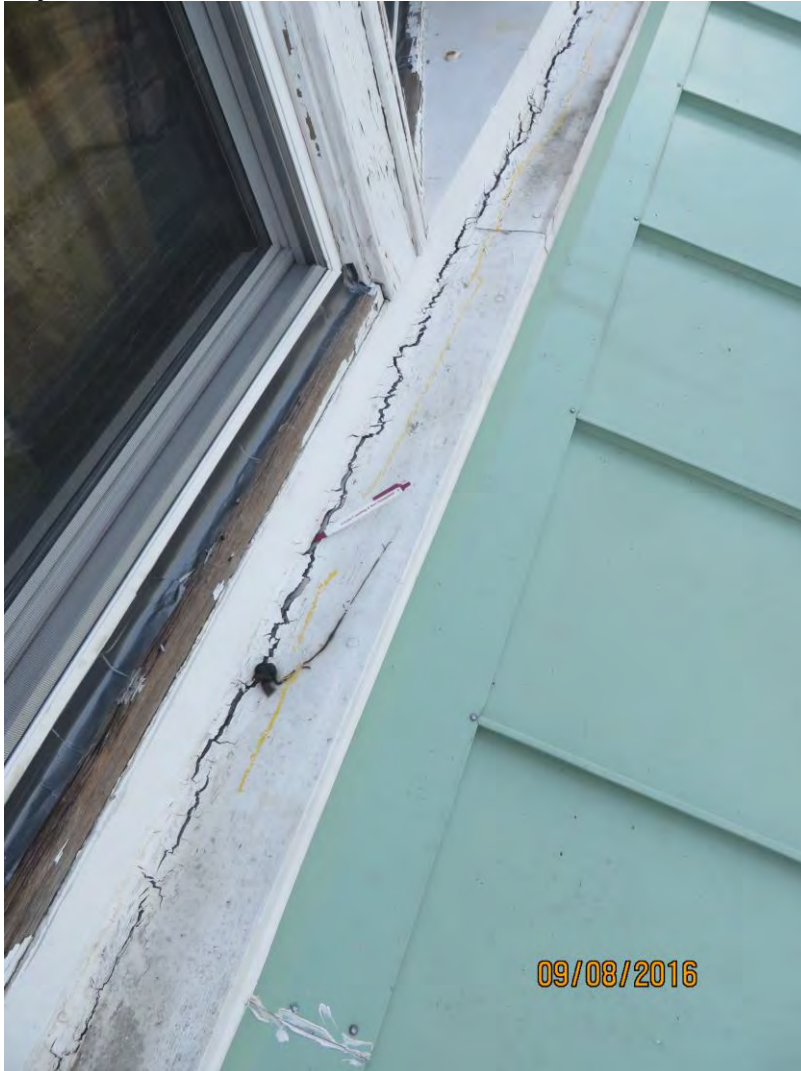
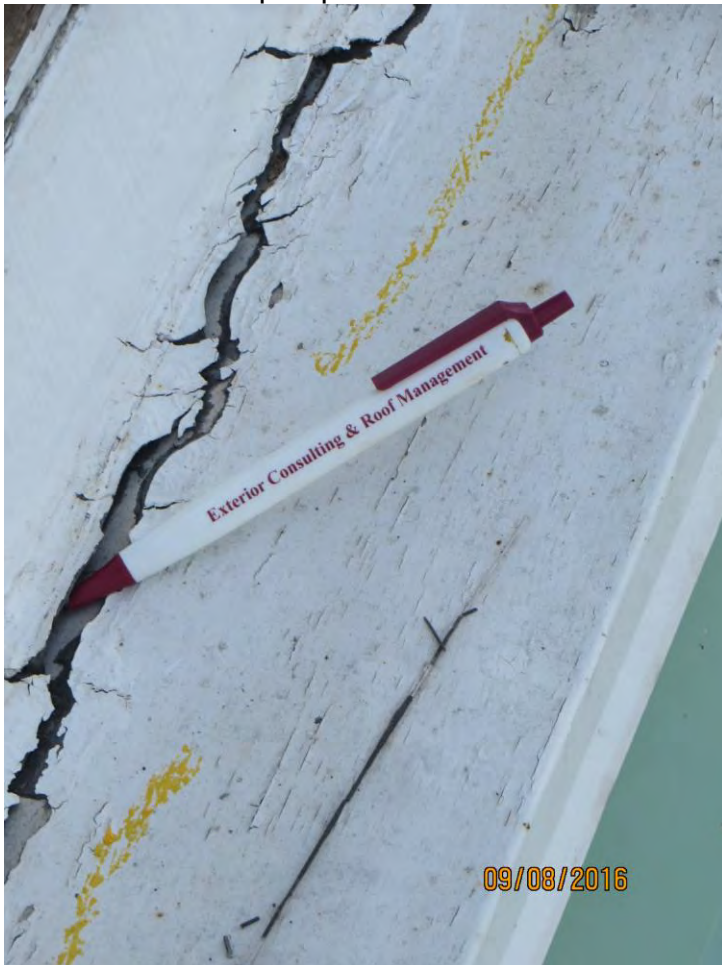
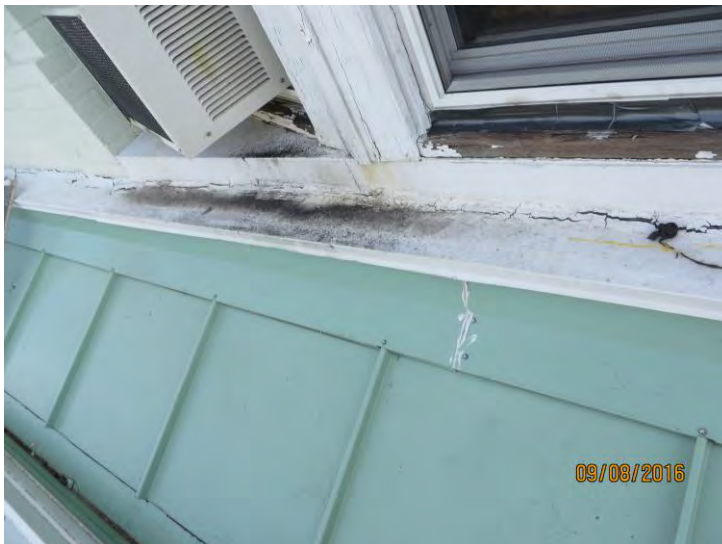
Photo 9 Crack along metal water table below windows, see yellow marking adjacent to crack

Photo 11 Water table crack continues across the building's front
