C.T. MALE ASSOCIATES

Re: *Results of Water Spray Testing*
Pike Plan Restoration Project
Kingston, NY
C.T. Male Associates Project No. 15.5150

REF: Kingston-Pike Plan: Water Tests
34 North Front Street: Dominick's Café/Dream Weavers

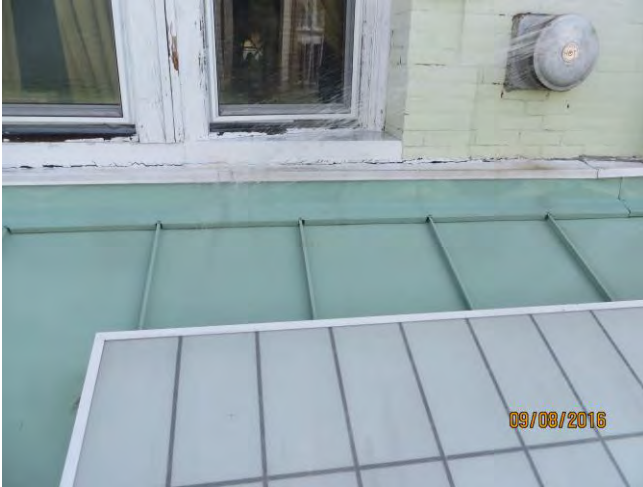
Photo 12 Begin water test at 10:47 AM across the building's front focusing on the water table crack with window sills taped

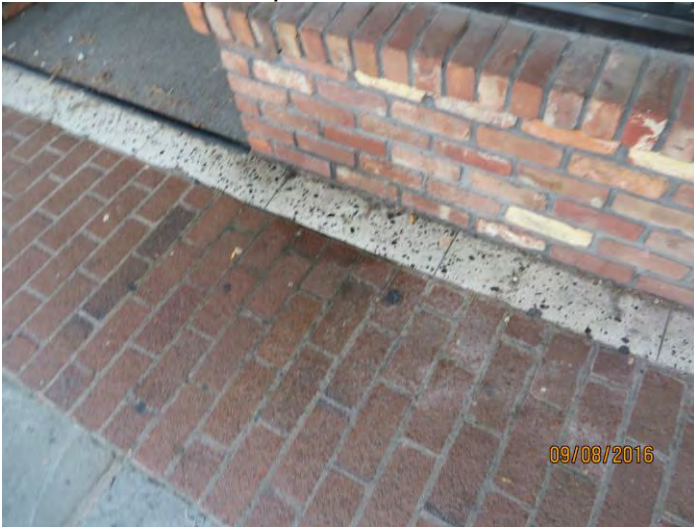
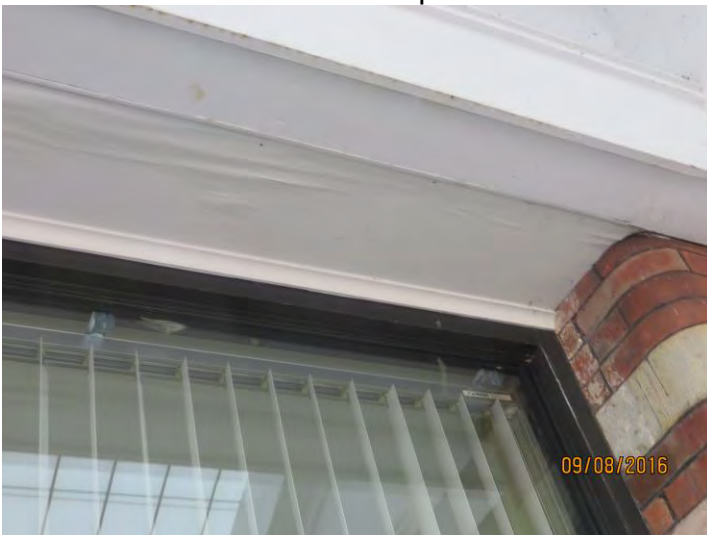
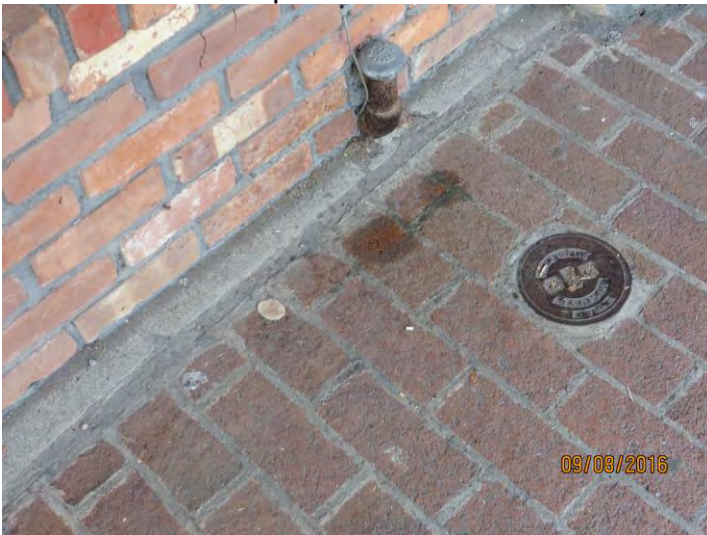
Photo 15 water drops on side walk below soffit

Photo 16 additional water drops at soffit

Photo 17 water drops on sidewalk beneath soffit of photo 16
