Rondout Riverport Shoreline Stabilization and Public Access – Phase II

Project Advisory Committee – Meeting 6 July 27, 2020

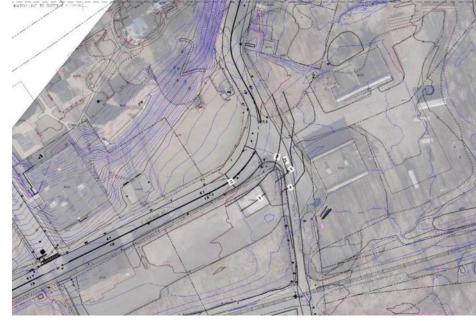
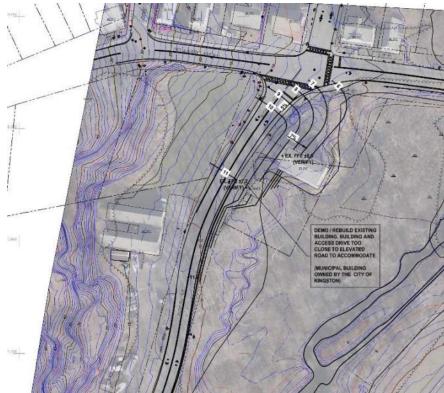
North Street Plans

East Strand to North Street Curve

Slopes 5% to tie into paper street and Barney Millens property

Delaware Avenue Connection

- Slopes at 7% to tie into building property
- 126-132 North Street (city-owned)
- 126 North Street (private property)
 - commercial use property)

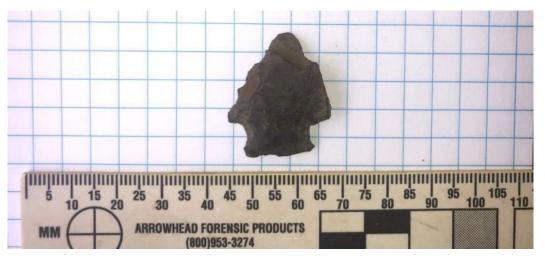
Trolley Trail Plan Development – Kingston Point Park

- Trail to be improved to create better access (stone dust)
- Phase 1B Archaeological
 Assessment revealed several pre-historic artifacts
- Phase II will be conducted to determine if site should be placed on National Register
- City will retain ownership of artifacts
- Additional wetland delineation may be required – pending review of existing mapping

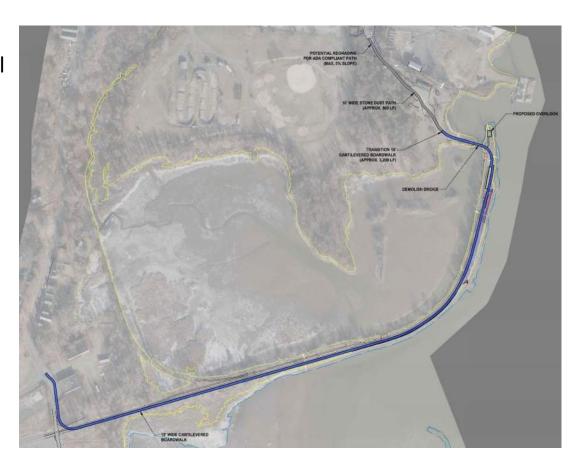
Trolley Trail Plan Development – Causeway – Phase C

- Initial phase of elevation 2030's levels predicted to rise 6" in central range scenario
- Construct cantilevered boardwalk to tie into trail at Kingston Point Park where SLR elevation is determined
- Construct cantilevered boardwalk to tie into North Street/East Strand where SLR elevation is determined
- Pilings designed to be raised to accommodate SLR
- Living shorelines protected and restored during and after construction
- Flow between Hudson River and Tidal Wetlands maintained

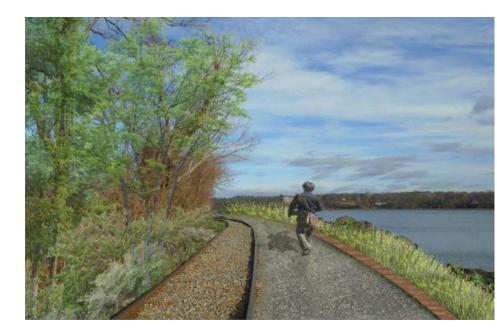
Trolley Trail Plan Development – Trolley Trail Causeway

TYPICAL PIER CONNECTION DETAIL
