**DRAFT**  
**EAST STRAND STREET FLOODING AND**  
**STORMWATER MANAGEMENT ANALYSIS**

**EAST STRAND STREET AT THE RONDOUT WATERFRONT**  
**CITY OF KINGSTON, NEW YORK**

April 5, 2013

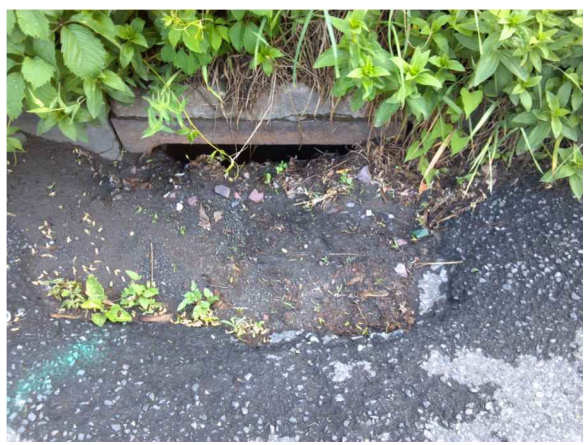
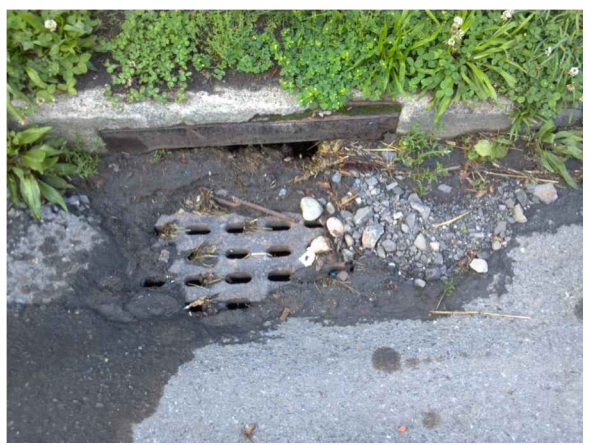
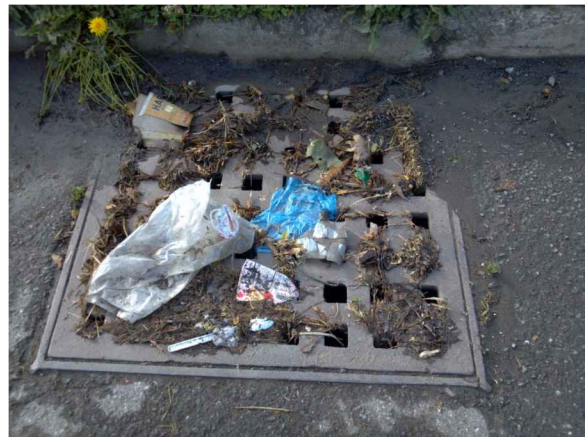
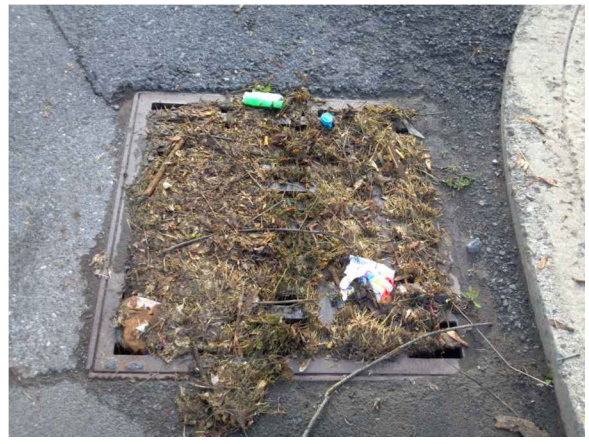
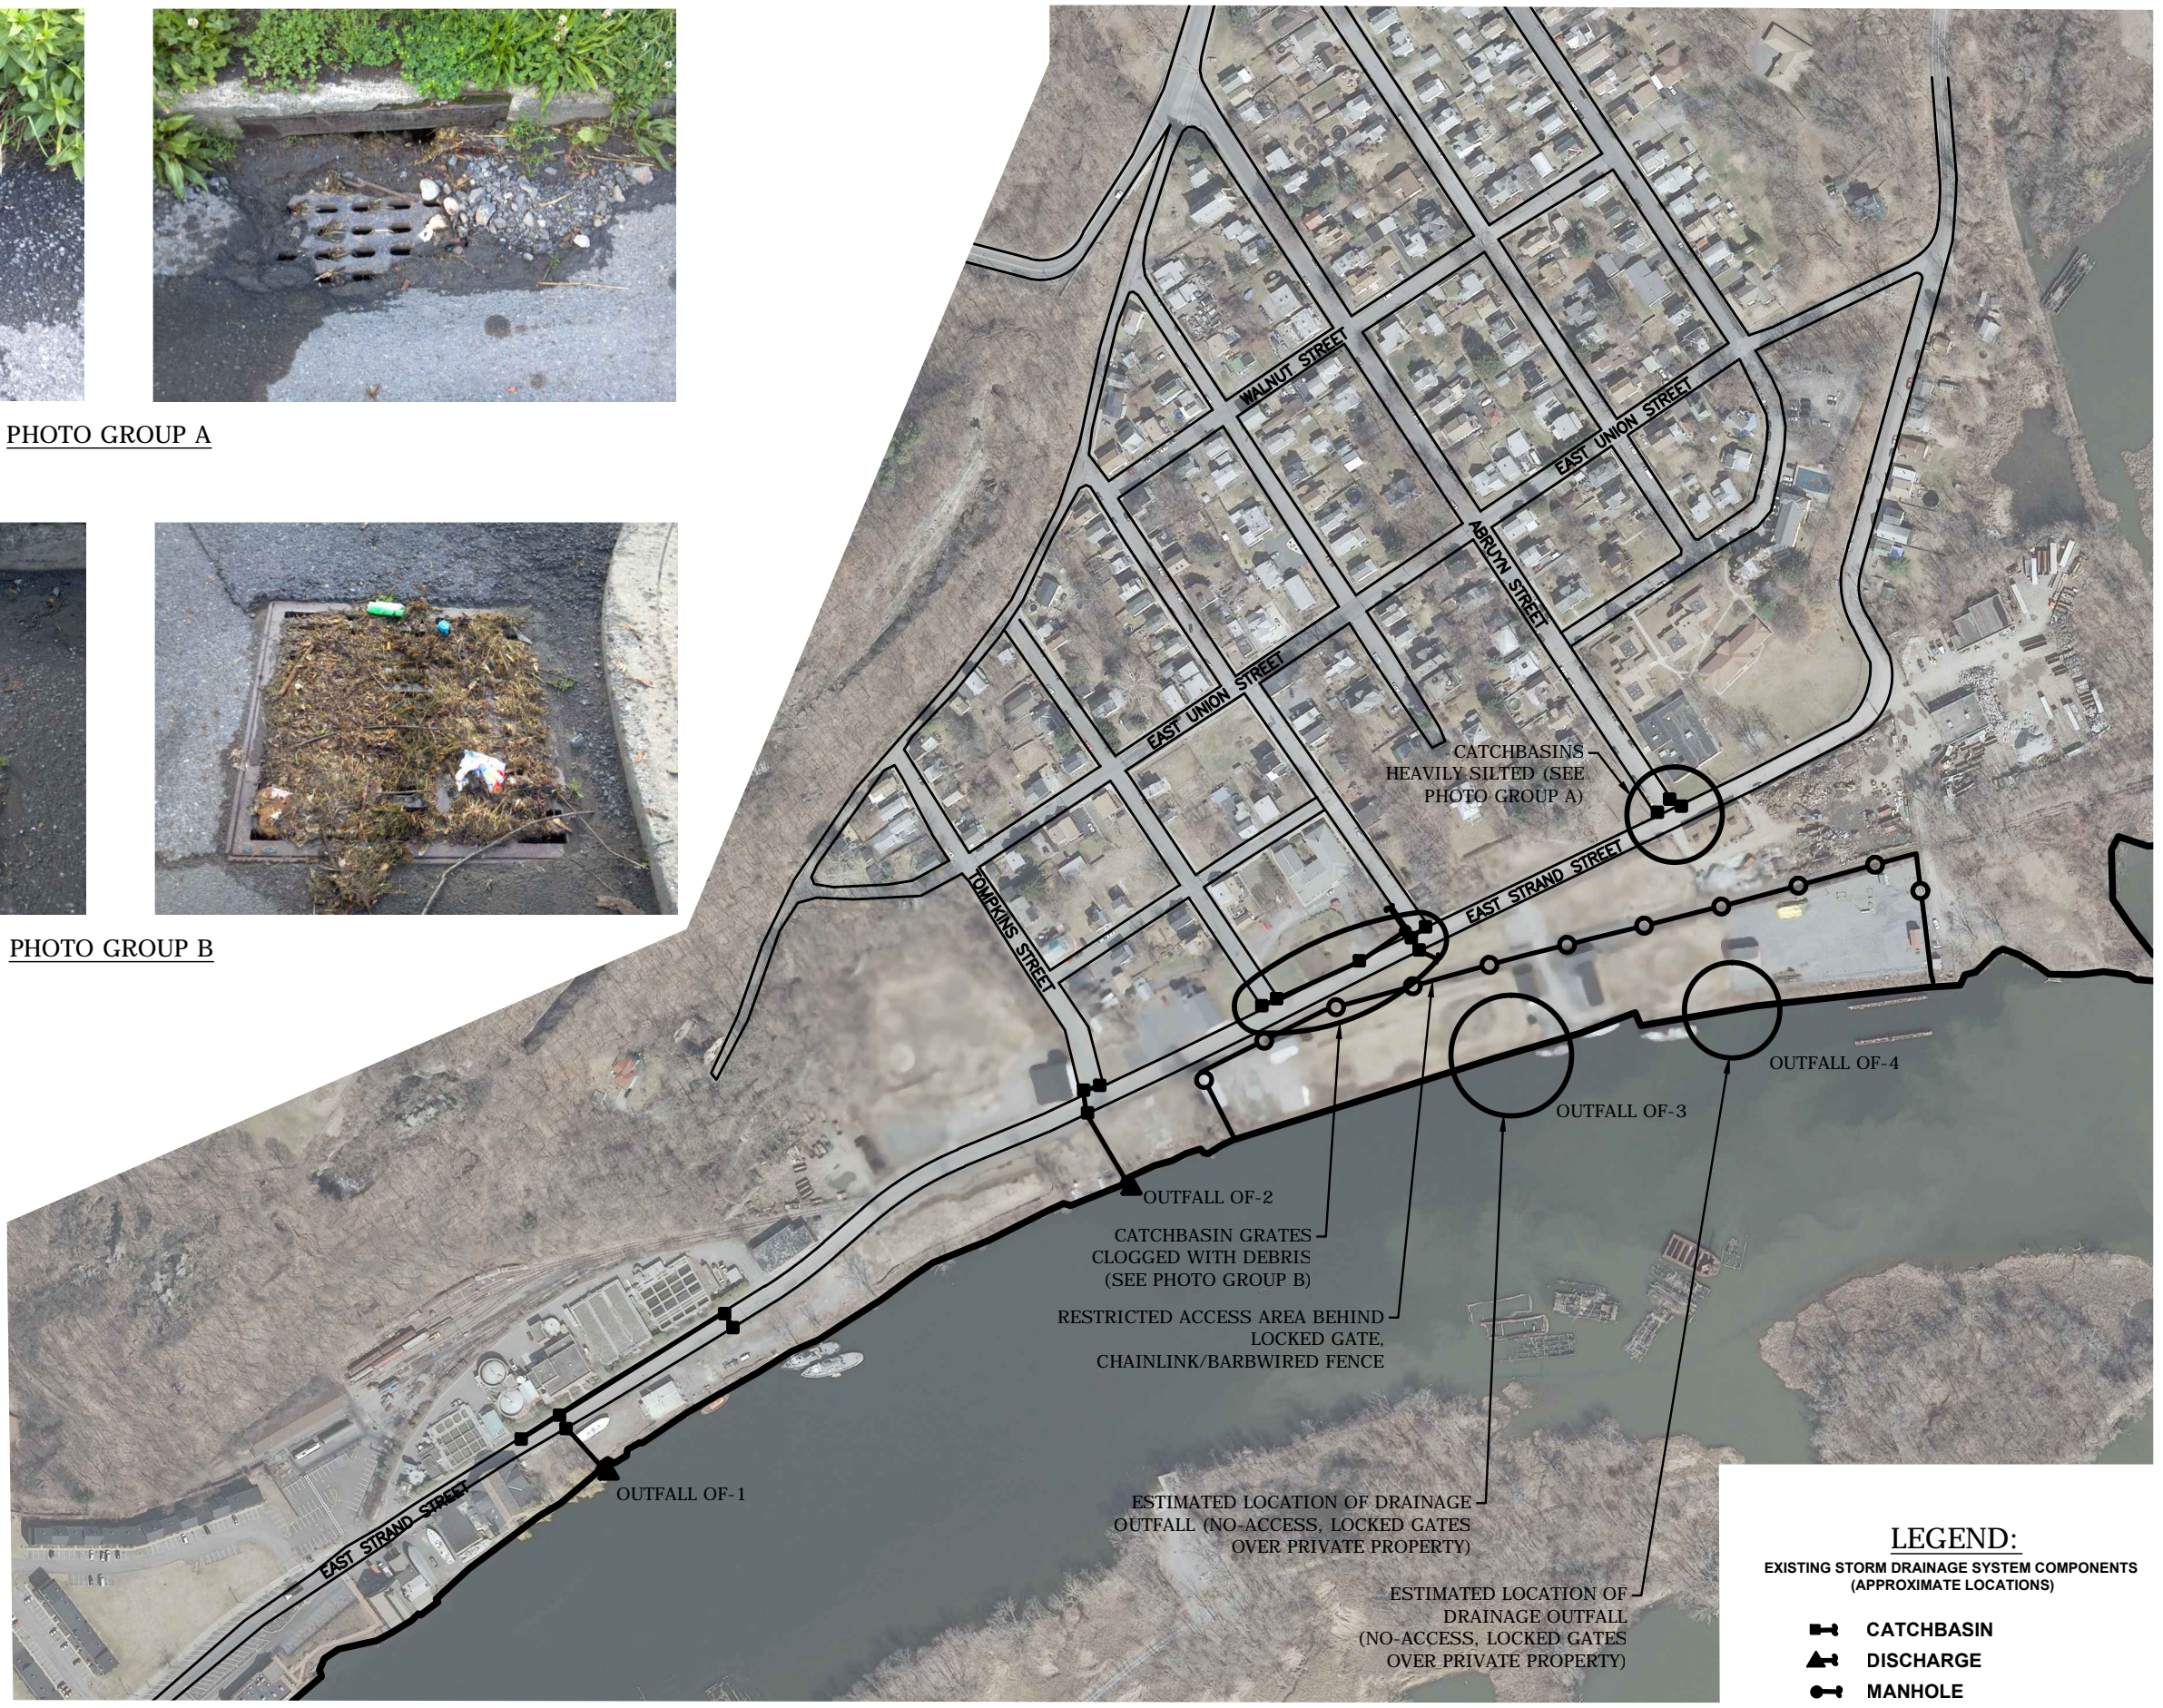
**FIG.2**

Many drainage structures were found to be in need of routine maintenance to remove silt and debris collection clogging their inlets and sumps (see Figure 2). Structures connected to Outfall 1 appeared to be in reasonable condition. Structures connected to Outfall 2 had some minor siltation and debris blockage while structures connected to Outfall 3 and Outfall 4 were severely impeded by debris and silt.

A request was submitted to the City of Kingston Public Works Department for cleanout of these structures prior to survey, in June 2012, and a formal memorandum documenting the conditions was submitted to the city in December 2012.

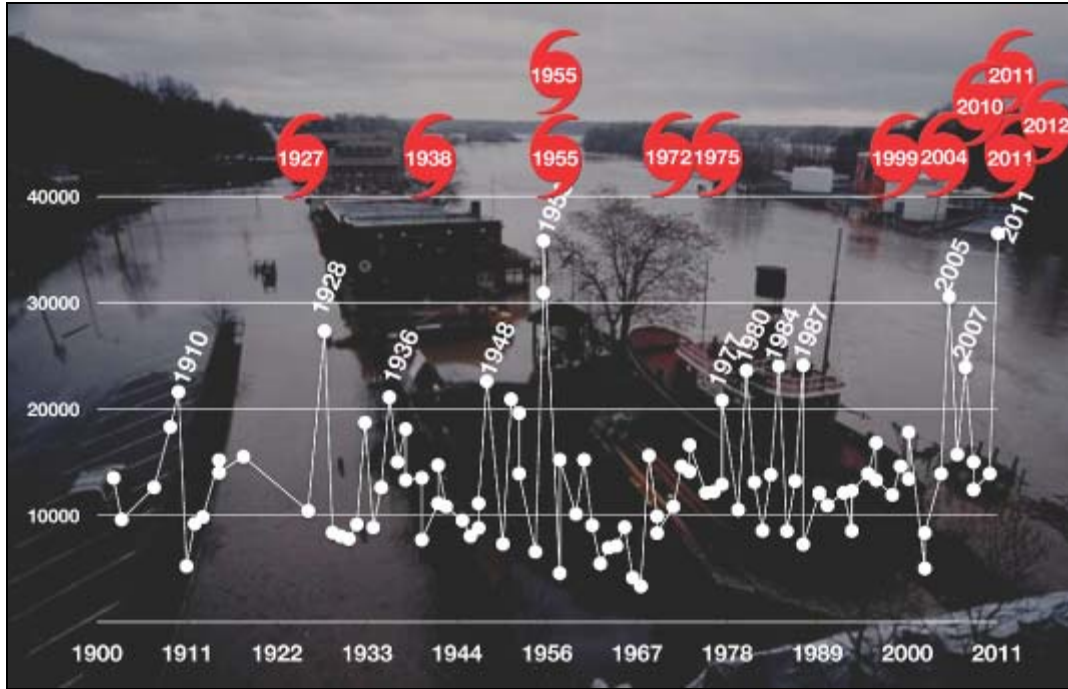
**FIGURE 5**  
**Peak Discharge (cfs) in Rondout Creek vs. Tropical Weather Systems**

1. Source: Scenic Hudson, 2012
2. Vertical axis represents discharge in cubic feet per second.
3. Horizontal axis represents year.

As seen in Figure 5, many of the highest peak-flow events in the Rondout Creek coincide with tropical weather systems. However, some tropical storm events did not cause excessively high flows in the Rondout such as in 1927, 1938, 1972, 1999, and 2004. Conversely, some high flow events were not a direct result of a tropical weather system, such as in 1928, 1980, 1984, 1987, 2005, and 2007.

flooding. Figure 5 presents a comparison of tropical weather systems known to have affected the Kingston area and the peak discharges recorded in Rondout Creek over the last 100 years.

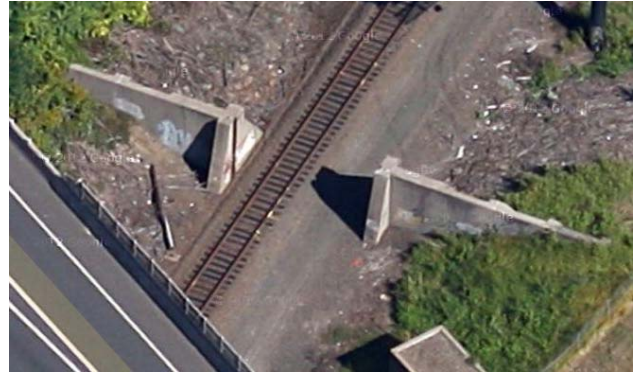
Figure 7: Photograph of Typical Bulkhead Installation

Accessways through the levees with at-grade sidewalks or driveways can be provided but may require bulkhead closures to seal the openings during floods. Bulkhead closures operate as manually controlled gates that allow access through the levee during dry times and seal against water during flood events but have the disadvantage of being manually opened and closed

in preparation for potential flood events. If levees or floodwalls are used, their terminal ends must be connected into high ground so floodwaters do not circumvent the walls and the lower lying land behind them.
