RONDOUT HARBOR MANAGEMENT PLAN

CITY OF KINGSTON, NY

**US Army Corps
of Engineers®**
New York District

June 2014

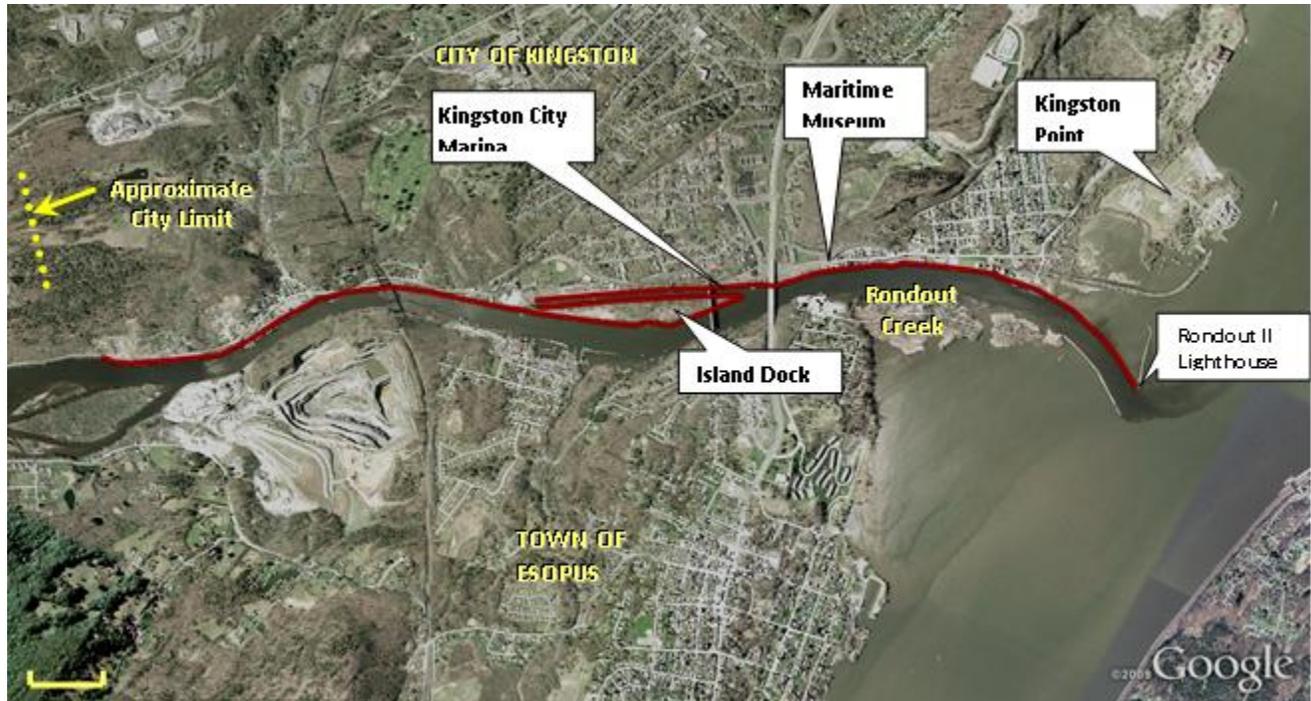
Figure 1 - Plan Area

The HMP area, as defined by the LWRP, is as follows:

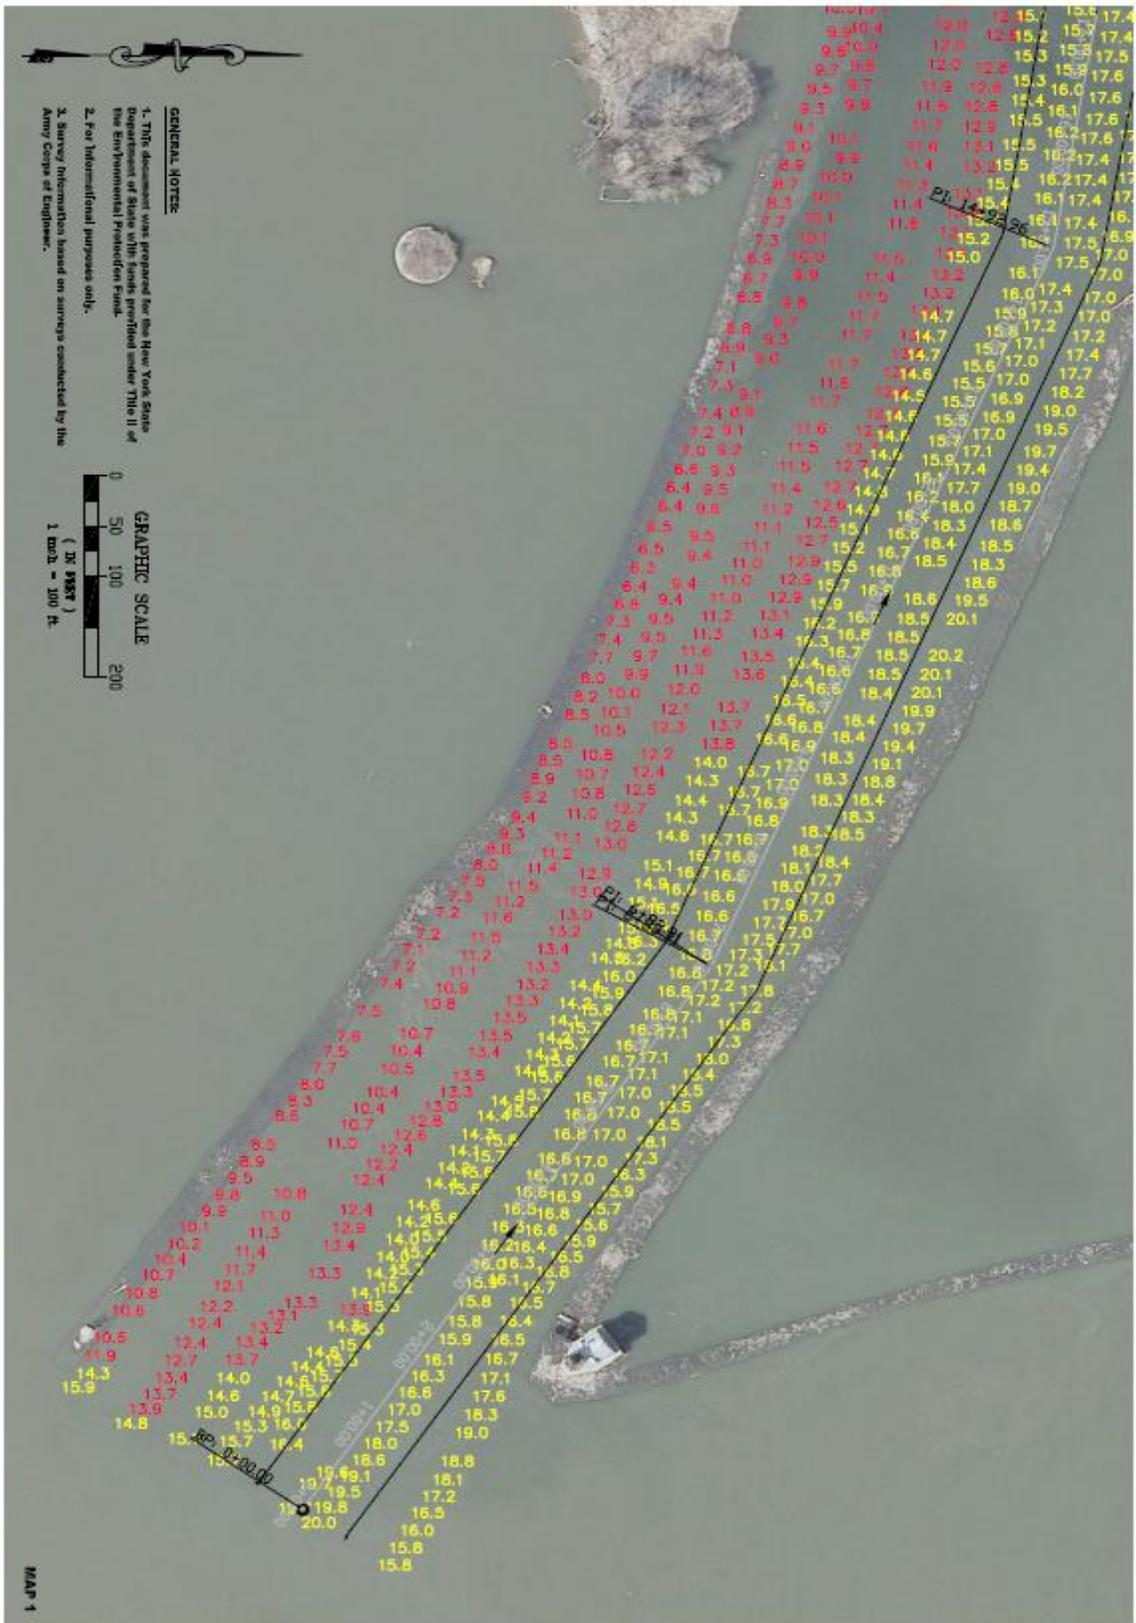
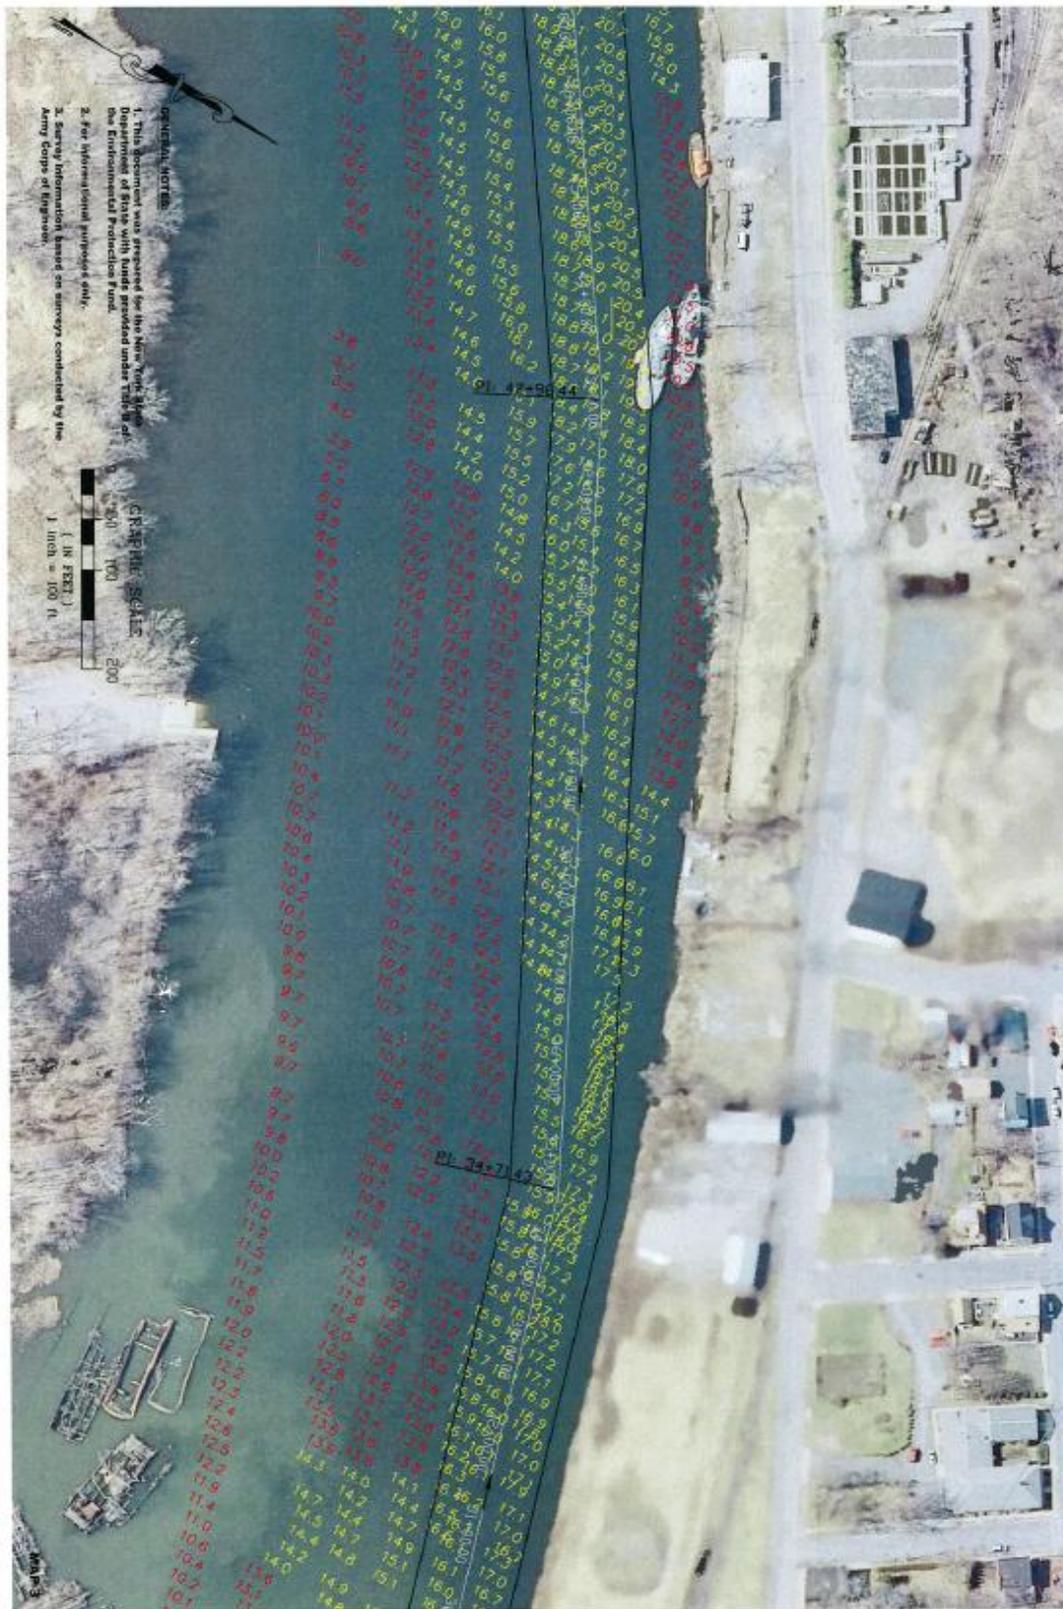
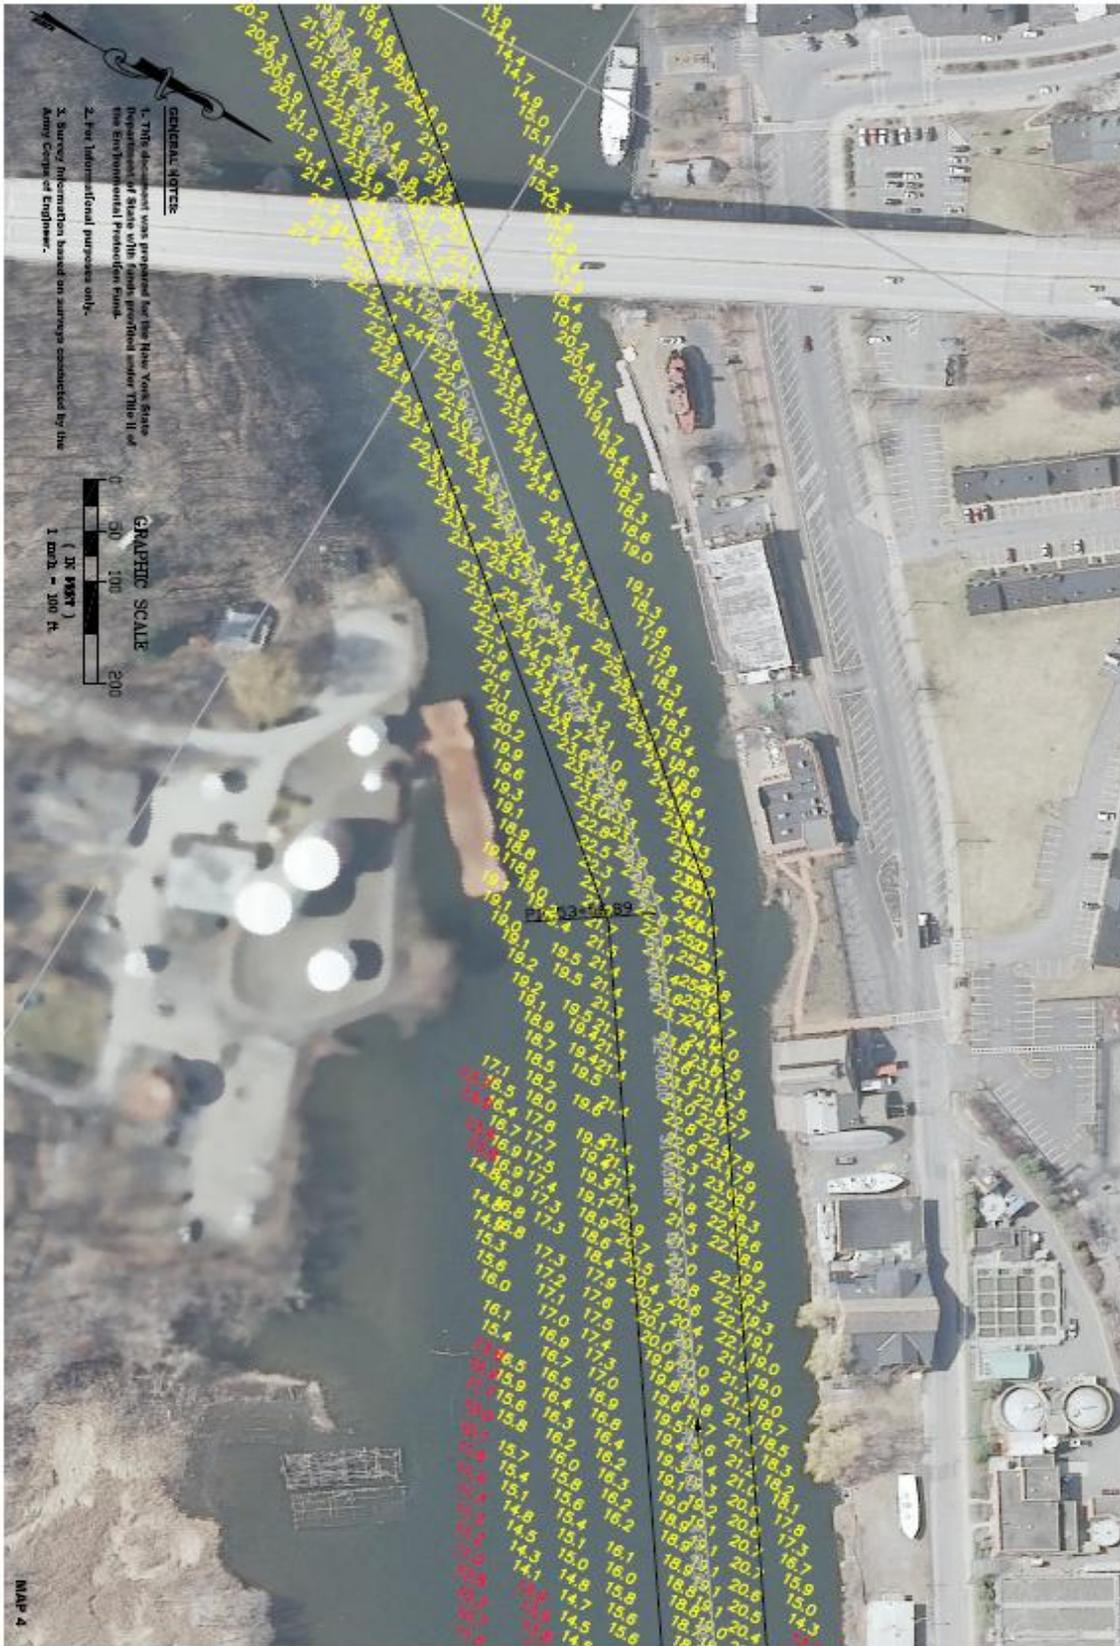
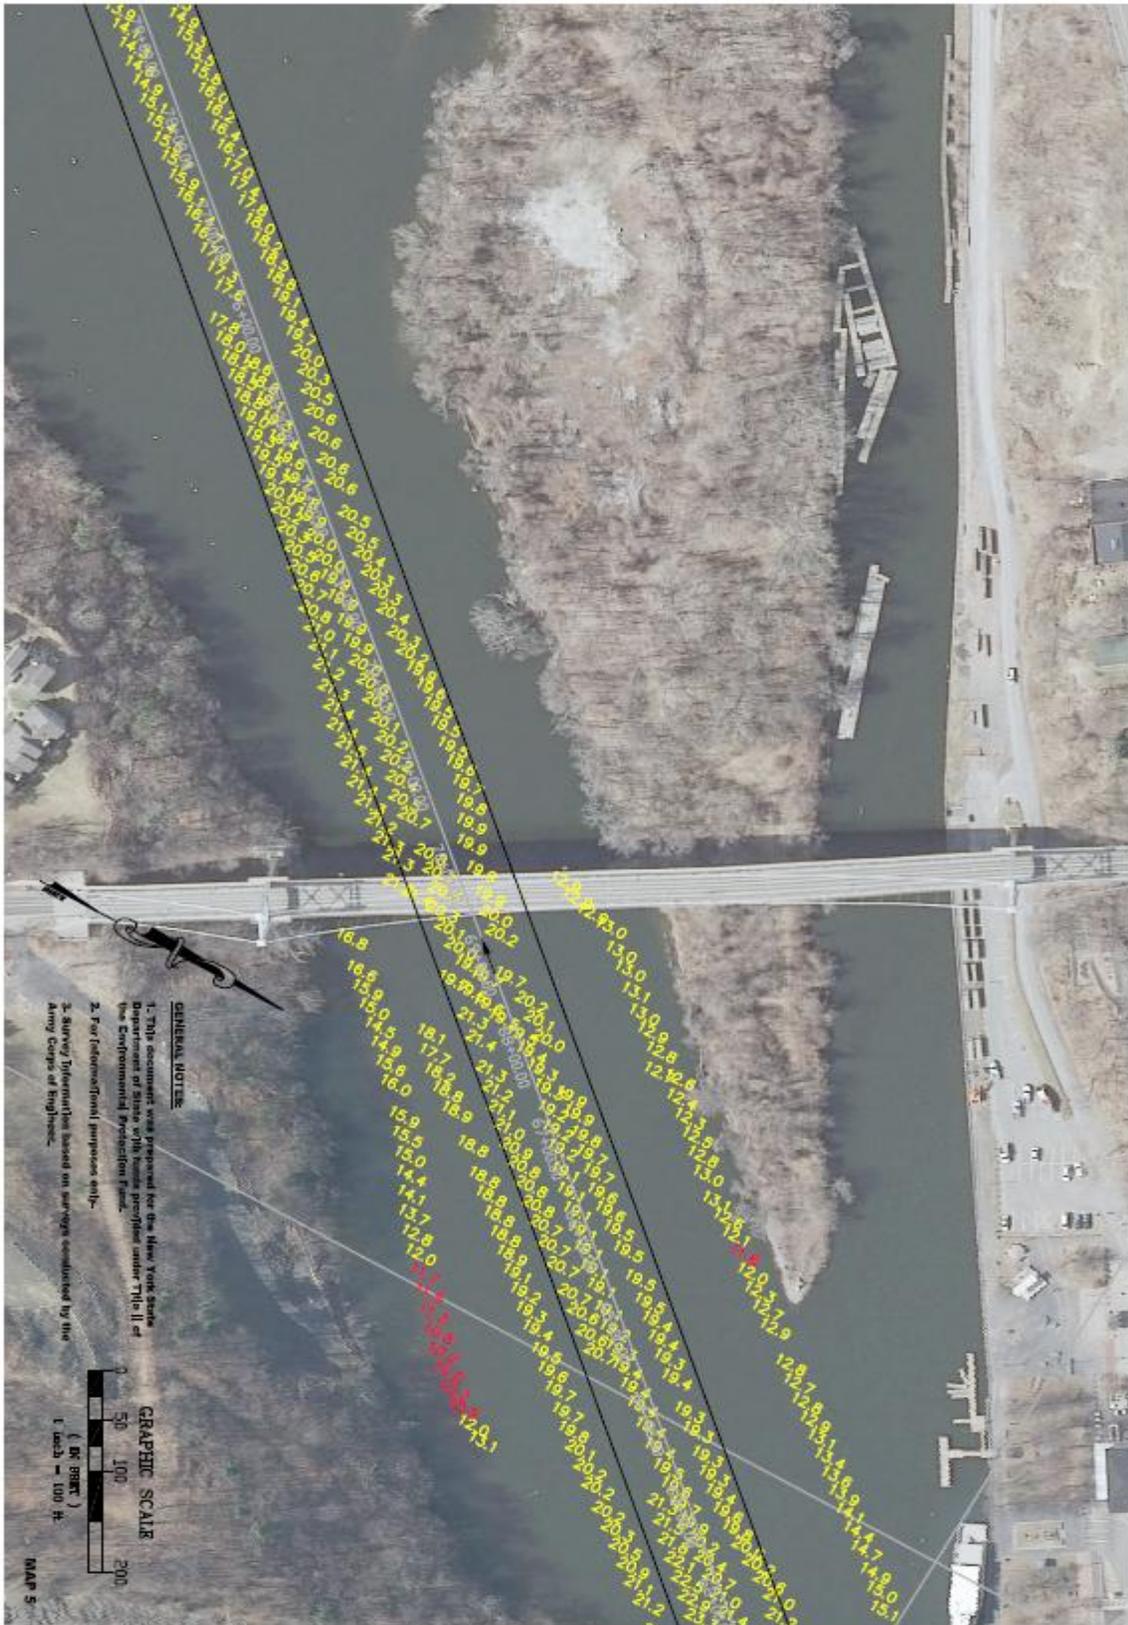
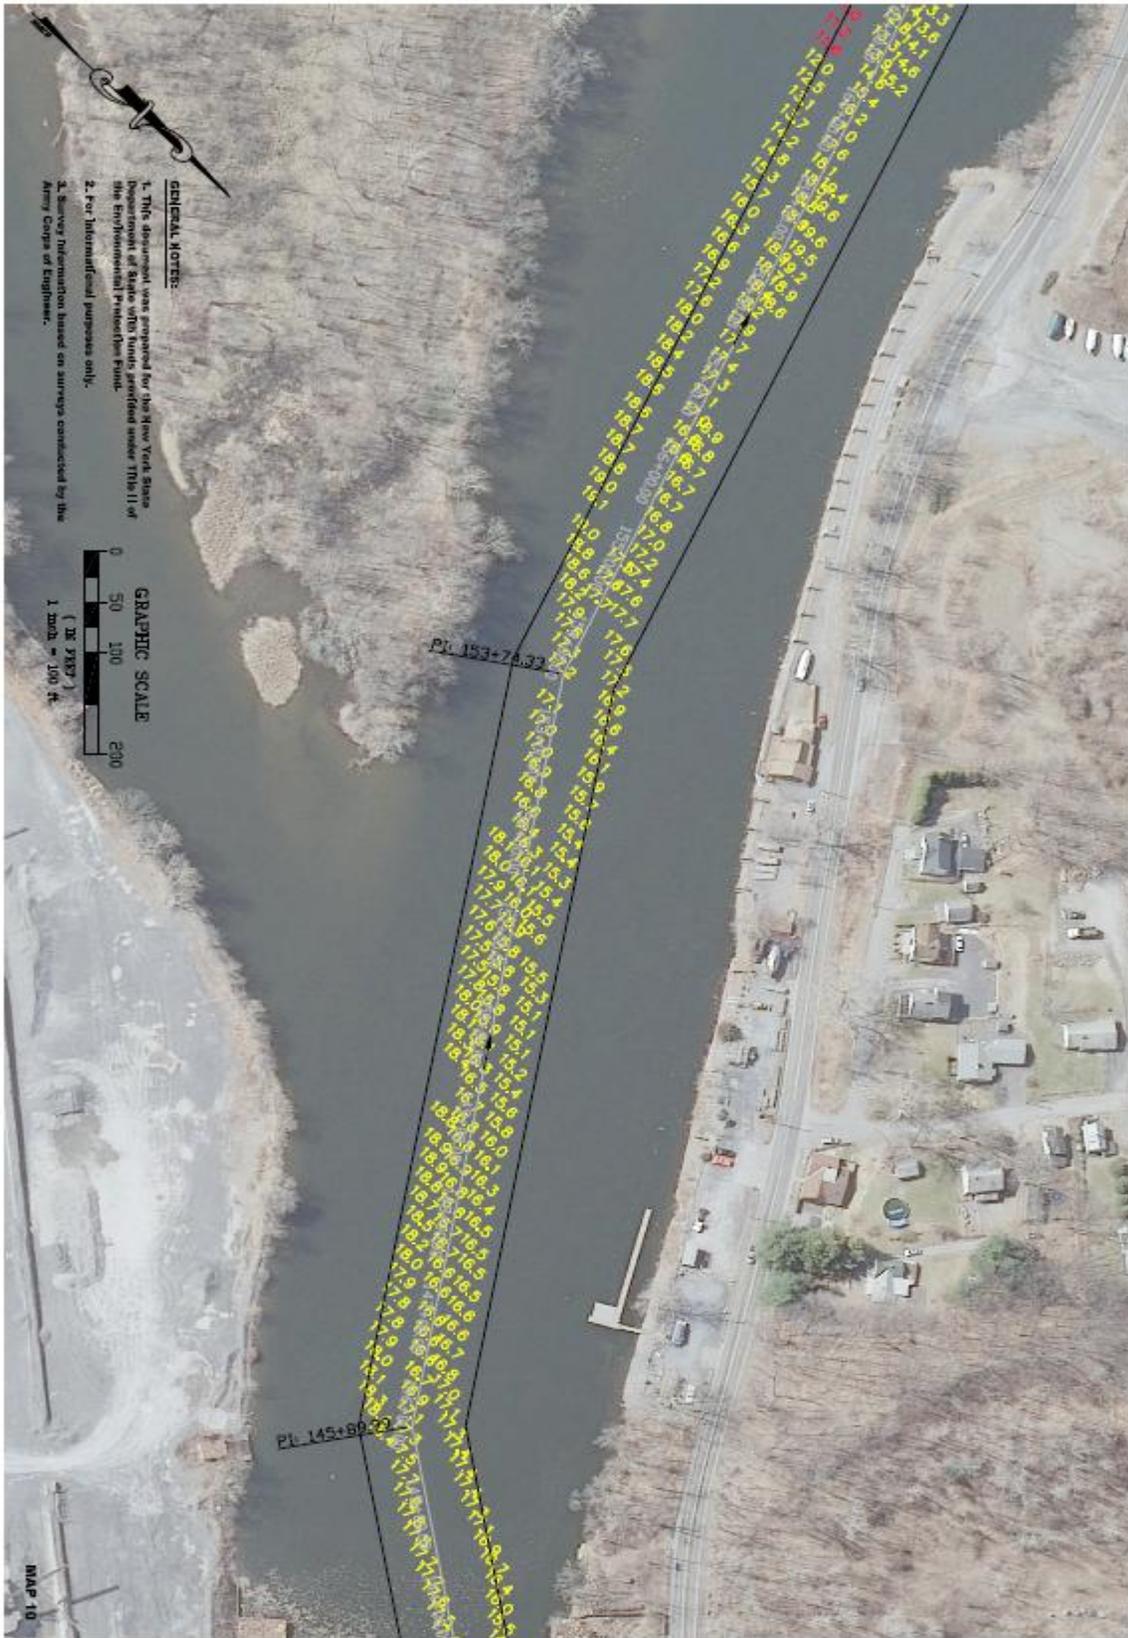
The following thirteen pages present the maps of the existing channel for the entire length of the plan area. Stationing, water depths, and aerial photographs are included on these maps.

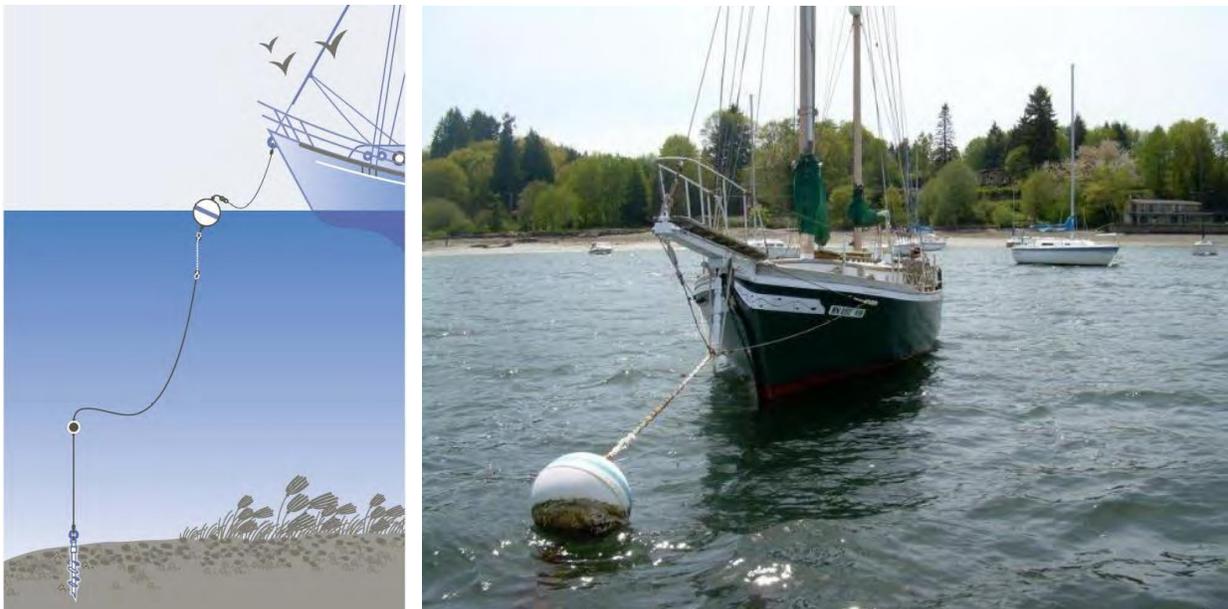
Figure 5: Typical Mooring section view and application

Mooring fields refer to a grid system of anchors where vessels can be docked for extended periods of time.

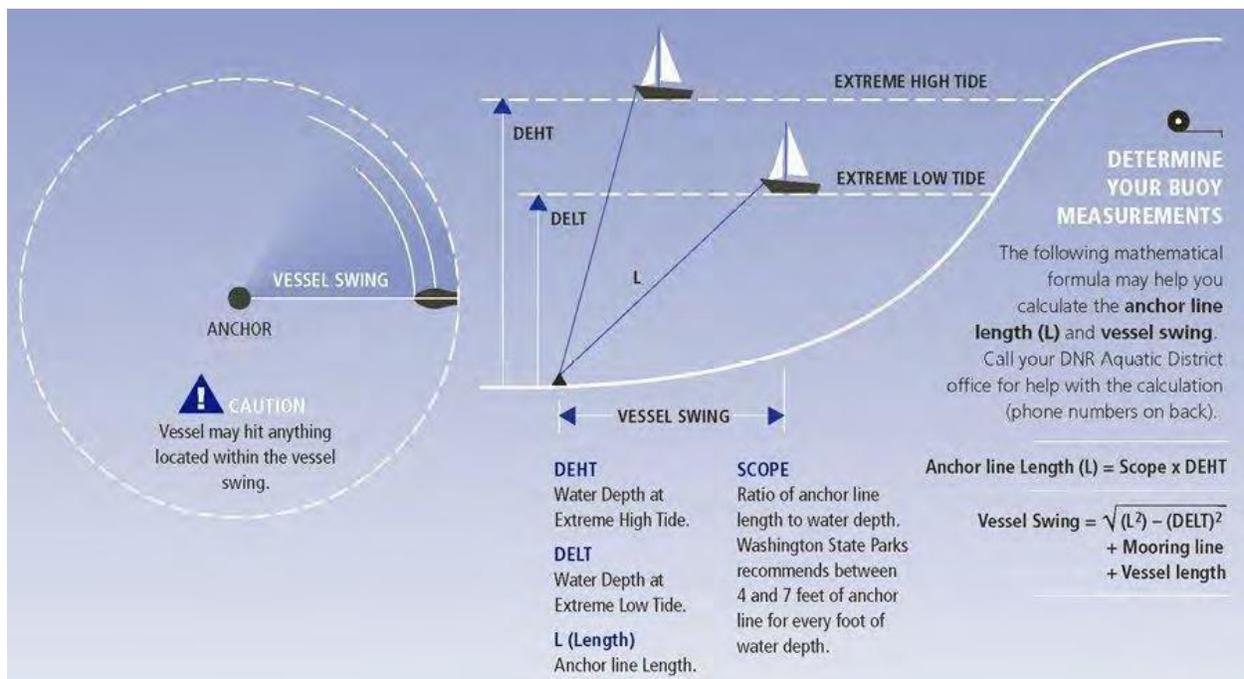
$$\text{Vessel Swing} = \sqrt{(L^2 - \text{DELT}^2)} + \text{mooring line (10ft. assumed)} + \text{vessel length}$$

Figure 6: Vessel Swing and Anchor Line—showing formula for calculating radius. (From DNR brochure: “Recreational Mooring Buoys for Residential Owners Next to State-Owned Aquatic Lands.”)

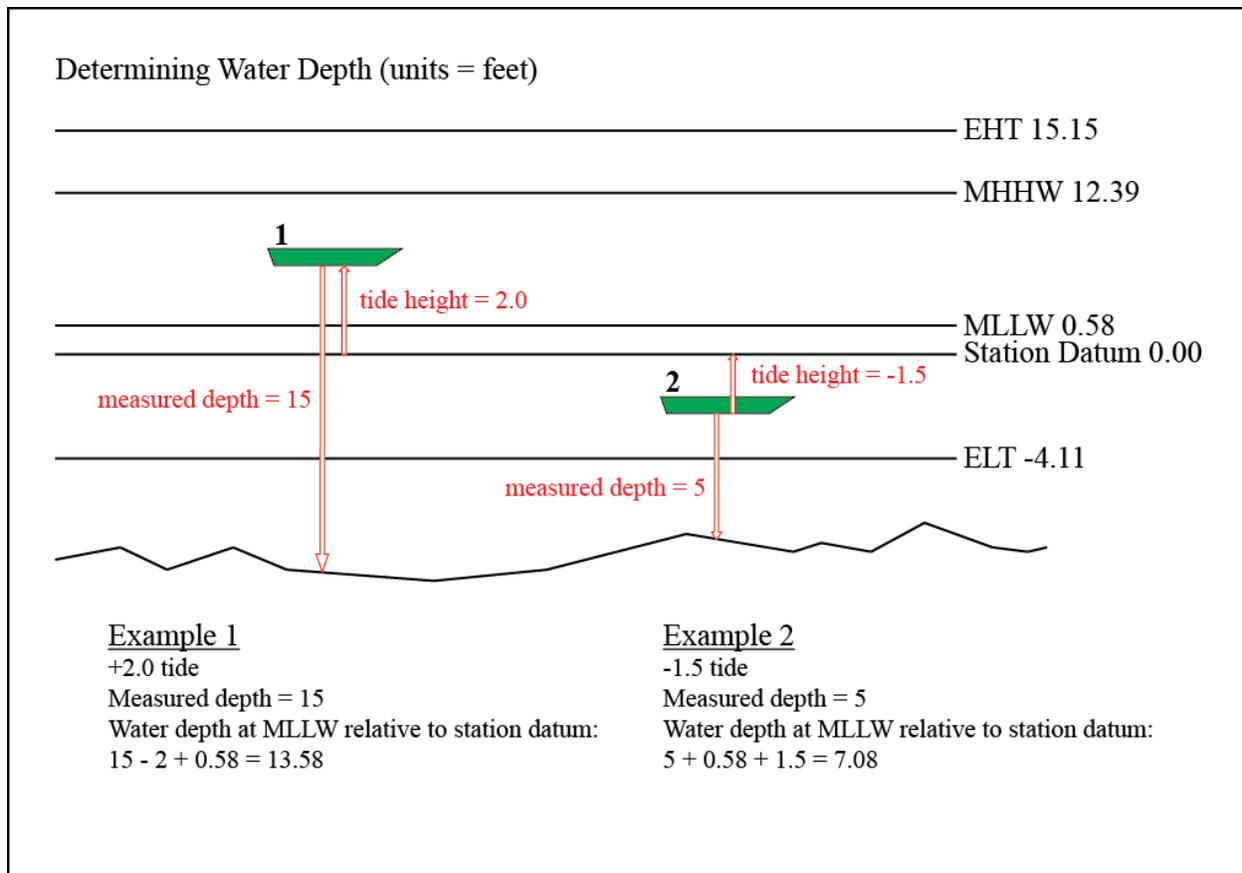
This required depth is determined by the optimal buoy density by factoring water depths, allowable vessel scope (by anchor type), and estimated vessel lengths.

Figure 7: Mooring tidal depth level example

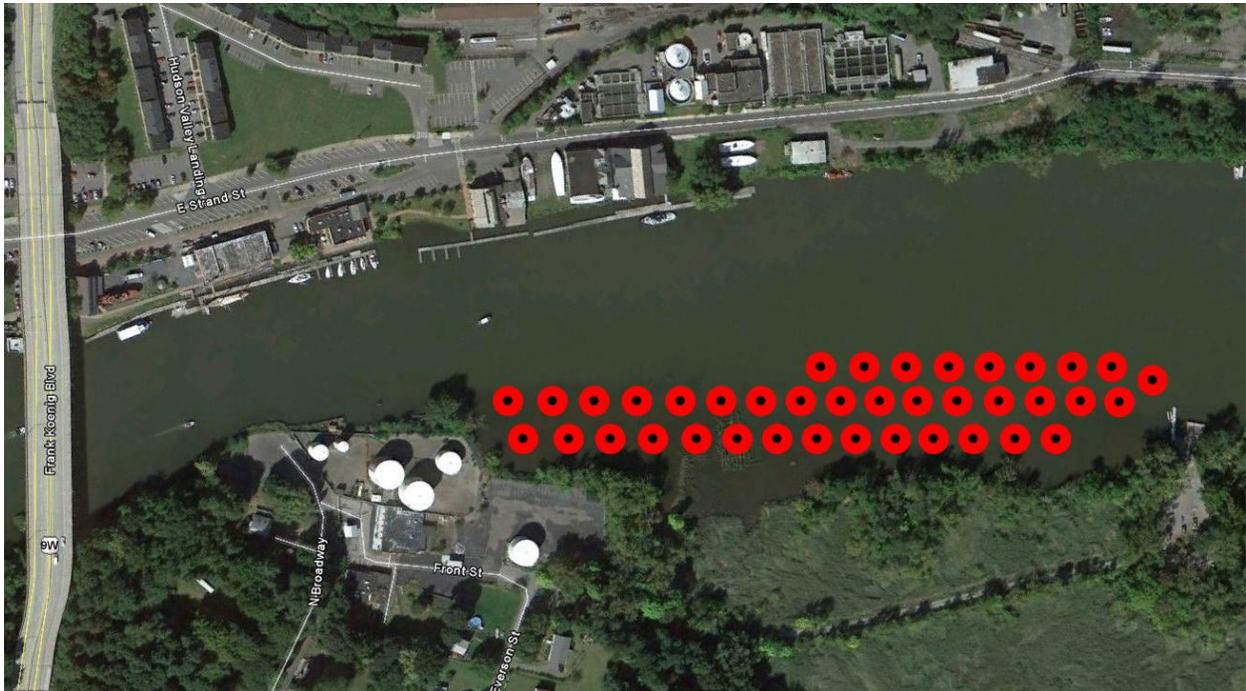
Figure 8: Mooring field proposed location 1: STA 53+00, across Cornell Building

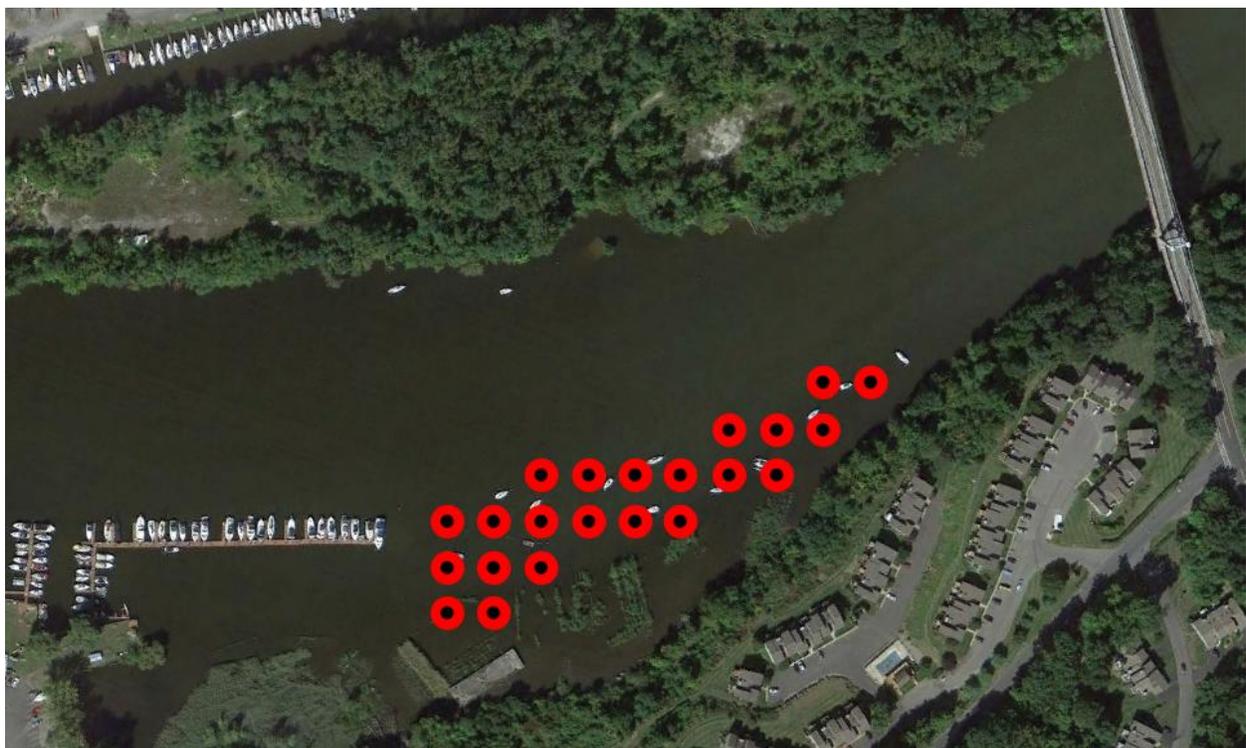
Figure 9: Mooring field proposed location 2: STA 85+00, across Island Dock

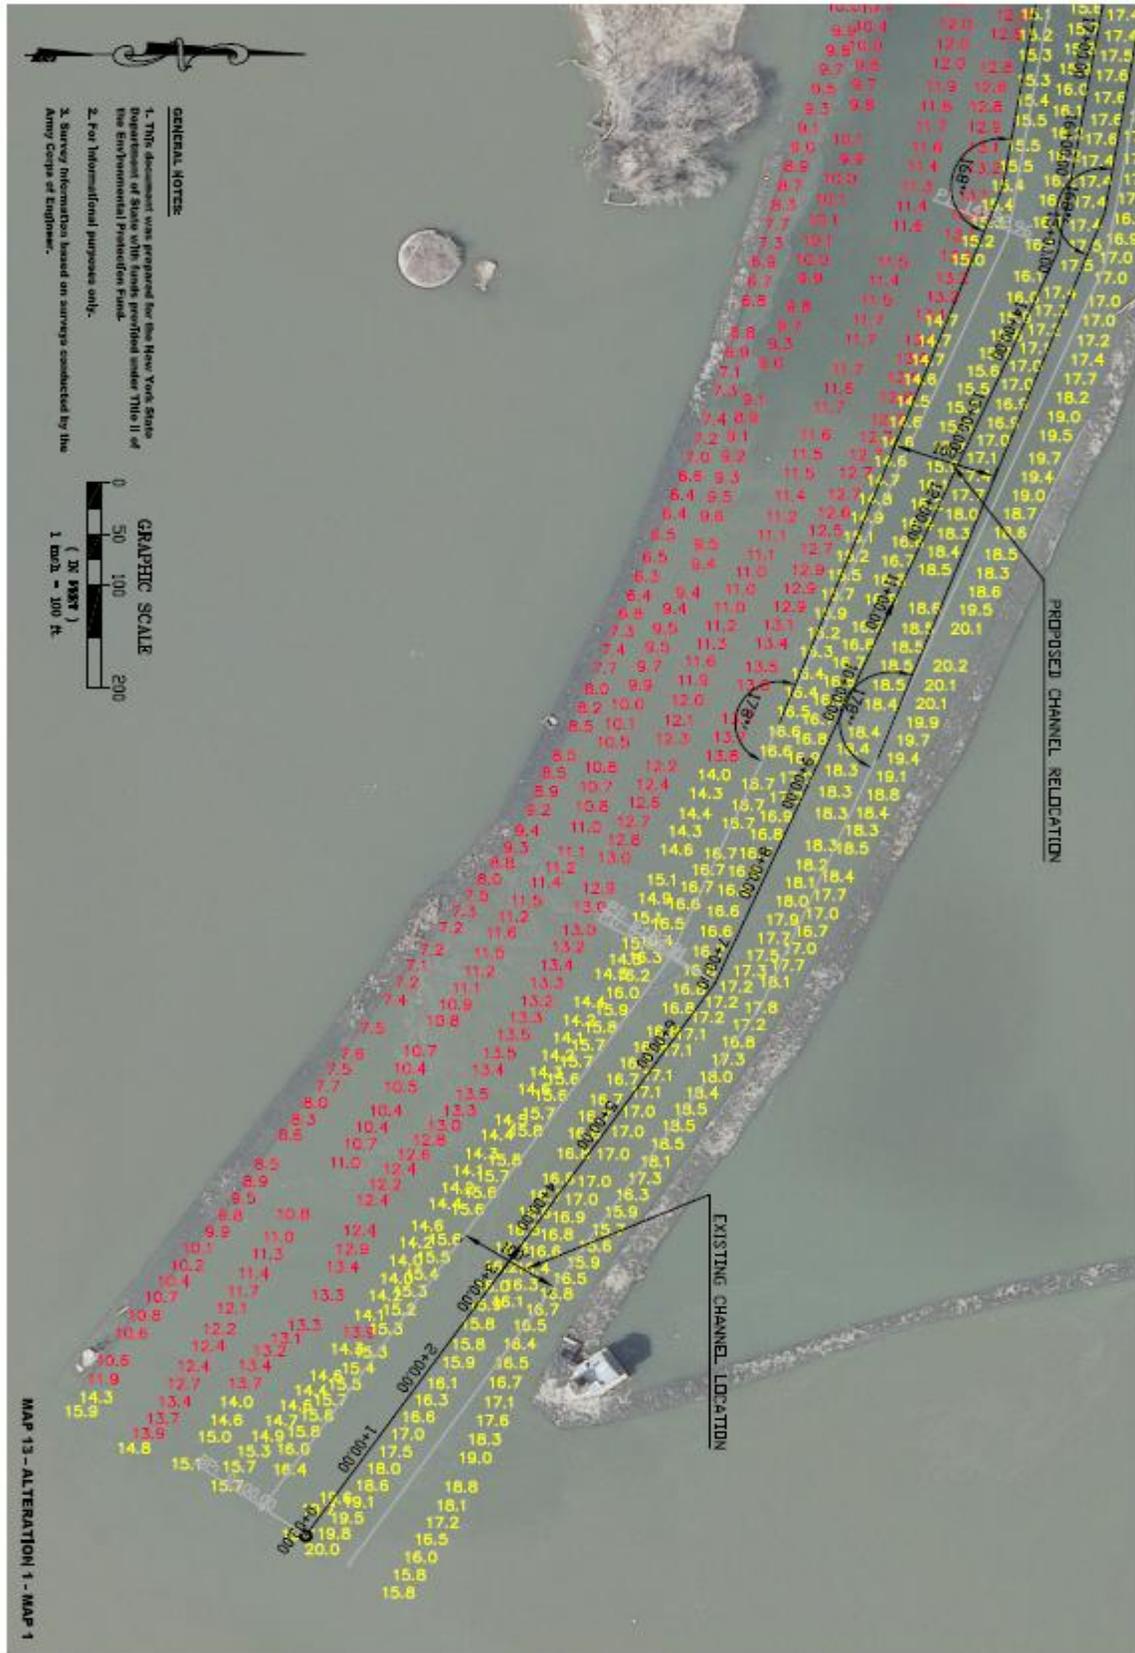
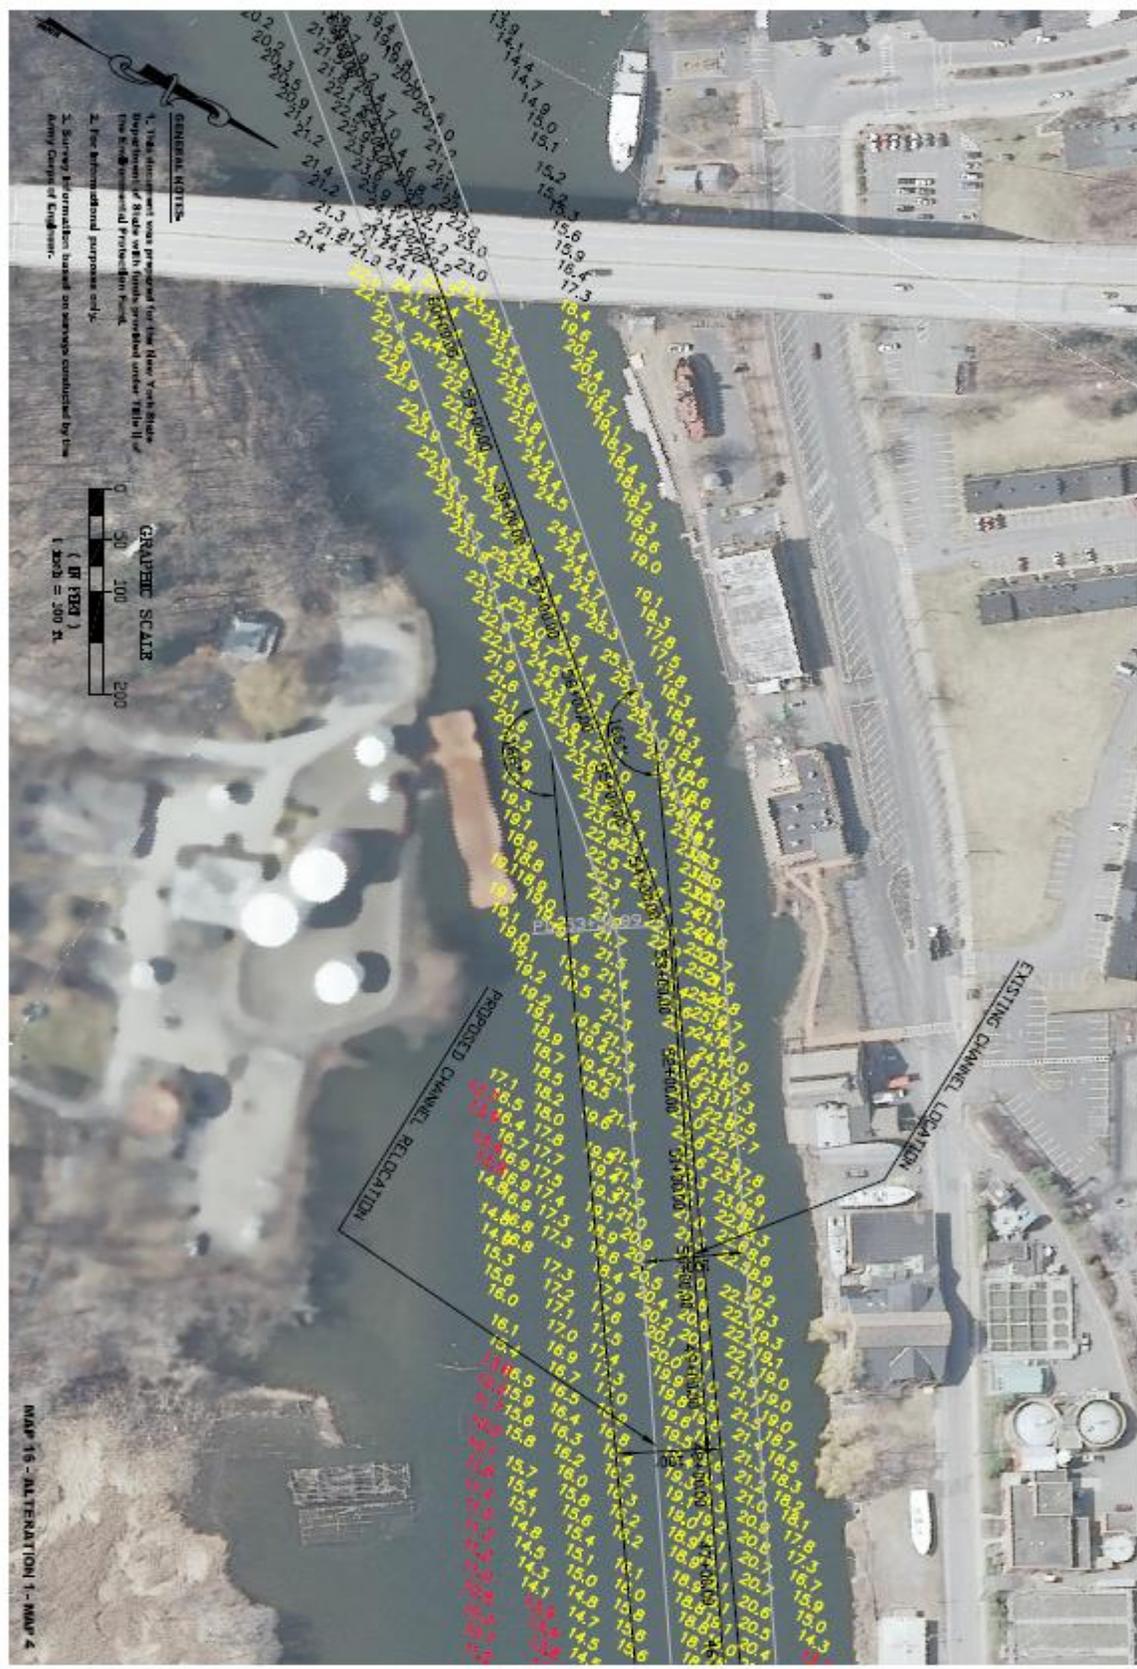
Following are maps showing the existing channel location and proposed channel relocation at several creek stations under the without-dredging alternative.

Table 5 - Distances to Proposed Channel, Alteration 1		
Distance Moved South (approximate)	Distance to Bulkhead (approximate)	Station Number Location (approximate)
12 feet	50 feet	20+00
30 feet	75 feet	24+00
0 feet	21 feet	32+00
37 feet	95 feet	48+00
49 feet	97 feet	54+00
0 feet	100 feet	59+00

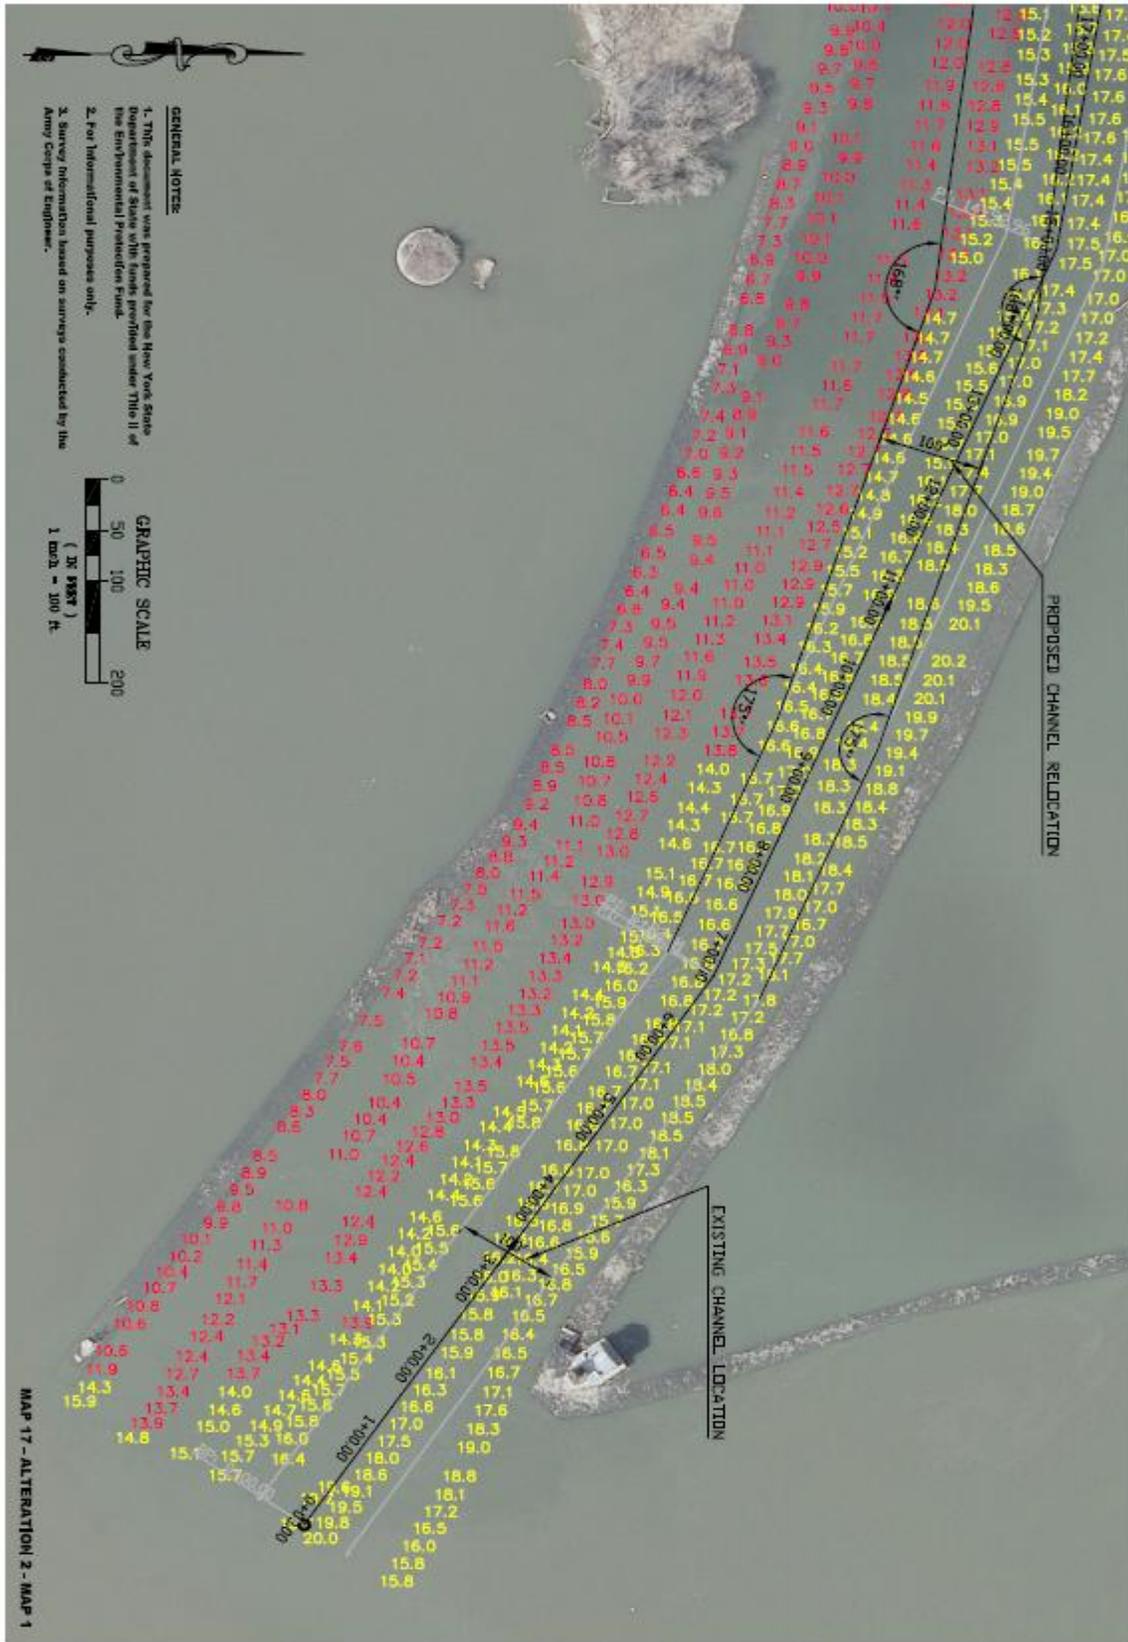
Following are maps showing the existing channel location and proposed channel relocation at several creek stations under the with-dredging alternative.

There are two principal areas in which dredging would need to occur. The first area begins at approximately Station 13+50 through Station 22+00, and encompasses approximately one acre in area, with additional depths needed between 0 ft and 1.5 ft. The second area begins at approximately Station 31+50 through Station 42+00, and encompasses approximately two acres in area, with additional depths needed between 0 ft and 2.5 ft.

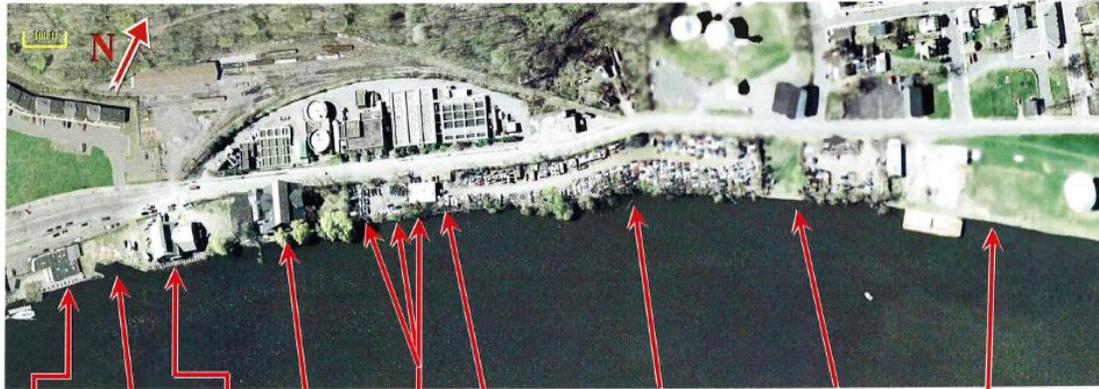
Figure 7 - Rondout Creek Map 2

Located at the tip of the Rondout Creek, the Rondout II Lighthouse is protected by the jetty, which was reconstructed in the 1990s, and which is depicted in Photo 11. The lighthouse serves as the end of the planning area for this harbor management plan.

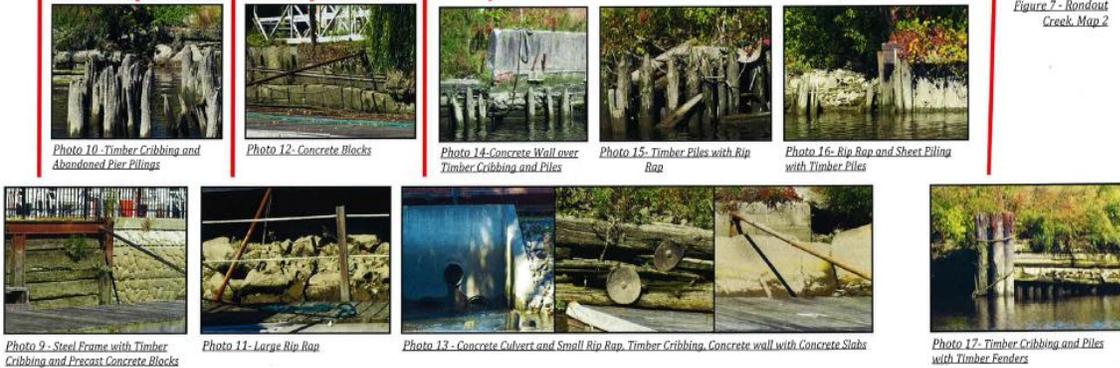
Photo 10 - Timber Cribbing and Abandoned Pier Piling

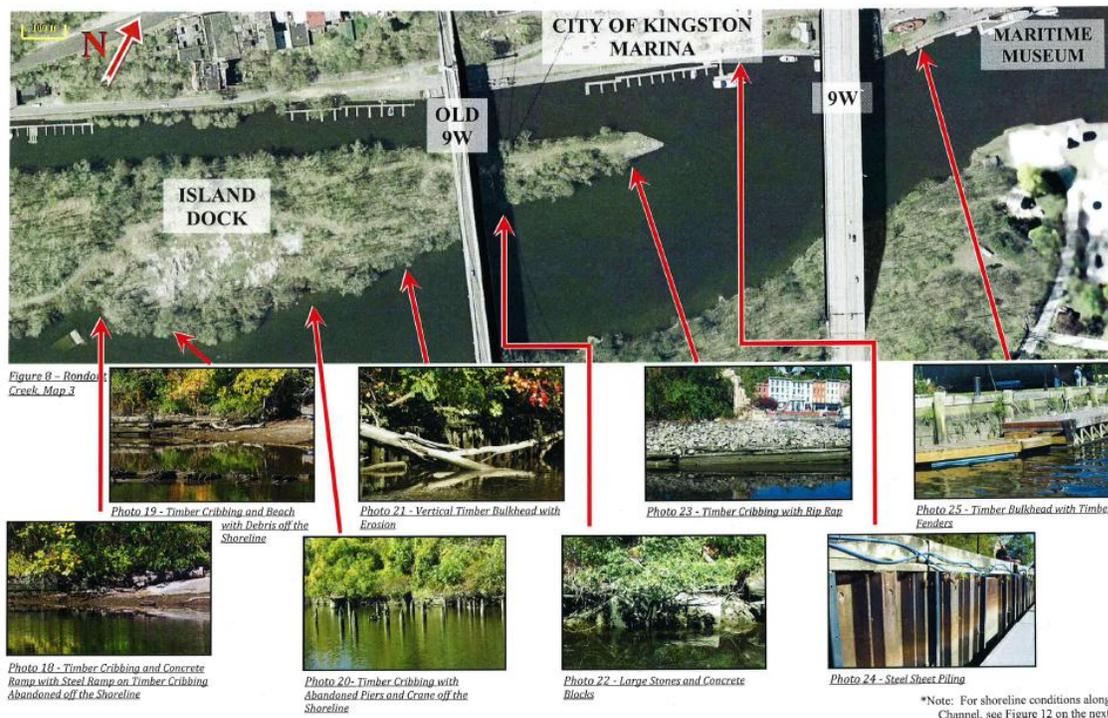
Above, Figure is 9.

Consisting of timber cribbing on timber piles, with groups of timber piers acting as a fender system, this 580 ft (+/-) section of bulkhead appeared to be in fair condition, with cracked cribbing and missing connector rods.

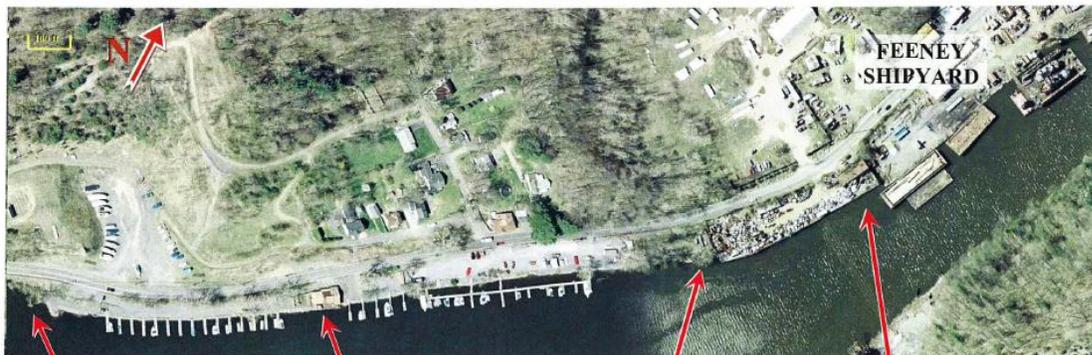
Figure 12 - Rondout Creek, Map 5

The Kingston Power Boat Association was fronted by a horizontal timber cribbing bulkhead with vertical timber fenders. The 640 ft (+/-) of newer cribbing was in good condition and stabilization did not appear to be necessary.
