RONDOUT HARBOR MANAGEMENT PLAN

CITY OF KINGSTON, NY

**US Army Corps
of Engineers®**
New York District

June 2014

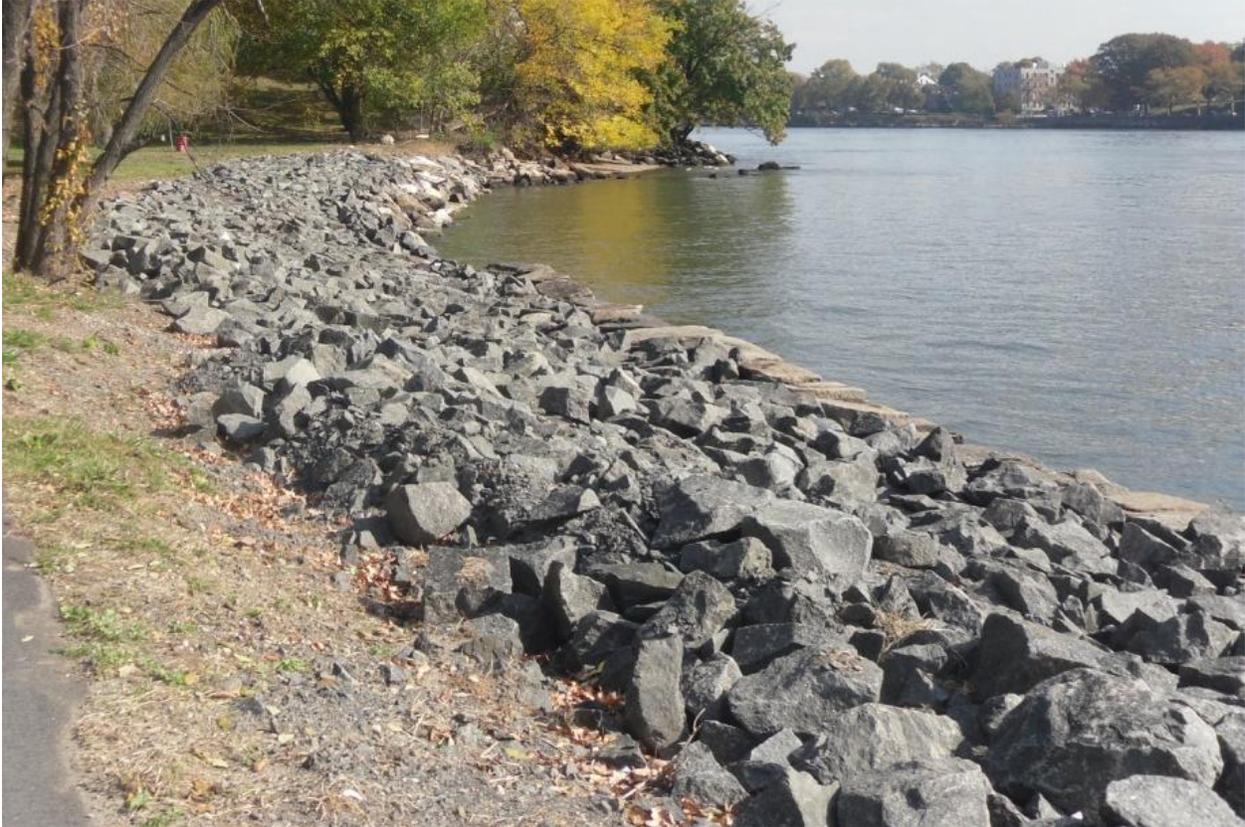
Rip rap consists of durable, large size stone on well-graded bedding placed along a shoreline to prevent scour. Rip rap can also be used to buttress deteriorated walls, if the geometry of the shoreline is acceptable. In 2010, the City of Kingston reported a cost of approximately \$100 per cubic yard for rip rap installed at that time.

Figure 14 - Rip rap
(Photo: Randall's Island Seawall Stabilization – HDR)

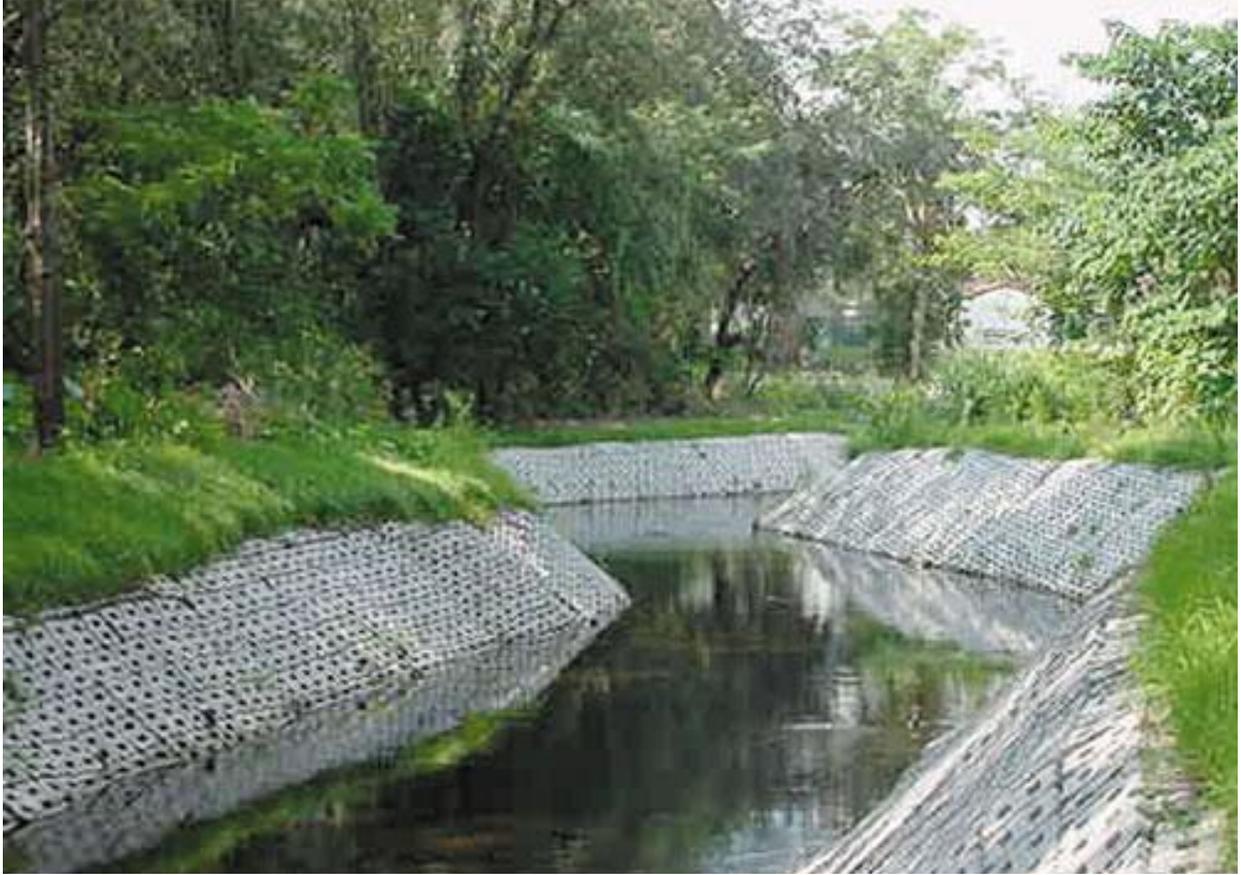
Articulated Concrete Block (ACB) is a revetment system using precast concrete blocks, either chained together or placed side by side in a mat form. This system is flexible and able to conform to any changes in the subgrade, while it maintains a protective cover. Due to its flexibility, however, ACB is meant for shore protection rather than stabilization. Stabilization must be achieved prior to the block placement. The core of the block can be left open for vegetation, helping to improve shoreline stabilization, or it can be grouted in combination with anchor rods. The approximate cost was \$35 per square foot in 2010.

Figure 15 - Articulated Concrete Block
(Photo: landandwater.com)

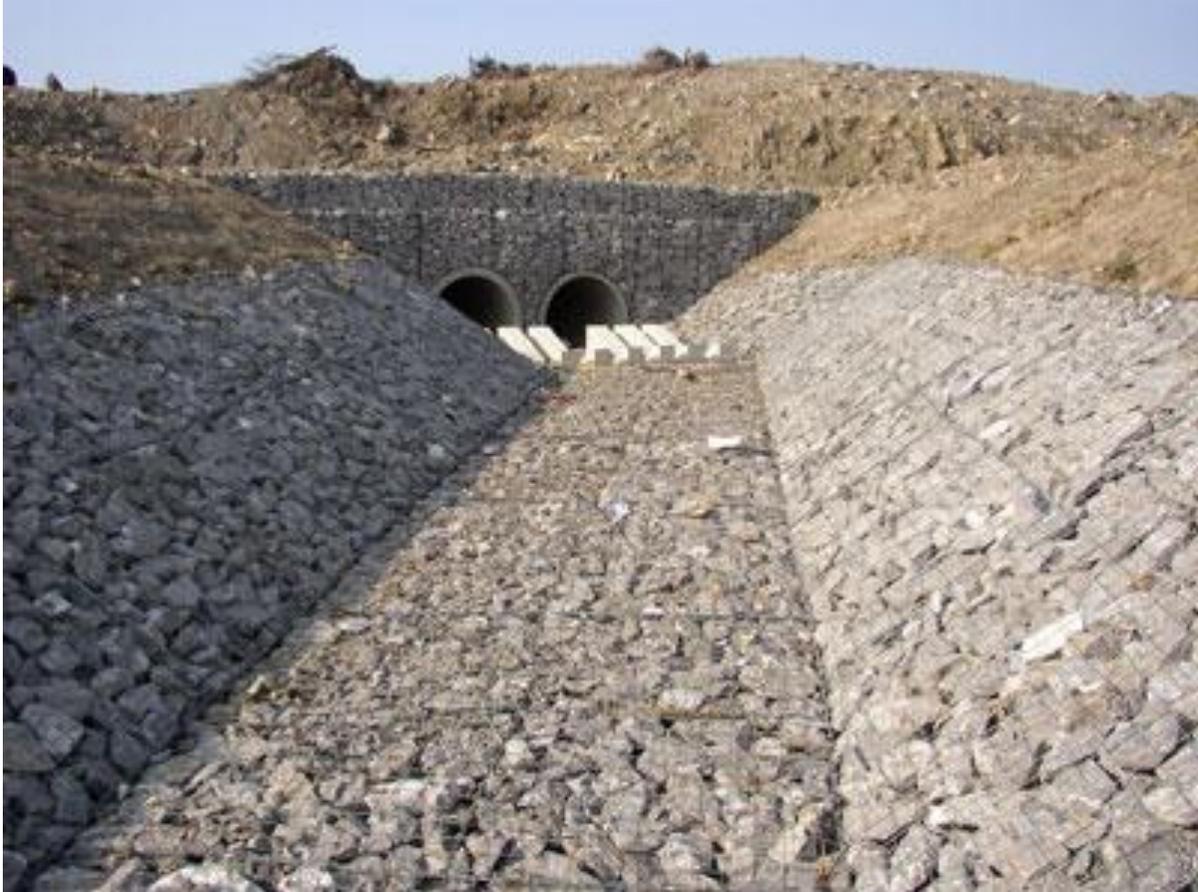
Gabion mattresses can be used to stabilize the riverbed, as well as the shoreline, depending on the geometry of the bed. Vegetation can grow through the baskets to provide a more natural appearance. The approximate cost was \$215 per cubic yard in 2010.

Figure 16 - Gabion Baskets
(Photo: ridgeway-online.com)

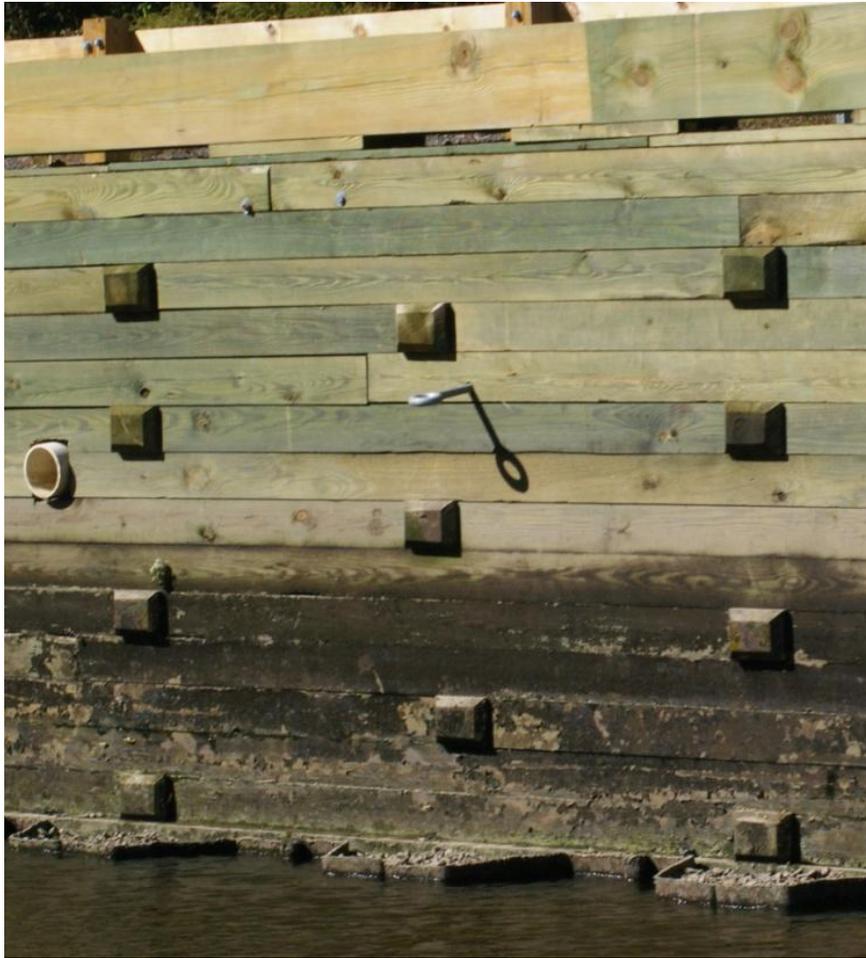
The Pedestrian Waterfront Walkway project, initiated by the City of Kingston in 2010, is the basis of comparison for a timber bulkhead replacement for the plan area. The bulkhead would consist of timber cribbing backfilled with stone and attached to steel sheet piling below the water line. The City of Kingston reported a cost of approximately \$1,000 per linear foot installed along the shoreline in 2010.

Figure 17 - Timber Bulkhead

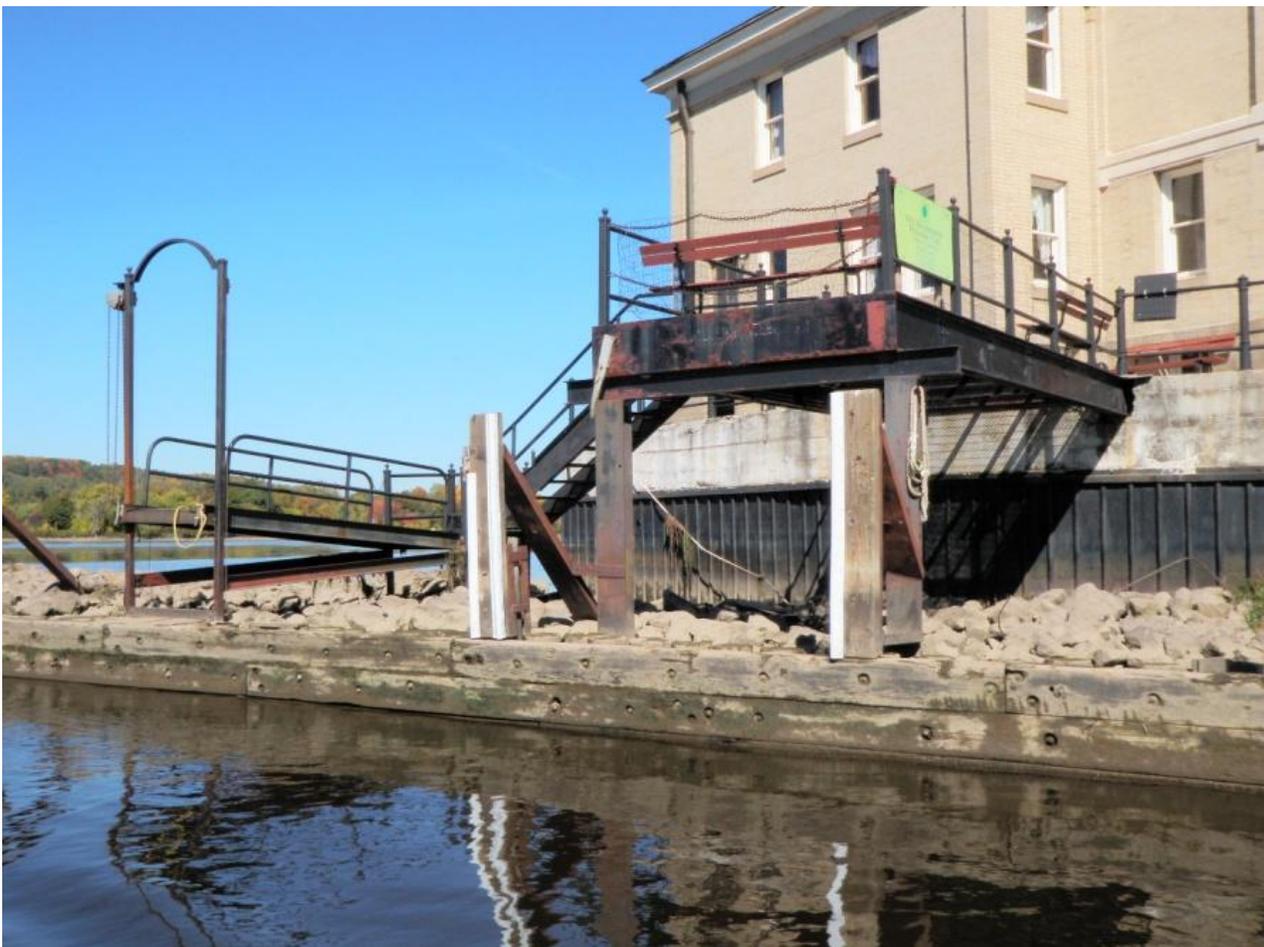
The Rondout II Lighthouse features an adjacent dock, along with a jetty that extends to the shore. The dock (*Photo 49*) is multi-leveled, and its bottom level has an inclined ramp. The ramp is about level with the top of the jetty, and it leads to a staircase for access to the top level, which is the same height as the base of the lighthouse. A jetty serves as an extension from the shore that projects into a body of water to influence the current or tide, or to protect a harbor or shoreline from storms and erosion. The lighthouse jetty is approximately 1,680 feet long and it has been prone to inundation by

Photo 45 - Rondout II Lighthouse Dock
(Photo: HDR)

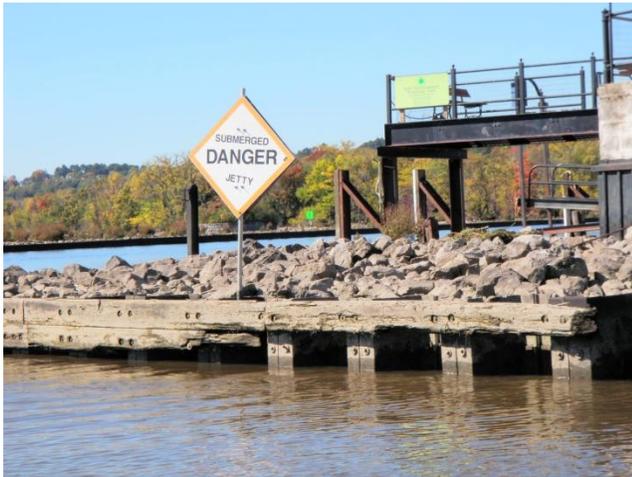
Photo 46 – Submerged Jetty Sign
(Photo: HDR)

The goal of a project at this location would be to provide pedestrian access from the shore to the lighthouse, while allowing for light vehicle emergency response capability, Americans with Disabilities Act (ADA) accessibility, maintenance of the jetty to serve the purpose of defining the federal navigation channel, and the protection of the shoreline from further erosion.

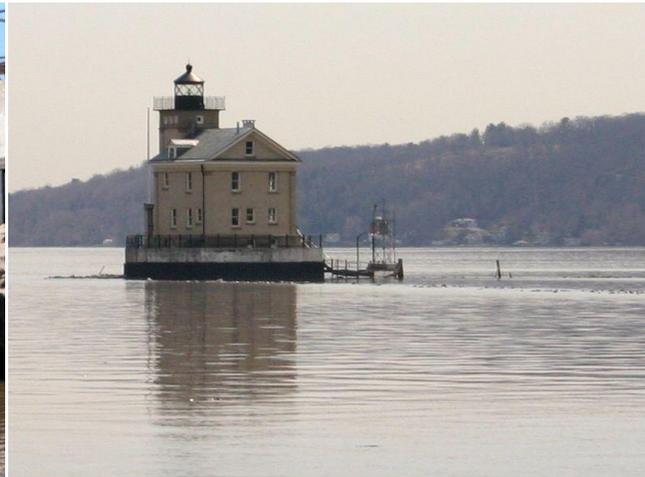
Photo 47 – Submerged Jetty
(Photo: www.kingstonlighthouse.com)

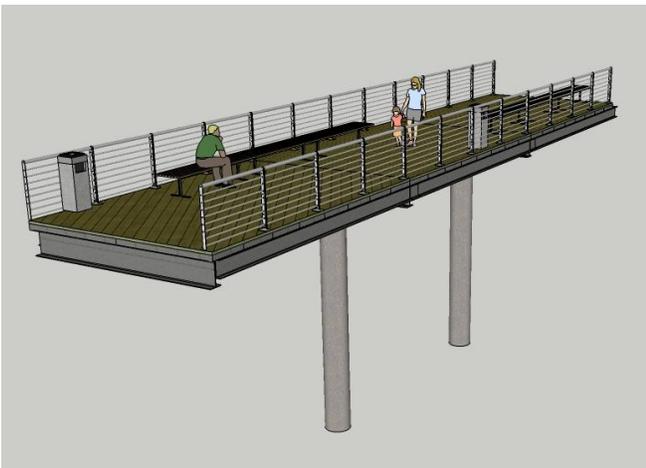
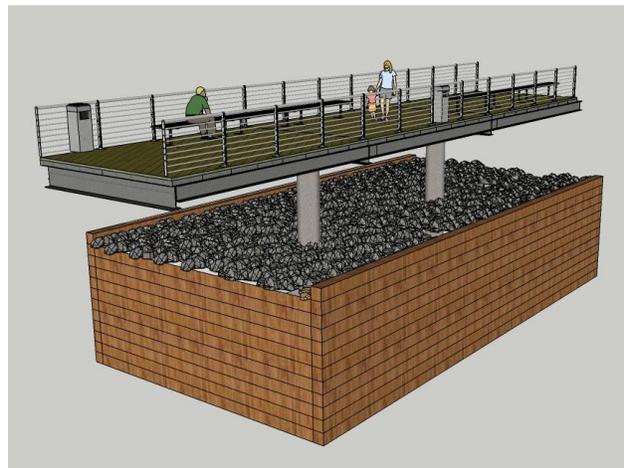
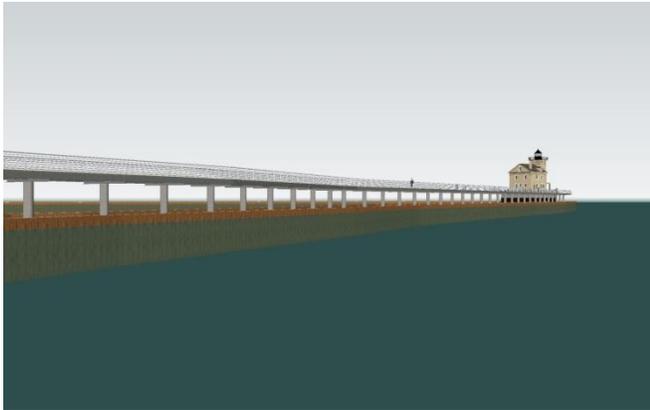
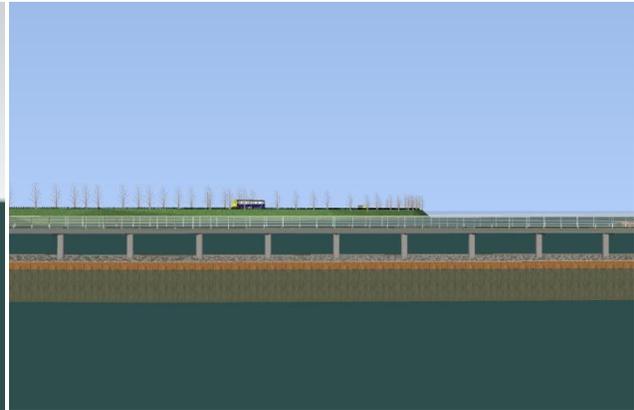
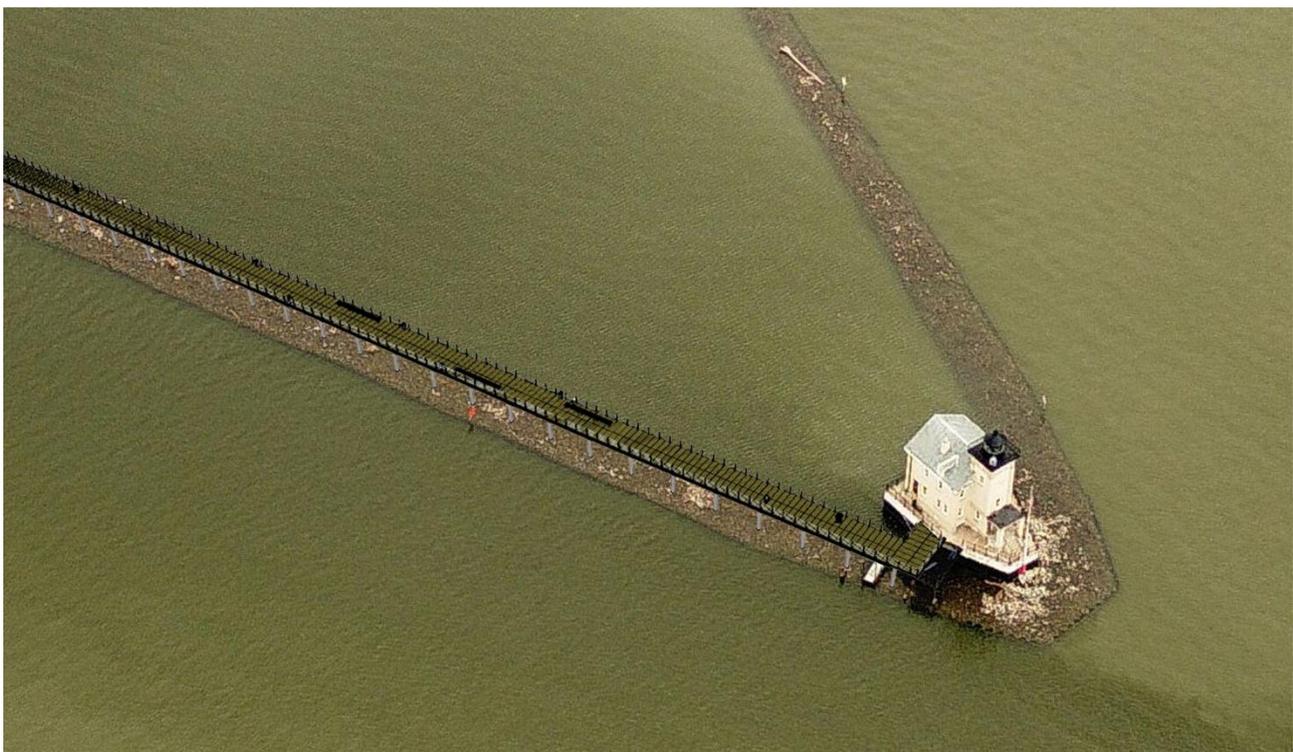
The open base of the walkway would allow for water and ice to flow beneath it, thereby limiting ice damming during the winter months. This open type of walkway also preserves views over the jetty to the land and river beyond.

Figure 18 – Walkway, Option 1

Figure 19 – Walkway, Option 1, with existing jetty

Figure 20 – Walkway, Option 1, easterly view

Figure 21 – Walkway, Option 1, with existing jetty, northerly view

Figure 22 – Walkway, Option 1, aerial view

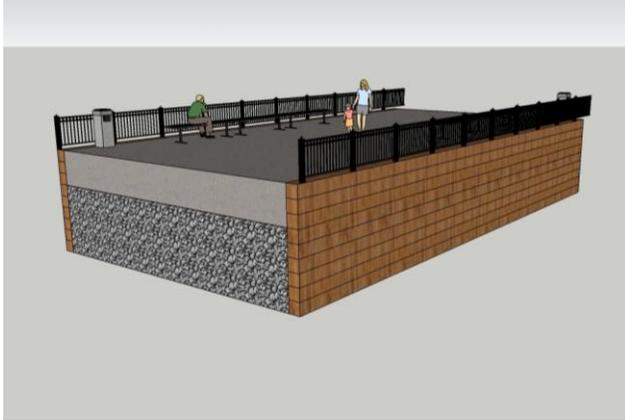
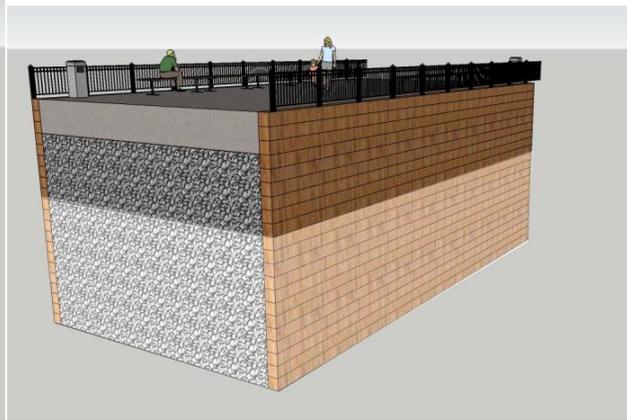
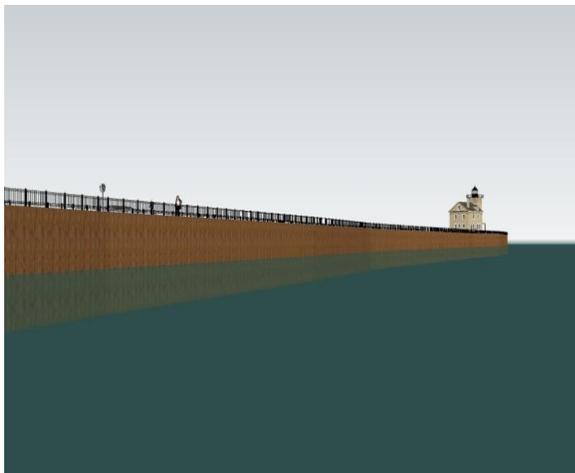
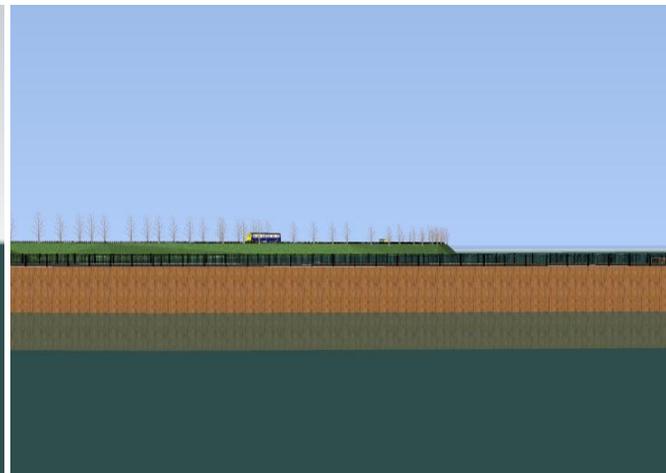
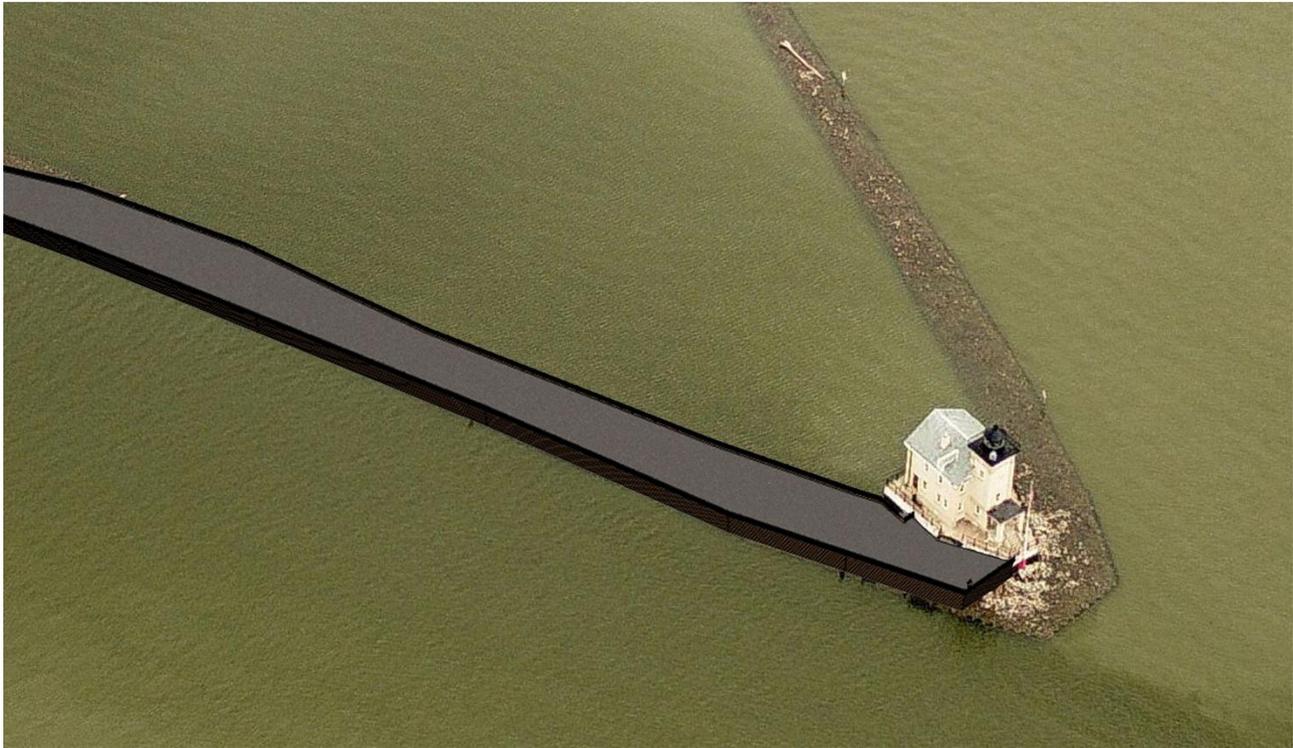
With a solid extension, this option is likely to be more expensive than the other two.

Figure 23 – Walkway, Option 2

Figure 24 – Walkway, Option 2, with existing jetty

Figure 25 – Walkway, Option 2, easterly view

Figure 26 – Walkway, Option 2, with existing jetty, northerly view

Figure 27 – Walkway, Option 2, aerial view

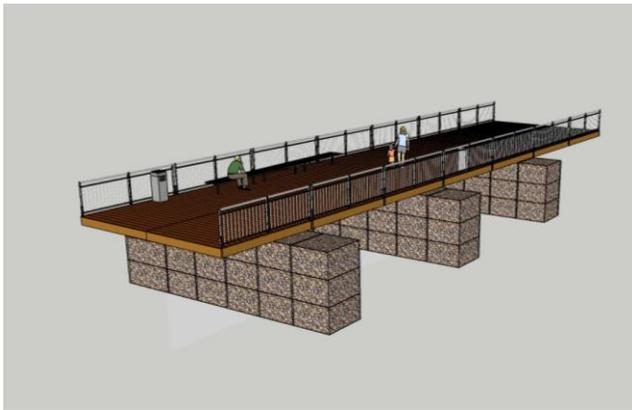
Figure 28 – Walkway, Option 3

The third option would construct the deck platform above rows of gabion baskets atop the existing jetty (Figure 28).

The gabion baskets can accommodate water plantings and vegetation to grow along them, allowing for natural aesthetics of the gabions. The gabions would rise to about eight feet above the existing jetty. With the gabions and decking, the 20 foot wide structure would be even with the lighthouse platform at nine feet above the existing jetty. The gabions would be placed atop the existing jetty sheet pilings, and would support the deck above. Since the jetty is not a consistent width, it is assumed that the 20 foot wide structure would span somewhere between the existing jetty sheet piles, with the gabions extending beyond the deck on either or both sides of it.

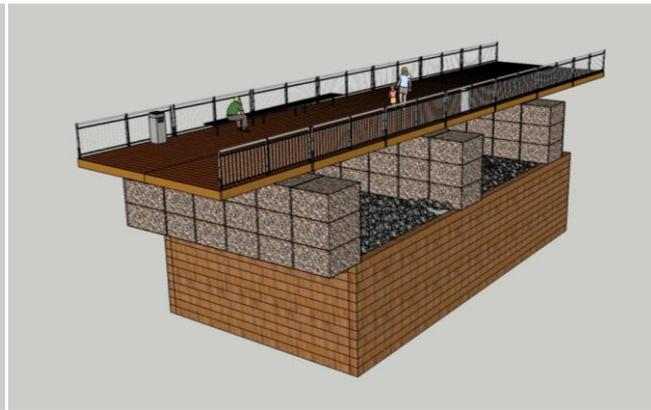
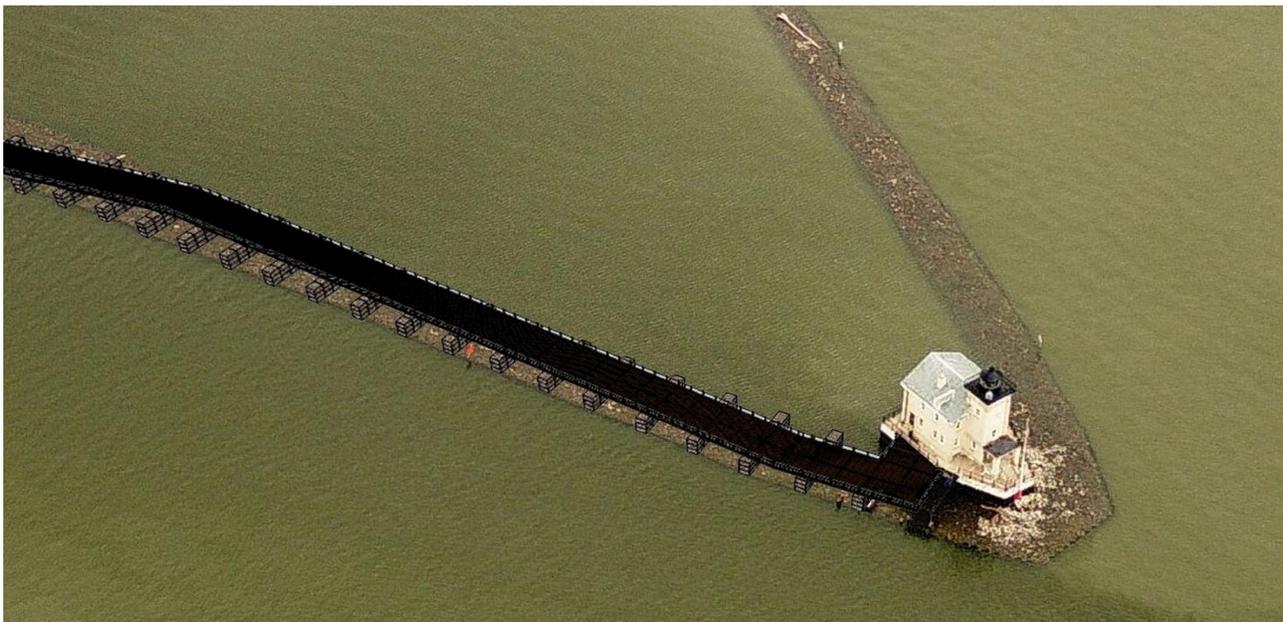
Figure 29 – Walkway, Option 3, with existing jetty

Figure 32 – Walkway, Option 3, aerial view

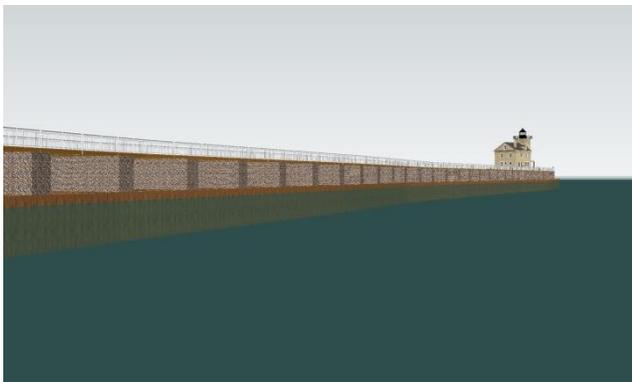
Figure 30 – Walkway, Option 3, easterly view

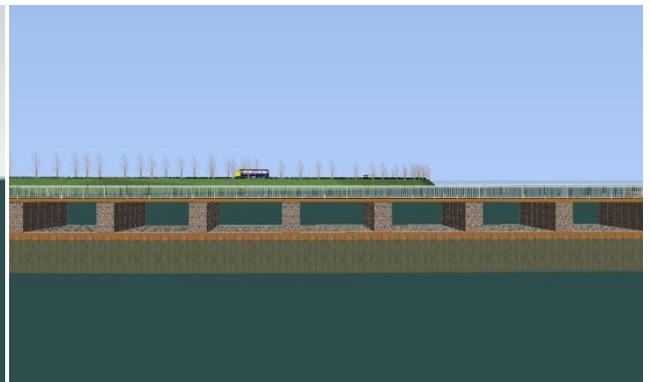
Figure 31 – Walkway, Option 3, with existing jetty, northerly view

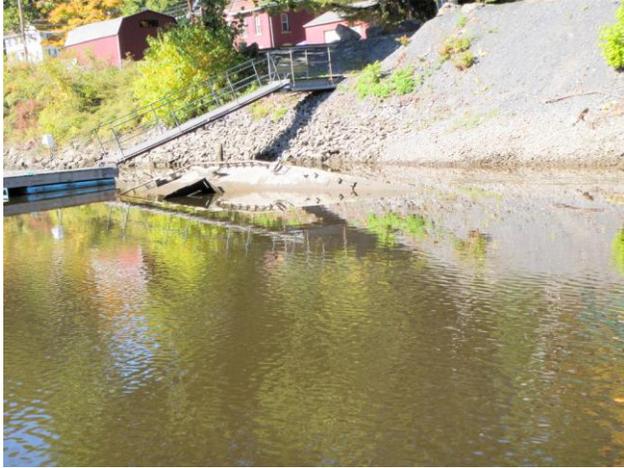
A partially submerged steel deck barge (Station 79+00) was observed on October 14, 2010 along Island Dock. There was also a deteriorating dry dock (Station 24+00) along the northern shore east of the Route 9W bridge. Other hazards, such as old pile fields and sunken vessels, may exist in the plan area. These may be located as part of the bathymetric survey. The LWRP reports that some of these barges may contain items of historic value, the removal of which would have to be coordinated through the City of Kingston Landmarks Commission and NYSOPRHP.

Photo 48 – Submerged Steel Deck Barge
(Photo: HDR)

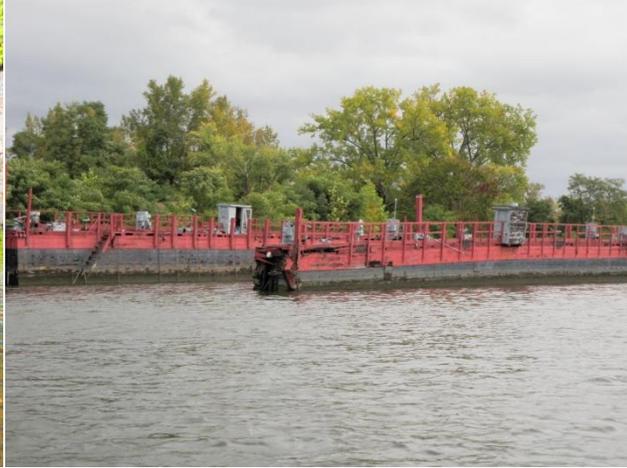
Photo 49 – Dry Dock
(Photo: HDR)

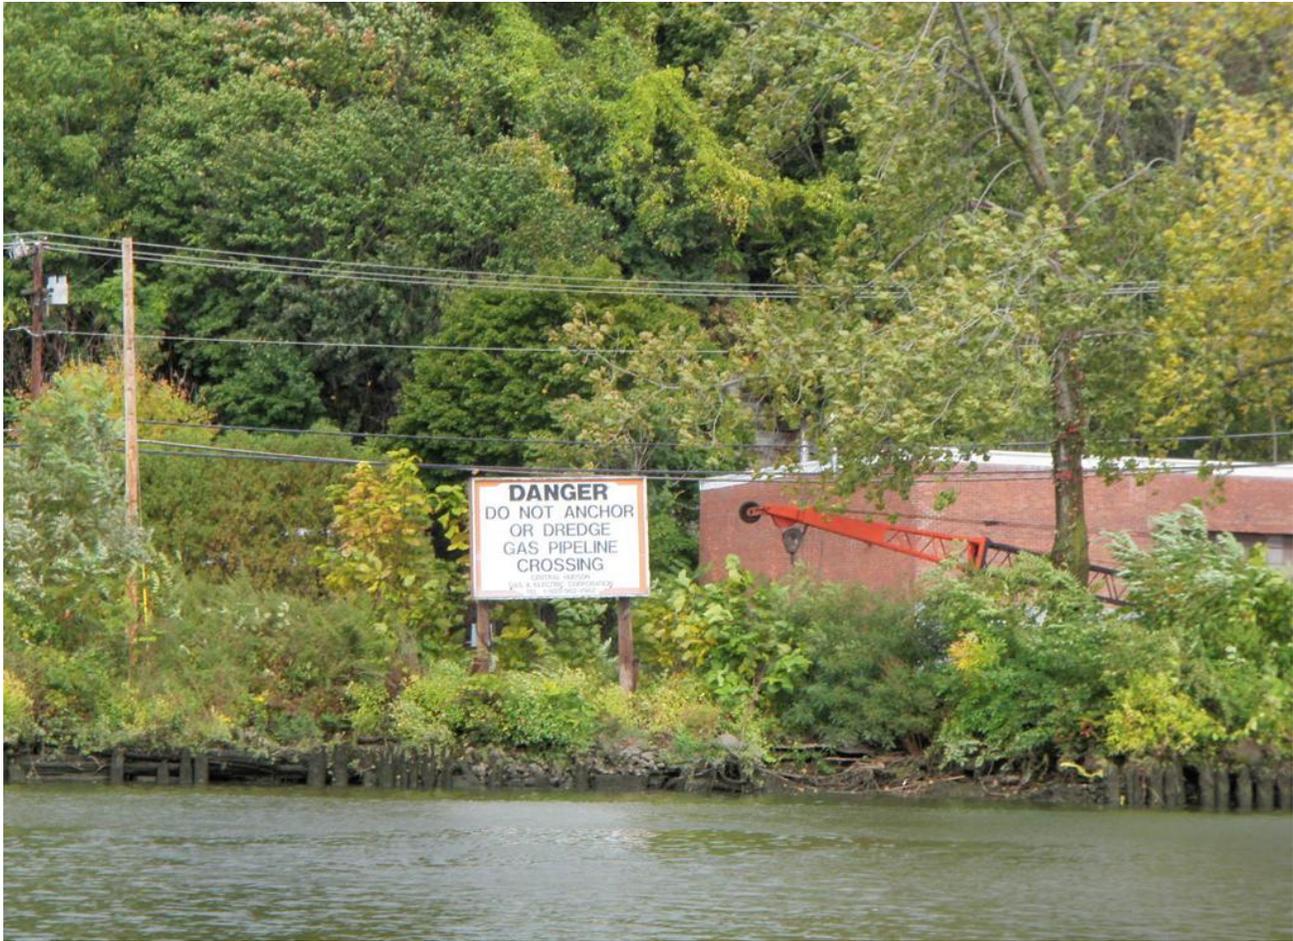
There are several designated cable crossing areas in Rondout Creek. The location and depth of any cables in the plan area would have to be determined, and any conflict with proposed in-water work, such as sheetpile driving, identified. The need for any protective features, such as armor stone to be placed over the cables, would also have to be addressed.

Photo 50 - Pipeline Crossing
(Photo: HDR)

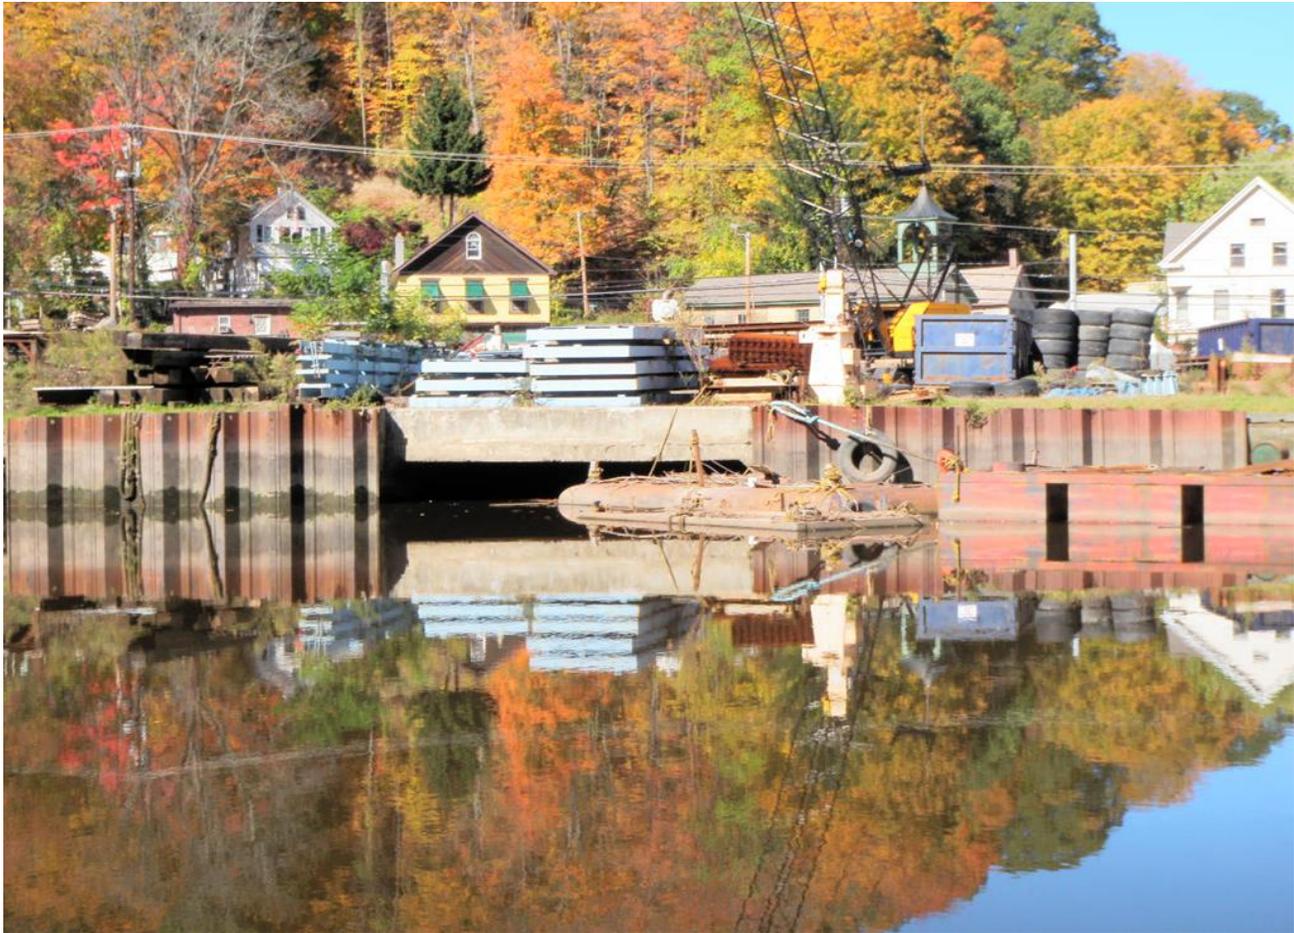
Twaalfskill Brook is a small stream (NYSDEC, Class C) entering the Rondout Creek from the north, near Wilbur (Station 131+00), via a double-barreled box culvert. The outfall from the City of Kingston wastewater treatment facility (Station 47+00) enters the northern side of Rondout Creek approximately a half-mile east of the Route 9W bridge. Any changes to the outfall potentially affecting the flow/dispersion of the treatment plant effluent would have to be addressed.

Photo 51 – Twaalfskill Brook Outfall
(Photo: HDR)
