C.T. MALE ASSOCIATES

Re: *Results of Water Spray Testing*
Pike Plan Restoration Project
Kingston, NY
C.T. Male Associates Project No. 15.5150

REF: Kingston-Pike Plan: Water Tests
34 North Front Street: Dominick's Café/Dream Weavers

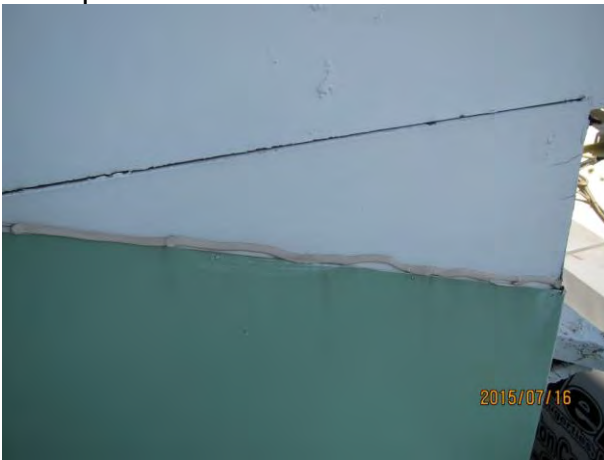
At the step between the sloped metal canopy roof and the adjacent flat roof, the metal base flashing is open at the top and can easily allow water to enter, see photo 13 and 14. Metal counter flashing is absent.

Photo 13 metal base flashing is open at the top and no metal counter flashing at the top

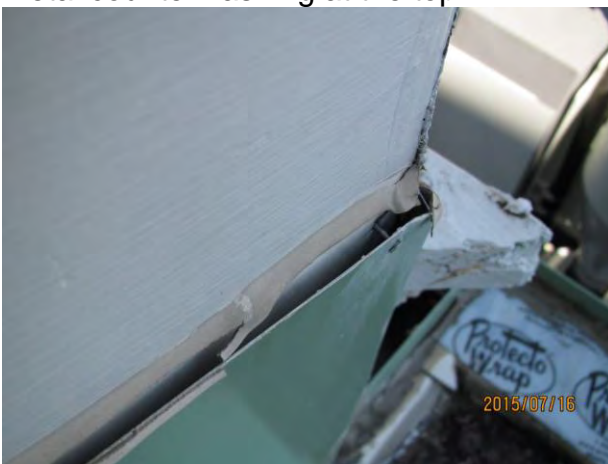
Photo 14 top view of photo 13, metal base flashing is open at the top and no metal counter flashing at the top

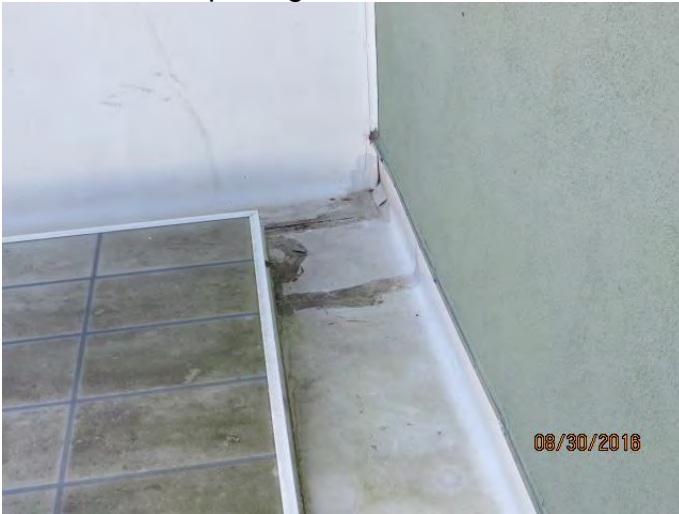
There are several openings in the roof membrane that allows water to enter, see photos 4 thru 9 and 31 and 32. These locations were water tested and leaks were observed at each locations in a very short period of time, see photos 33 thru 43. Water testing of the roof membrane at the open seam adjacent to the second skylight, started at 9:56 AM and water was observed below at 10:05 AM. Water testing at the base flashing opening started at 10:08 AM and water was observed below at 10:13 AM.

Photo 4 Two openings in roof membrane

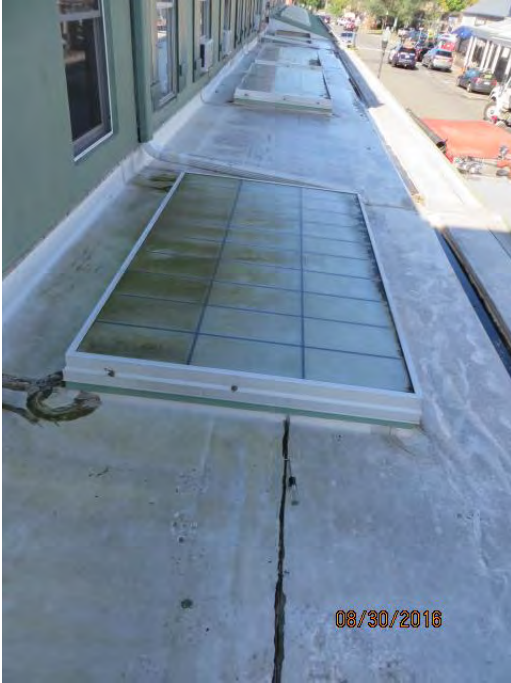
Photo 8 Opening in roof membrane west side of near skylight

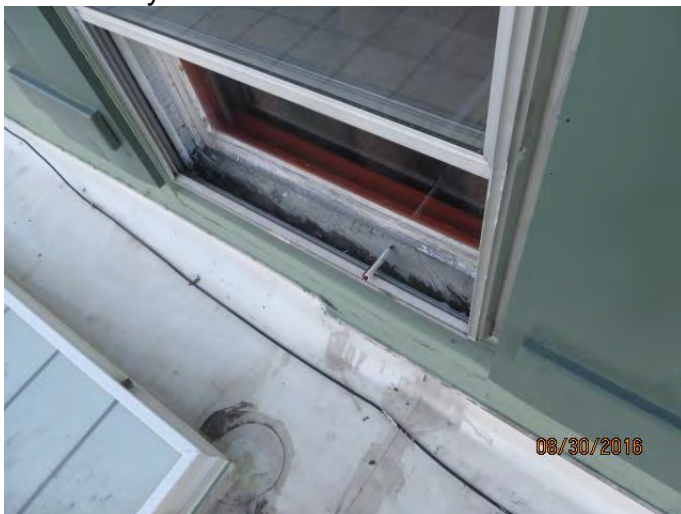
There are many opportunities for water infiltration through the windows, see photos 10 thru 18 and 21 thru 28.

Photo 23 Eighth window from the west end, outer closure not closed, allows water entry

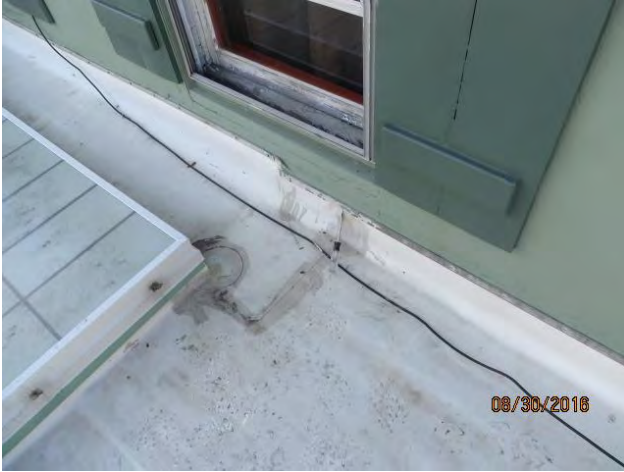
Photo 31 Eighth window from west end, opening in base flashing

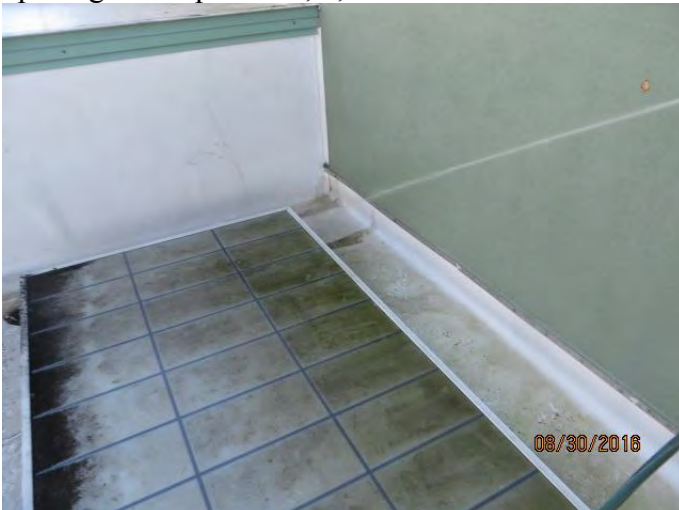
Photo 33 Start water test at west end of 44 N. Front St. at 9:51 AM at roof membrane openings from photos 4, 5, 6 and 7.

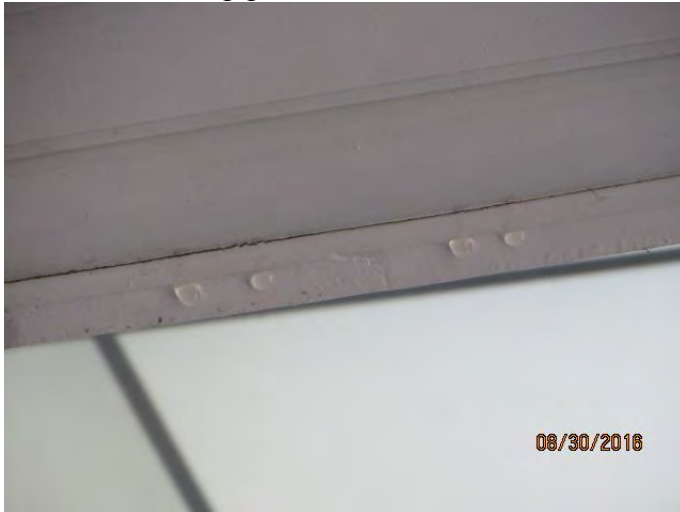
Photo 40 Close up photo 39

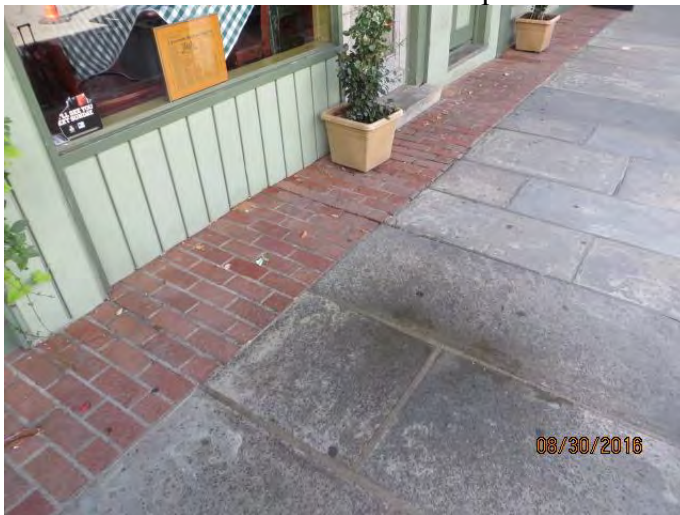
Photo 41 Water on sidewalk beneath photo 40

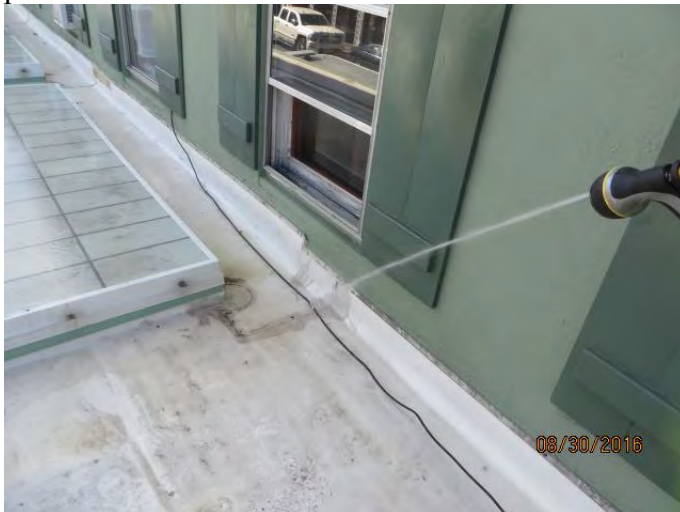
Photo 42 Water test open roof membrane at eighth window from the west shown in photos 31 and 32. Started water test at 10:08 AM

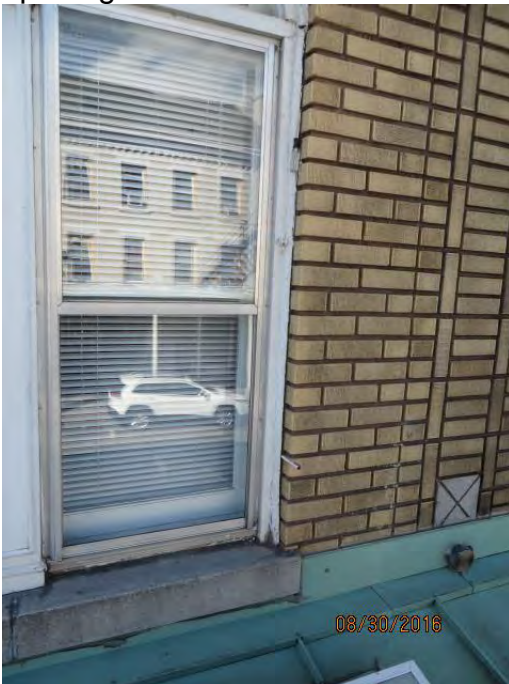
Photo 5 Roof canopy over 54 North Front Street, see probe in large window jamb opening

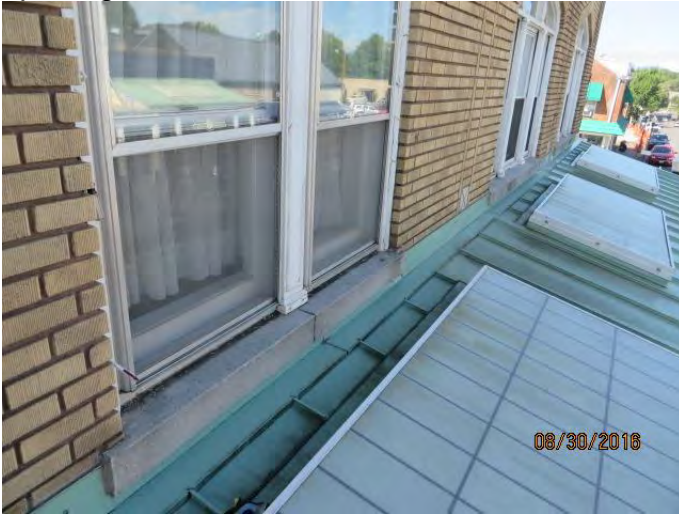
Photo 6 Roof canopy over 54 North Front Street, see pen in large window jamb opening

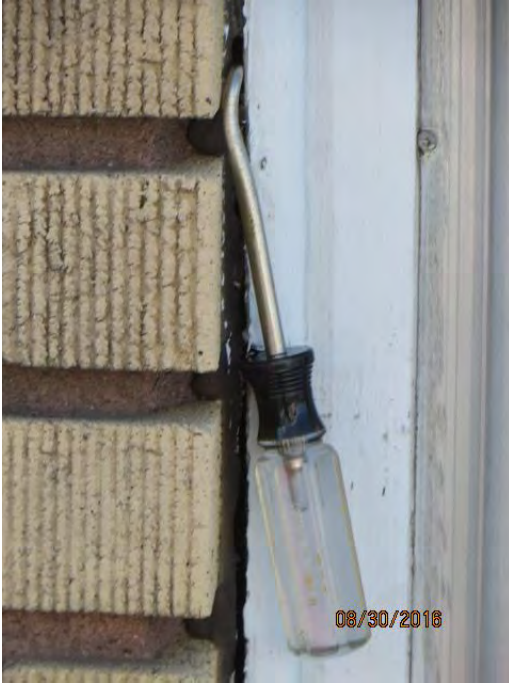
Photo 8 Probe in large window jamb opening

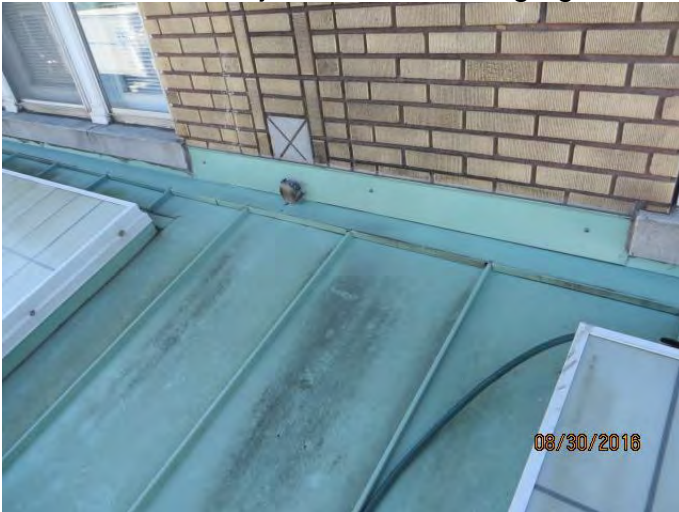
Photo 9 Electrical junction box through green metal base flashing

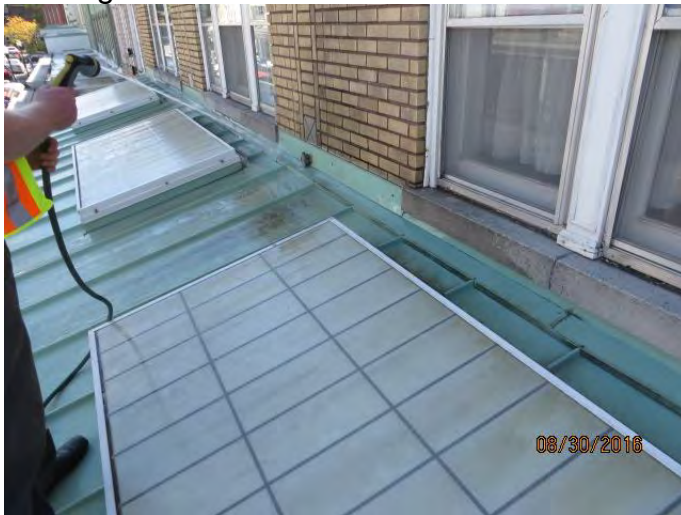
At 10:34 AM, water test began at the green metal base flashing, see photos 11 and 12. Leaks were observed, see photos 11 and 12, at the outer edge of the canopy, at 10:44 AM, not previously reported, see photos 13 thru 18.

Photo 11 Begin water test at green metal base flashings across the width of building

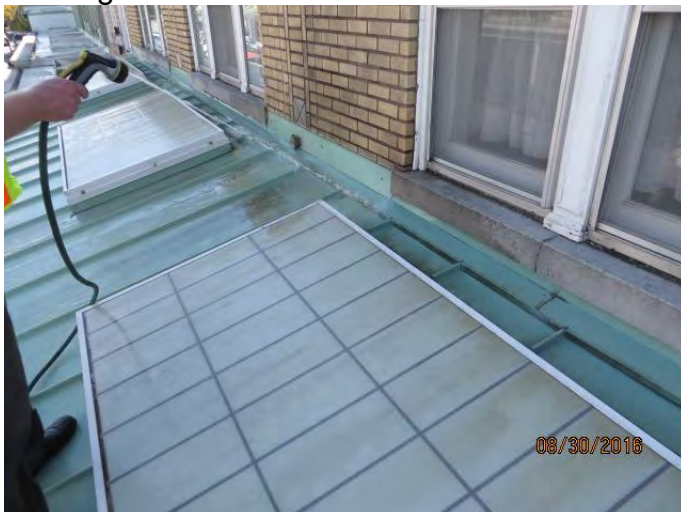
Photo 12 continuing water test at green metal base flashing across width of building

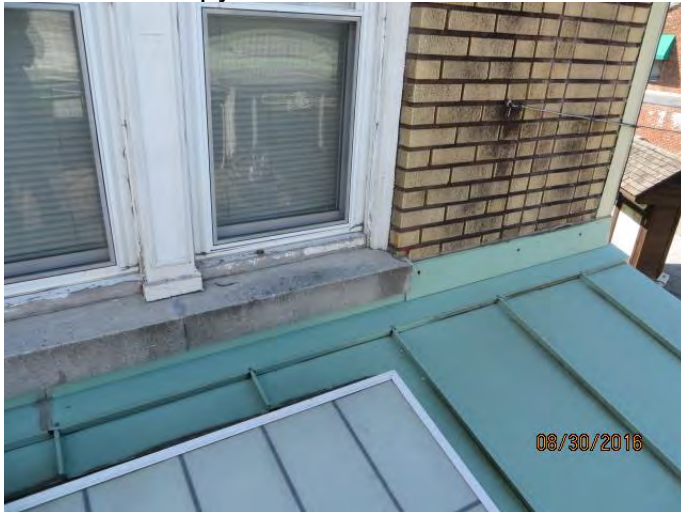
Photo 2 Canopy roof over 58 N. Front St.

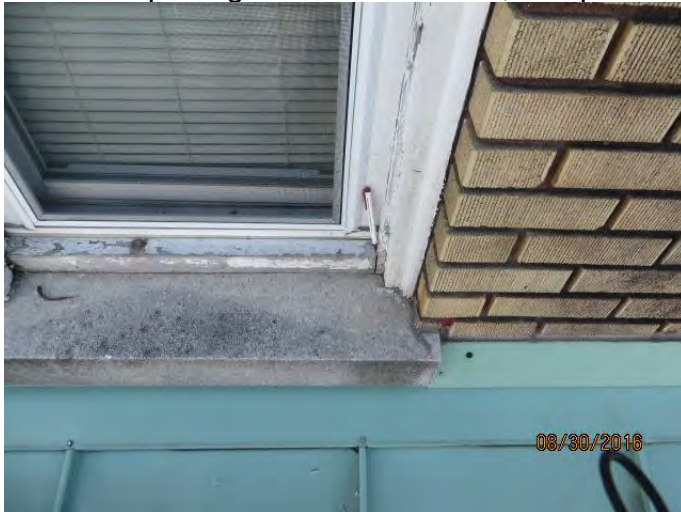
The wooden window trim has several cracks that could allow water to enter the building, see photos 3, 4, 5 and 6.

Photo 5 Opening in window sill trim, see pen

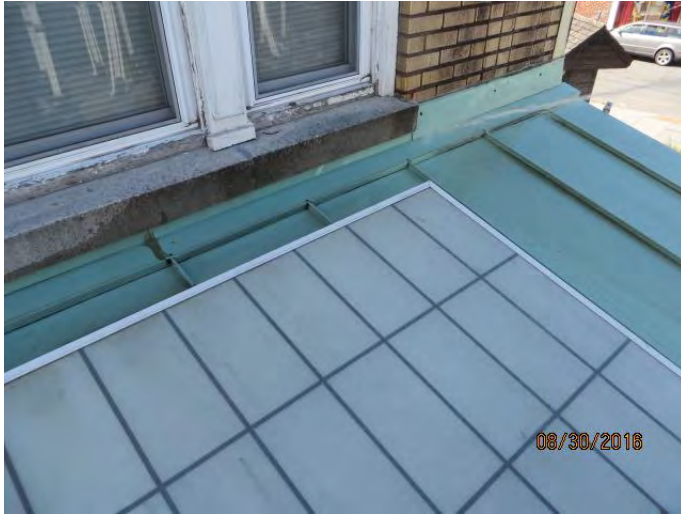
Photo 7 Begin water test on green metal base flashing at 11:08 AM across width of 58 N. Front St.

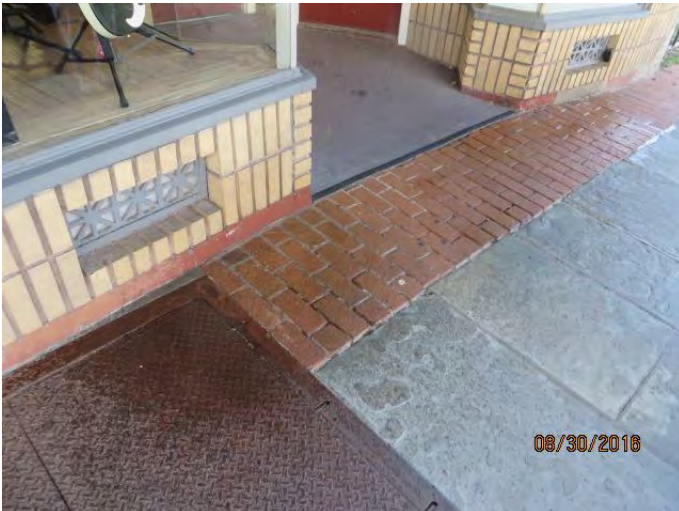
Within a minute of water testing commencement across the green metal base flashing, water began to pour out from between the building and the canopy, see photos 9 thru 12.

Photo 12 Water on sidewalk across the front of 58 N. Front St.

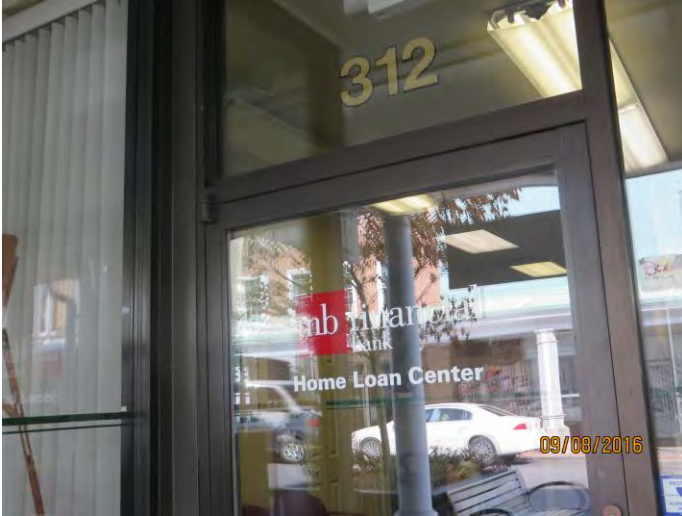
Photo 1 Front Entrance to 312 Wall Street

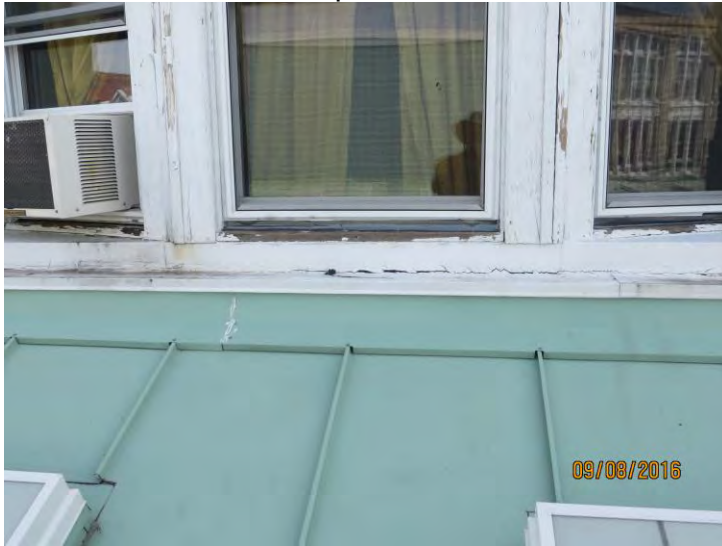
Photo 7 Window sills taped off for water test

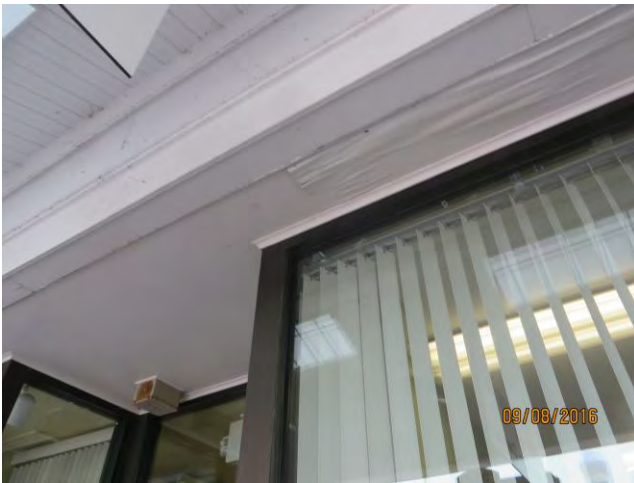
There is a large crack along the water table across the building's front, see photos 9, 10 and 11. Water test began at 10:47 AM focused on the water table crack and leaks appeared at 10:48 AM, see photos 12 thru 17.

Photo 13 At 10:48 AM, water drops appeared on the soffit below the water test area

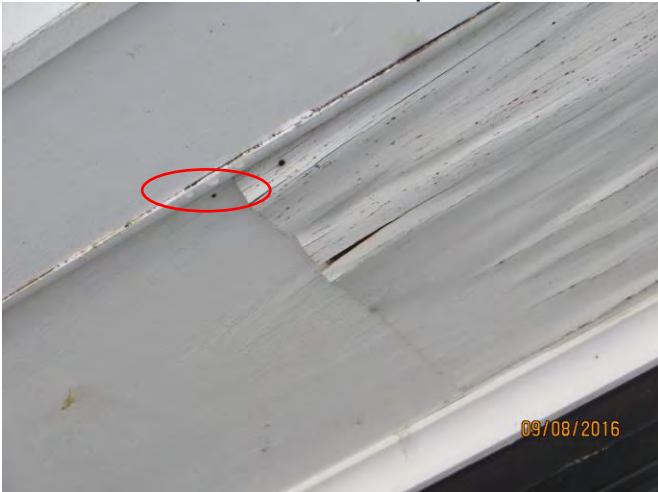
Photo 14 soffit with water drops. The water drops are difficult to see in the photo
