Canopy Framing Investigation  
Pike Plan Restoration Project  
Wall Street and North Front Street  
Kingston, New York

*C.T. Male Project No. 15.5150*

**CANOPY FRAMING INVESTIGATION  
PIKE PLAN RESTORATION PROJECT  
KINGSTON, NEW YORK**

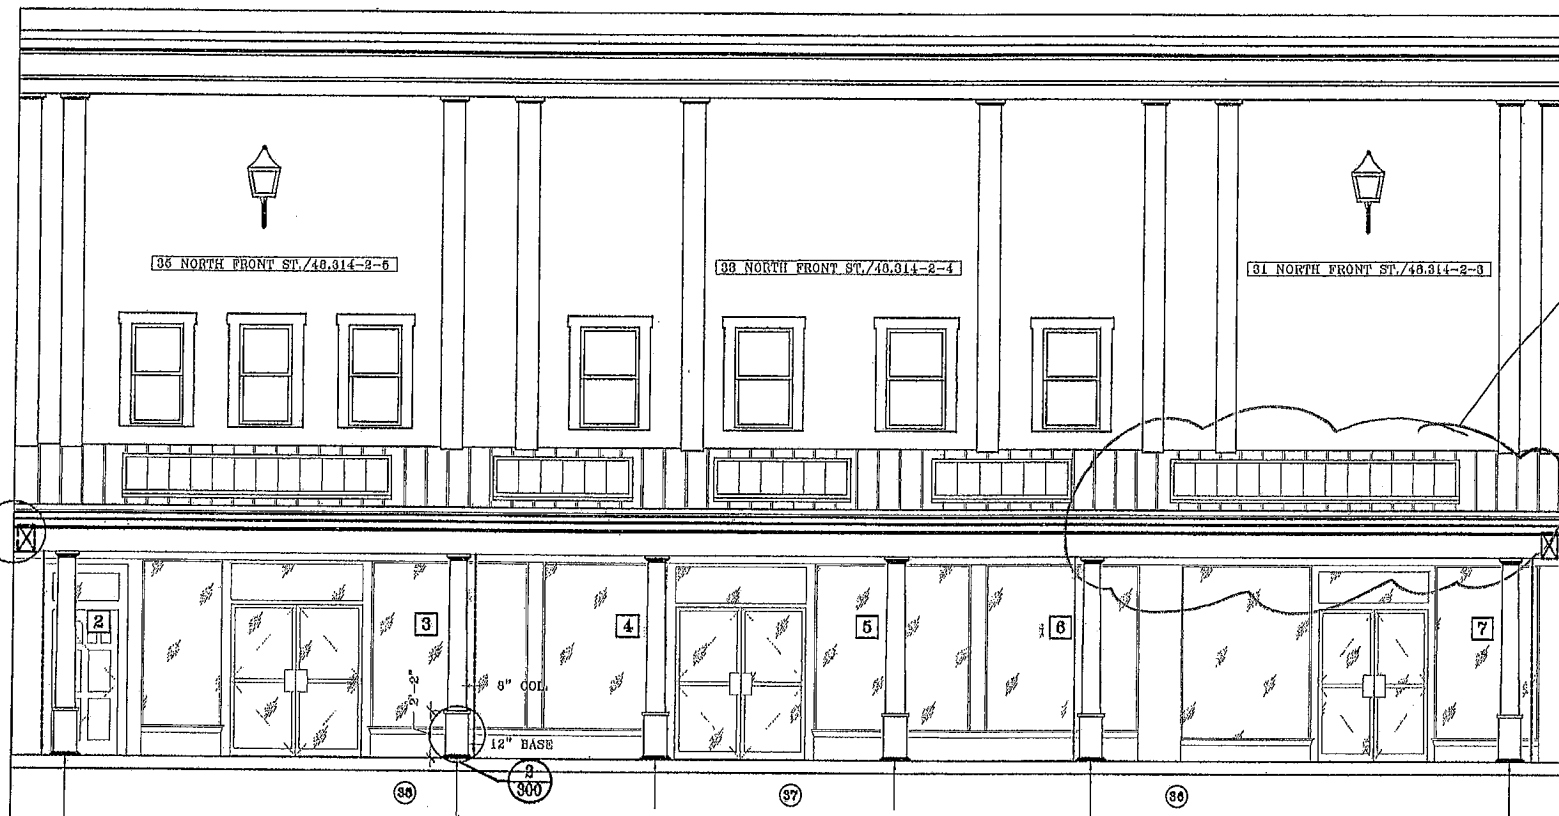
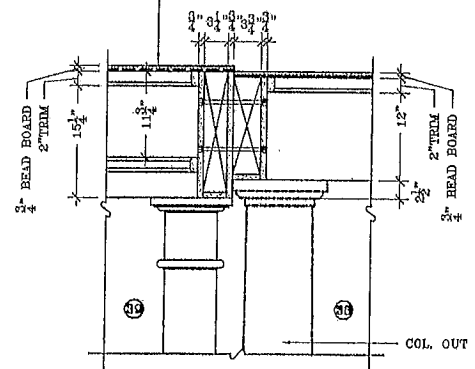
FRAMING LOCATION #1  
31 NORTH FRONT STREET

6 ALIKE / 12" TUSCAN SQ. BASE  
REMOVE AND REPLACE ALL COLS IN BAYS (36,37,38.) W/ 6" ROUND FIBERGLASS COLS. FABRICATE NEW GALV. BASE PLATES W/ NEW ANGLES. INSTALL NEW ROUND COL. BASES. BUILD NEW ROOF & SKYLIGHTS. INSTALL CHILING, INSTALL TRIM. FINISH FOR CHILING, FASOIA, TRIM COLS. TYP.  
NEW LIGHTING AND ELECTRICAL (TYP.)

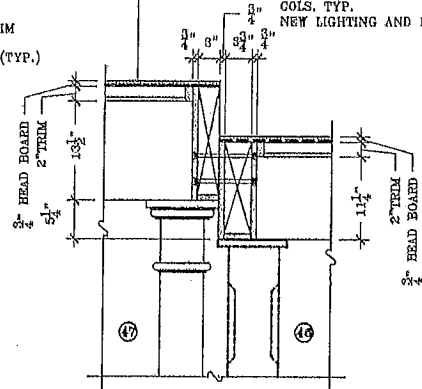
N FRONT STREET  
 SW ELEV.  
 & ROOF PLAN

4 ALIKE / 12" TUSCAN SQ. BASE  
INSTALL GALV. PLATES W/ NEW STL.  
ANGLES +/- 10" INTO NEW BASES  
INSTALL NEW COL. BASES.  
BUILD NEW ROOF & SKYLIGHTS  
REPAIR FASCIA & SOFFIT  
INSTALL CEILING, INSTALL TRIM.  
FINISH FOR CEILING, FASCIA, TRIM  
COLS. TYP.  
NEW LIGHTING AND ELECTRICAL (TYP.)

9 ALIKE / 12" TUSCAN SQ. BASE  
CUT EXIST'G ANGLES TO +/- 10"  
INSTALL NEW COL. BASES  
INSTALL NEW ROOFING & SKYLIGHTS.  
INSTALL CEILING & TRIM.  
FINISH FOR CEILING, FASCIA, TRIM  
COLS. TYP.  
NEW LIGHTING AND ELECTRICAL (TYP.)

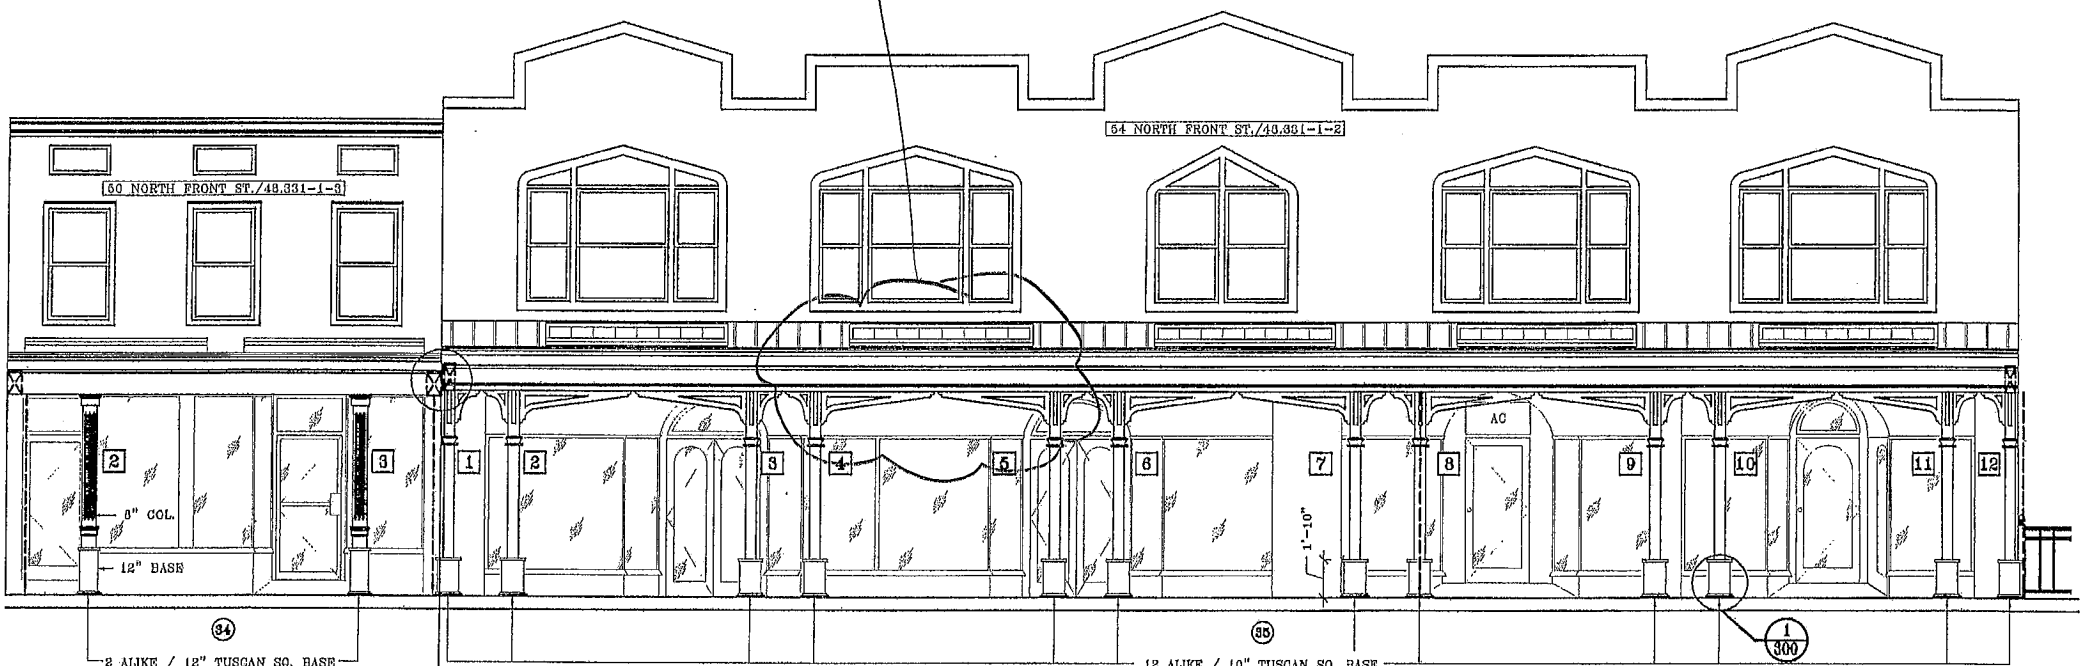
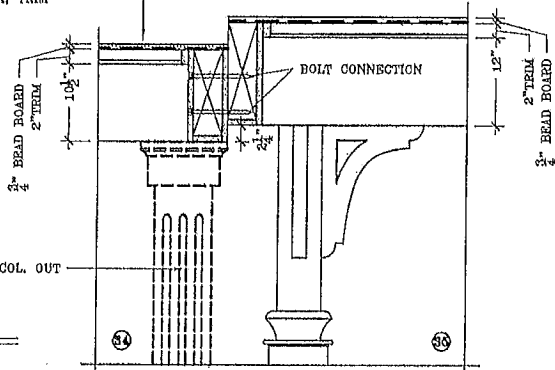
FRAMING LOCATION #3  
 54 NORTH FRONT STREET

34  
 2 ALIKE / 12" TUSCAN SQ. BASE -  
 CUT EXIST'G ANGLES TO 18" FOR NEW  
 CONNECTION, CUT EXIST'G COLS.  
 INSTALL NEW COL BASES.  
 INSTALL NEW ROOFING & SKYLIGHTS.  
 INSTALL CEILING & TRIM.  
 FINISH FOR CEILING, FASCIA, TRIM  
 COLS. TYP.

35  
 12 ALIKE / 10" TUSCAN SQ. BASE -  
 CUT OFF COLS. @ TRANSITION FROM  
 SQUARE TO ROUND. EXST'G ANGLES TO  
 REMAIN. INSTALL NEW COL BASES.  
 ATTACH COLS. TO BASE W/ EXISTING L'S  
 BUILD NEW ROOF & SKYLIGHTS.  
 INSTALL CEILING, INSTALL TRIM.  
 FINISH FOR CEILING, FASCIA, TRIM  
 COLS. TYP.  
 NEW LIGHTING AND ELECTRICAL (TYP.)

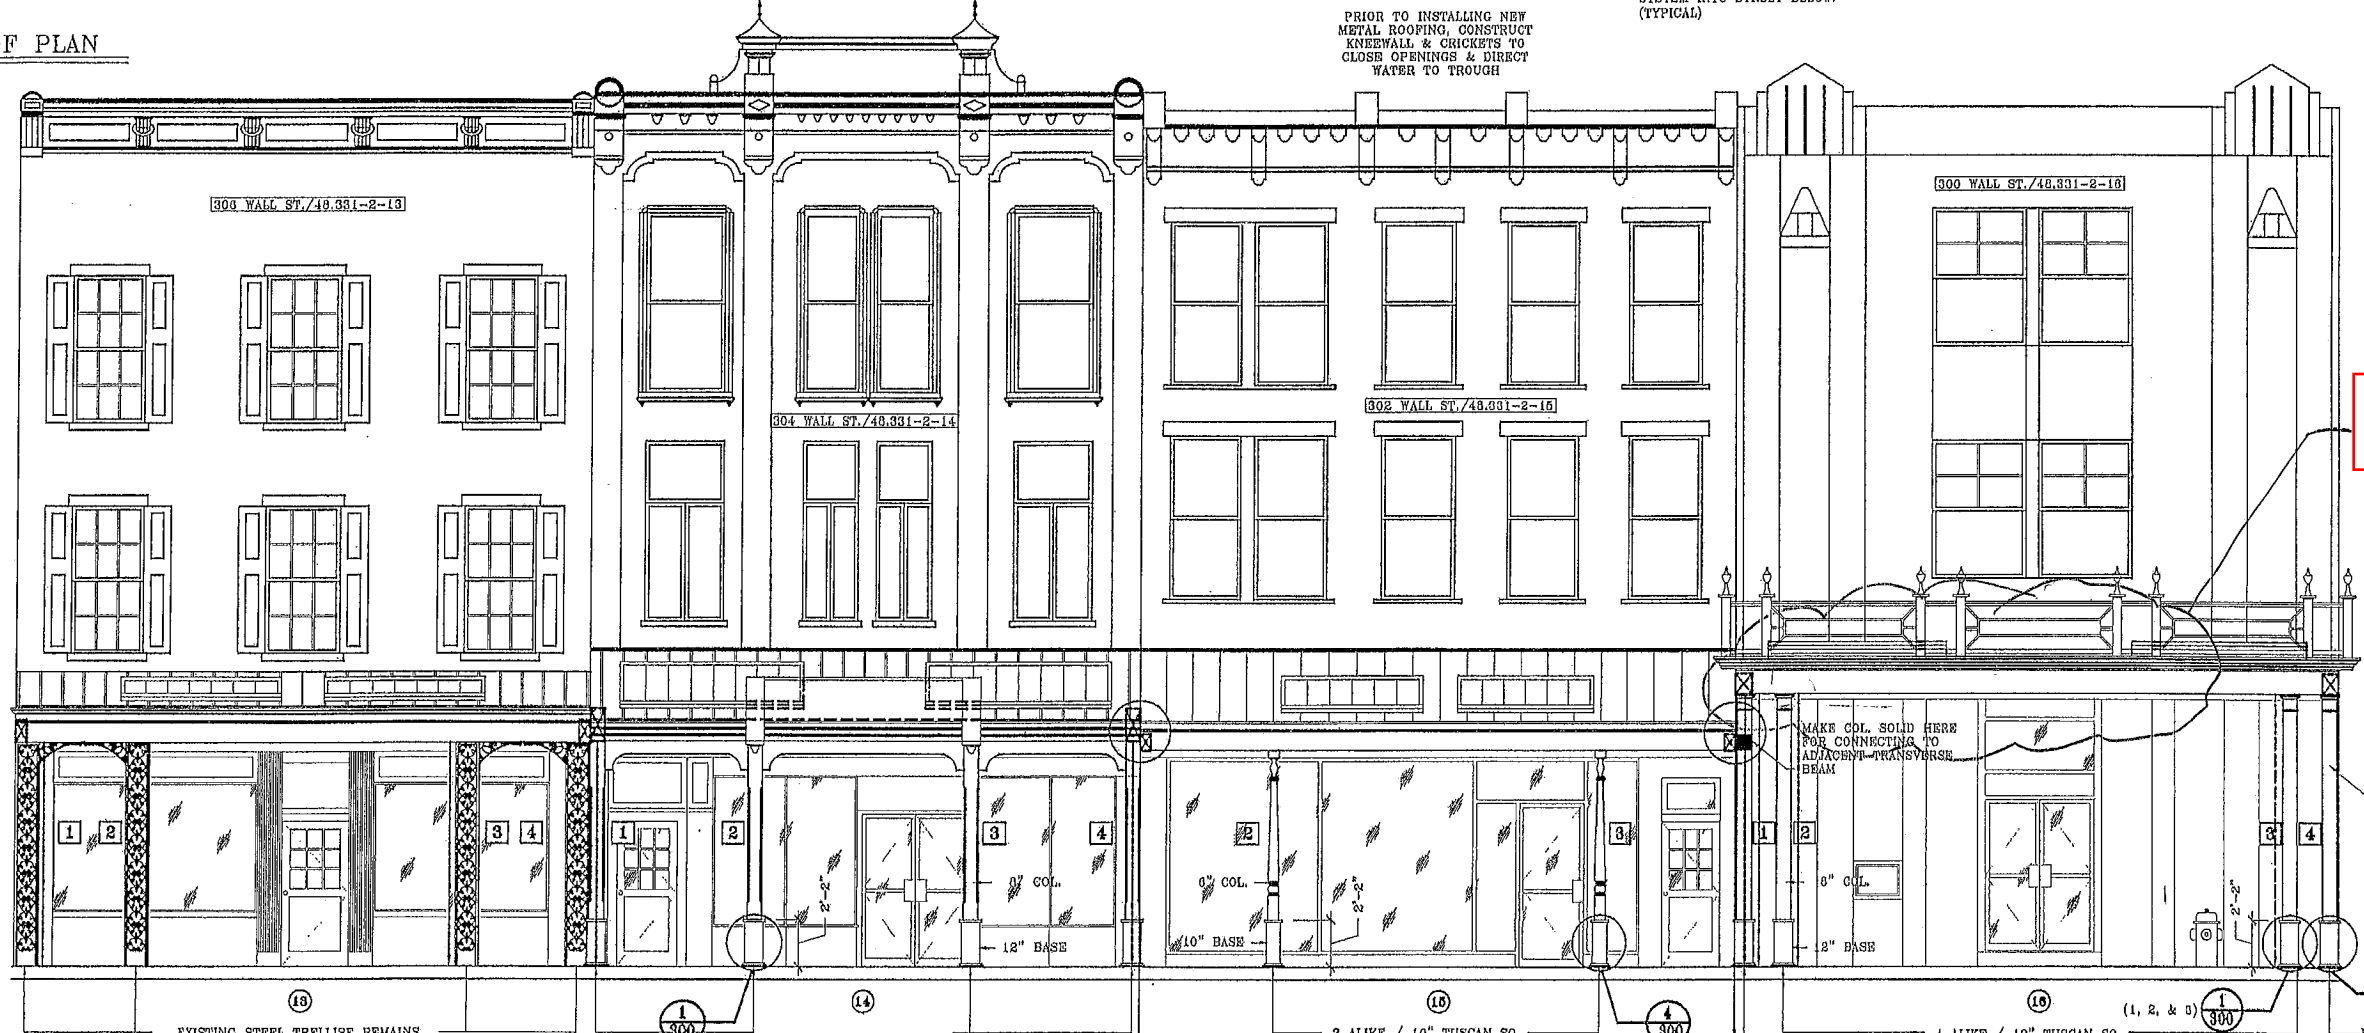
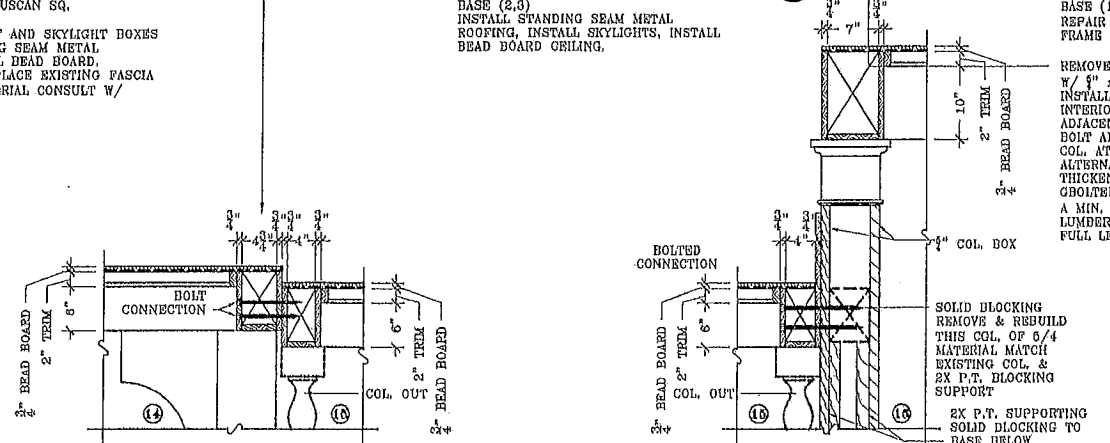
FRAMING LOCATION #4  
300 WALL ST.

EXISTING TROUGH TO NEW WHITE LEADERS  
NOTE: AT ROOF JUNCTIONS WHERE OPENINGS EXIST BETWEEN ADJACENT ROOFS FRAME CLOSURE & SHEATH EXT. SIDE W/PLYWD & FINISH W/CS & WATER SHIELD + EPDM.  
EXISTING TROUGH TO NEW WHITE LEADERS  
EXISTING TROUGH TO NEW WHITE LEADERS  
NOTE: DRAINAGE TROUGH & DOWN SPOUT LOCATIONS REMAIN. INSTALL SMOOTH WHITE PLASTIC LEADERS & ACCESSORY PARTS TO COMPLETE DRAINAGE SYSTEM INTO STREET BELOW. (TYPICAL)  
EXISTING TROUGH TO NEW WHITE LEADERS

NOTE:  
CEILING FINISH ON EXISTING RAFTERS:  
NANYUCKE® BEAD BOARD OR EQUIV.  
MATERIALS TO BE EXTERIOR GRADE,  
LATEX PAINT OVER PRIMER,  
EGG SHELL WHITE W/ SATIN FINISH.  
PAINT TRIM & COL W/ 0% VOC LATEX  
PAINT OVER PRIMER EGG SHELL WHITE  
W/ SATIN FINISH (TYPICAL).

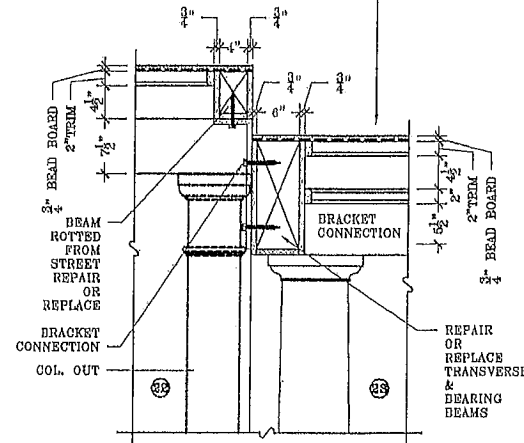
BUILD NEW ROOF & SKYLIGHTS  
 NO ANGLES EXIST AT THIS LOCATION.  
 FABRICATE & INSTALL NEW GALV. STL. BASE PLATE W/ STL. ANGLES APPROX. 18" LONG. CONNECT BASE TO FOOTING.  
 INSTALL NEW COL. BASES.

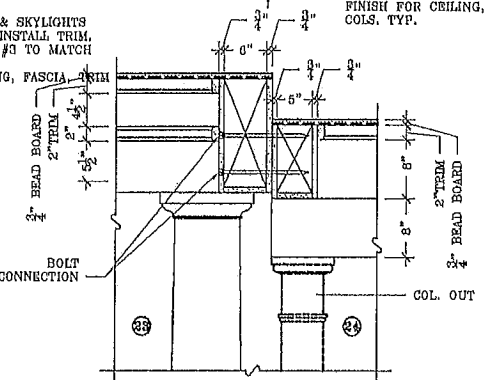
STEEL ANGLES EXIST, @ APPROPRIATE LENGTH. INSTALL #4 REBAR CONNECTOR. INSTALL NEW COL. BASES. INSTALL NEW ROOFING AND SKYLIGHTS. INSTALL CEILING, INSTALL TRIM. FINISH FOR CEILING, FASCIA, TRIM COLS. TYP.
