C.T. MALE ASSOCIATES

Re: *Results of Water Spray Testing*
Pike Plan Restoration Project
Kingston, NY
C.T. Male Associates Project No. 15.5150

REF: Kingston-Pike Plan: Water Tests
34 North Front Street: Dominick's Café/Dream Weavers

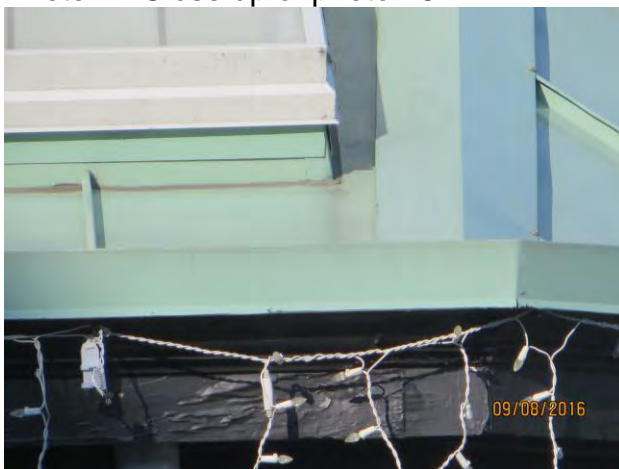
Photo 16 Previously not reported leak at top of column near white downspout

Photo 17 Close up of photo 16

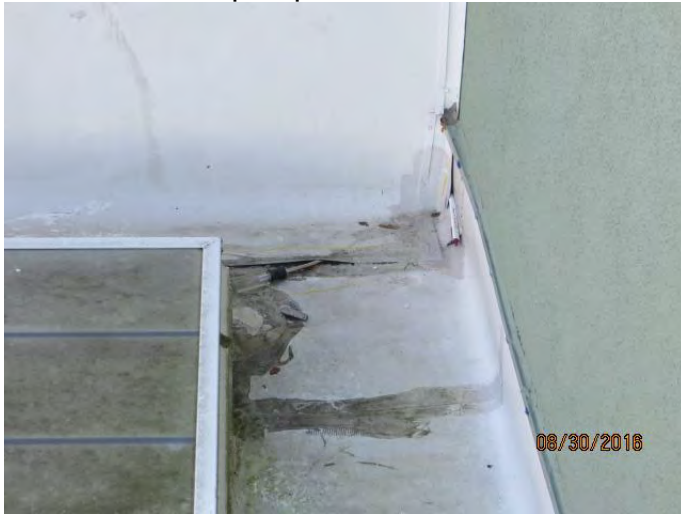
There are several openings in the roof membrane that allows water to enter, see photos 4 thru 9 and 31 and 32. These locations were water tested and leaks were observed at each locations in a very short period of time, see photos 33 thru 43. Water testing of the roof membrane at the open seam adjacent to the second skylight, started at 9:56 AM and water was observed below at 10:05 AM. Water testing at the base flashing opening started at 10:08 AM and water was observed below at 10:13 AM.

Photo 5 Close up of photo 4

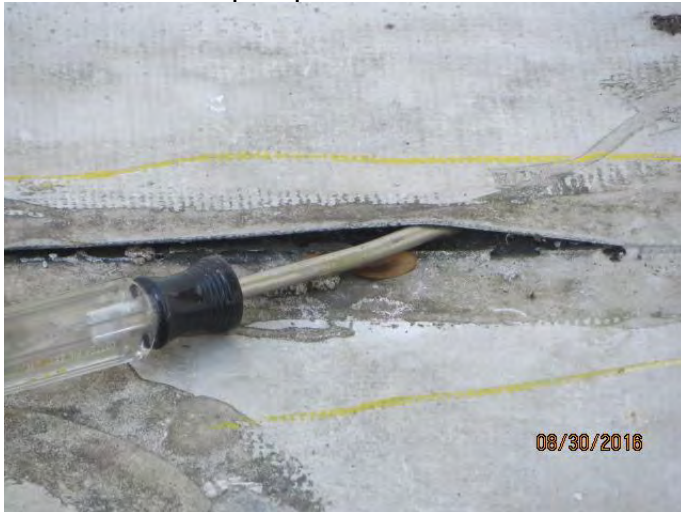
Photo 6 Close up of photo 5

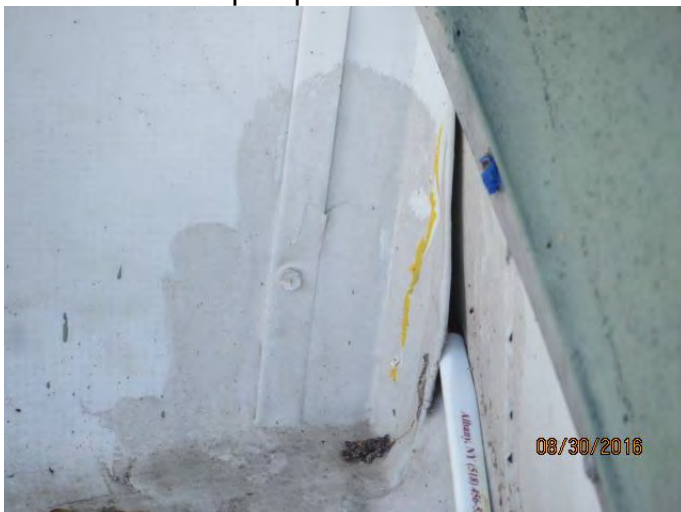
Photo 7 Close up of photo 5

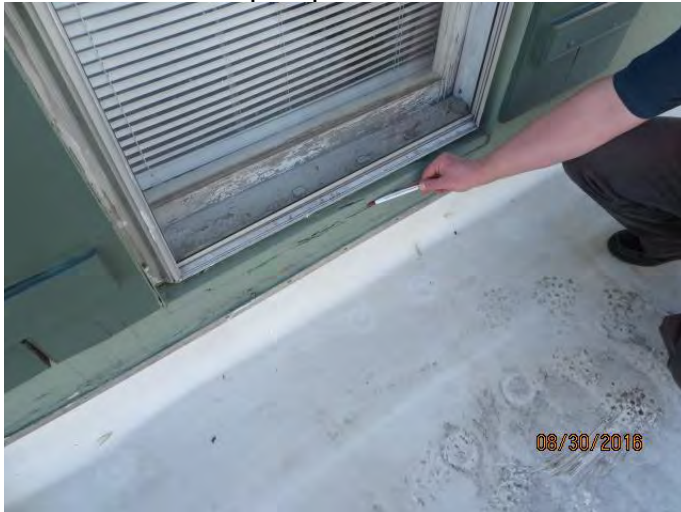
There are many opportunities for water infiltration through the windows, see photos 10 thru 18 and 21 thru 28.

Photo 11 Close up of photo 10

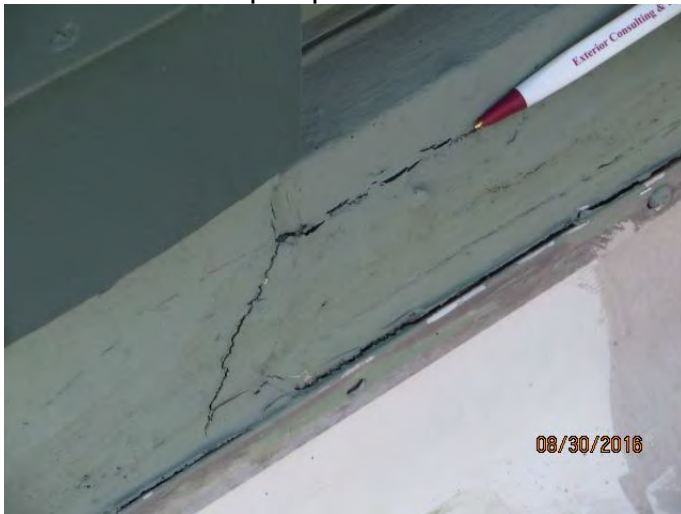
Photo 17 Crack in wood above base flashing

Photo 18 Close up of photo 17

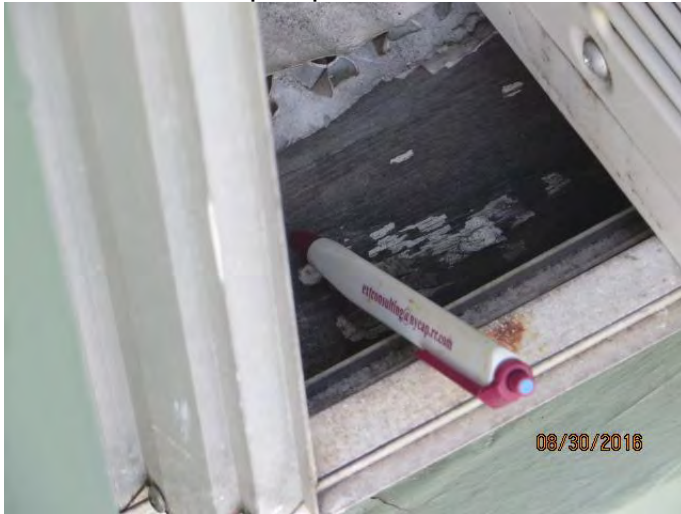
Photo 21 Sixth window from the west end, air conditioner closure not at window exterior, allows water entry

Photo 22 Close up of photo 21

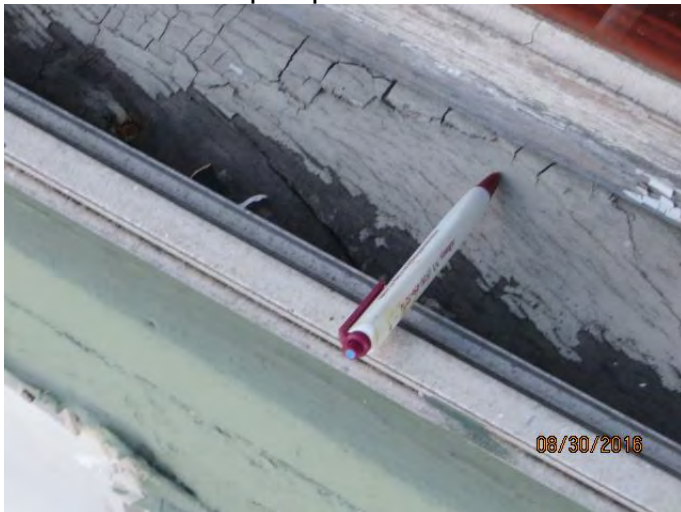
Photo 24 Close up of photo 23

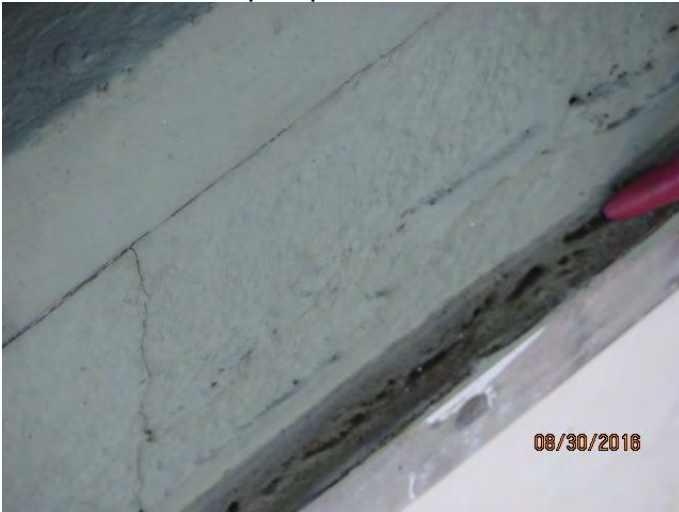
Photo 29 Ninth window from the west end (farthest east), cracks in sealant at top of base flashing

Photo 30 Close up of photo 29

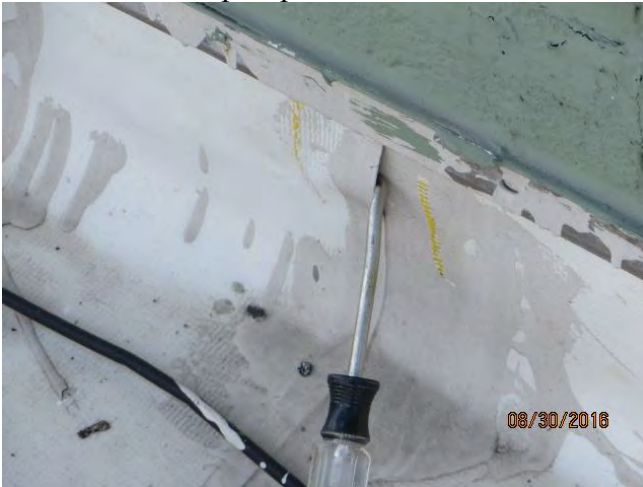
Photo 32 Close up of photo 31

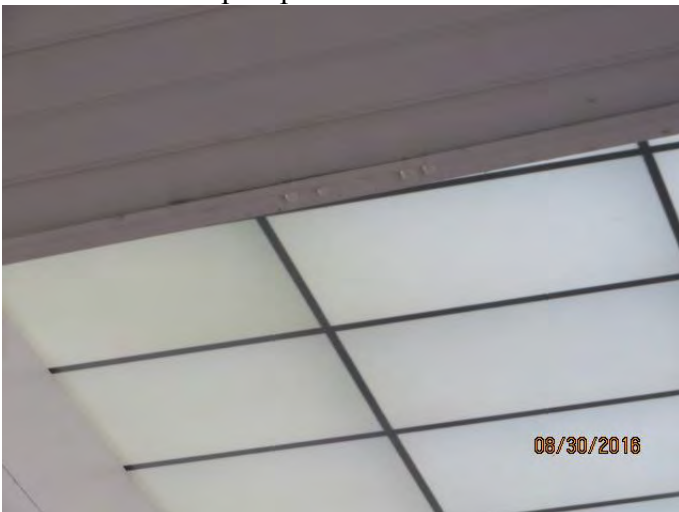
Photo 38 Water observed at skylight fascia at 10:05 AM beneath water test of photo 37

Photo 39 Close up of photo 38

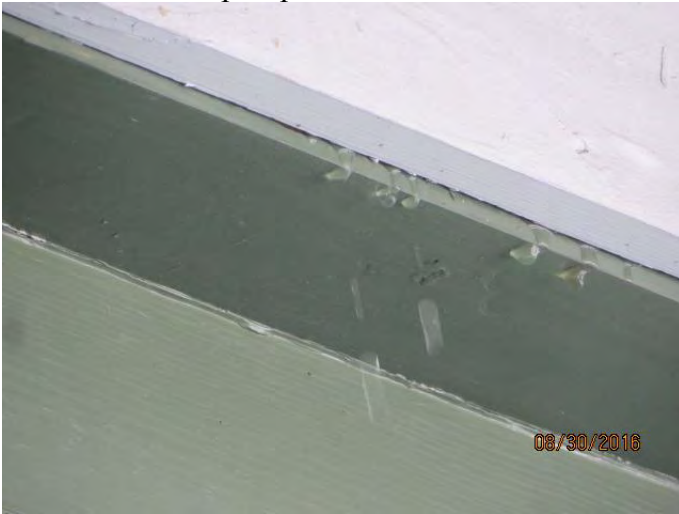
Photo 43 At 10:13 AM water observed at base of white fascia board beneath water test of photo 42

Photo 44 Close up of photo 43

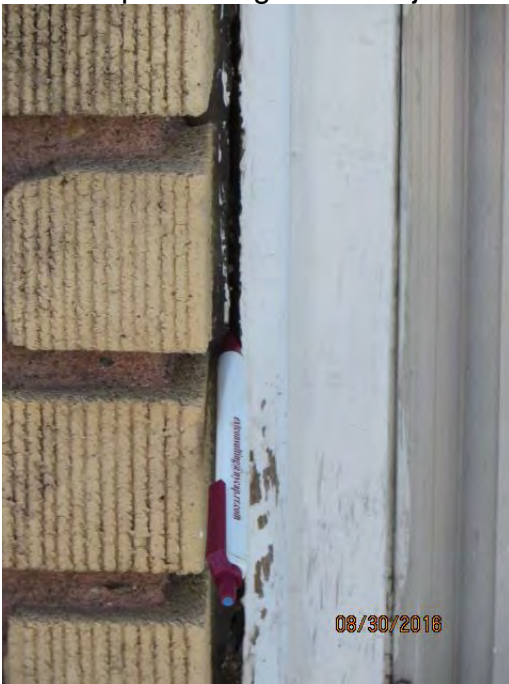
Photo 7 pen in large window jamb opening of photo 6

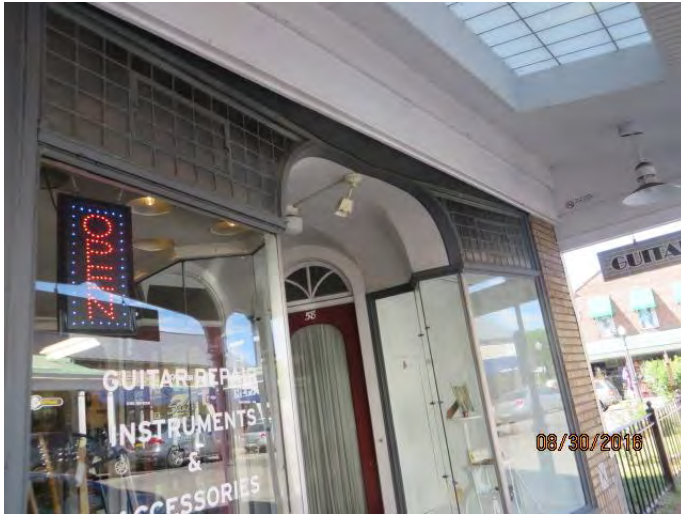
Photo 1 Guitar Store entrance

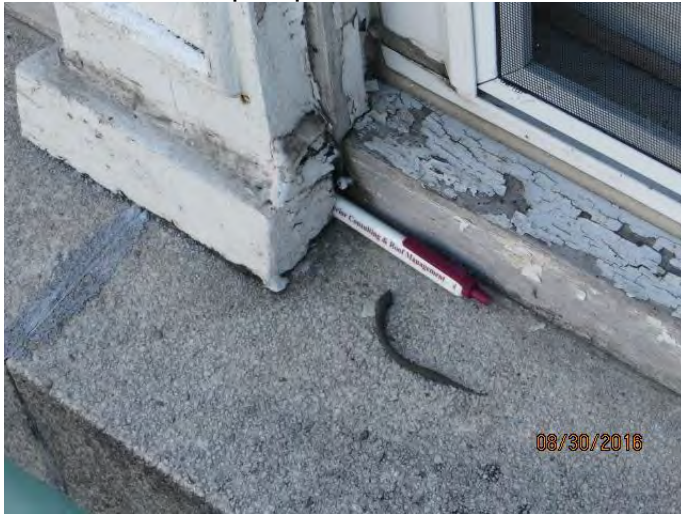
The wooden window trim has several cracks that could allow water to enter the building, see photos 3, 4, 5 and 6.

Photo 4 Close up of photo 3

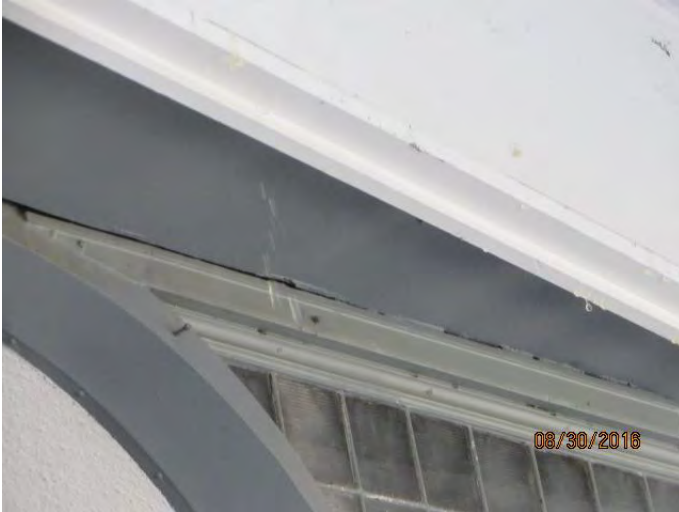
Within a minute of water testing commencement across the green metal base flashing, water began to pour out from between the building and the canopy, see photos 9 thru 12.

Photo 10 Close up of photo 9

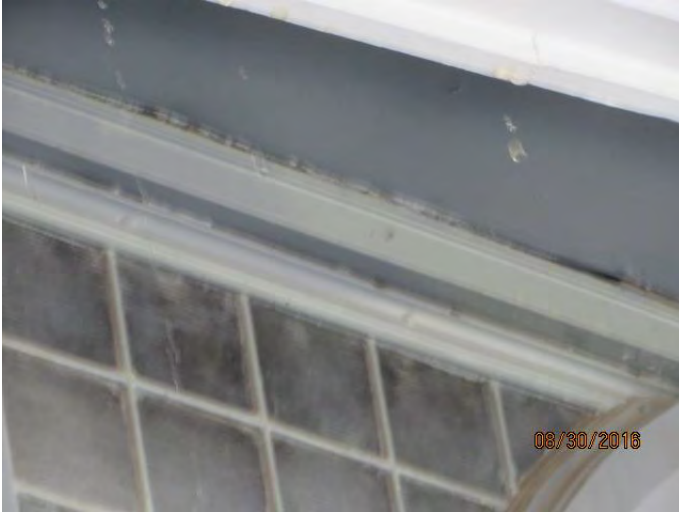
Photo 11 Close up of photo 9
